## Testimony of Indigo Null

### SB0563 – Real Property – Actions to Repossess – Judgment for Tenants and Proof of Rental Licensure

Hearing before the Senate Judicial Proceedings Committee, Feb. 22, 2022

## Inspection Report

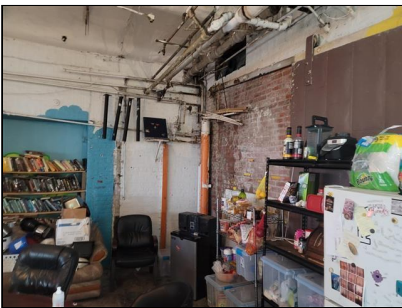
1.3 Item 8(Picture)

(2) Because this home was built before 1978, there is a good chance it has lead-based paint. In 1978, the federal government banned consumer uses of lead-containing paint as a potential health hazard, but some states banned it even earlier. Lead from paint, including lead-contaminated dust, is one of the most common causes of lead poisoning. Chipping, cracking, flaking and deteriorated paint was observed widespread throughout the building. All painted surfaces in the building should be repainted and repaired by a lead abatement contractor.

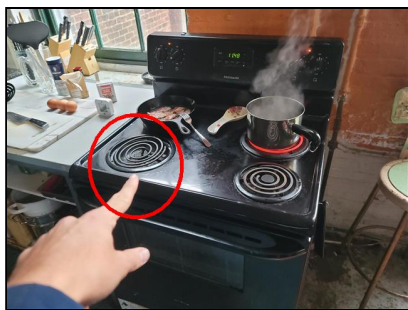
3.2 Item 1(Picture)

(2) The electric stove had one or more inoperable stove top burners. The Inspector recommends<sup>27</sup> service by a qualified technician.

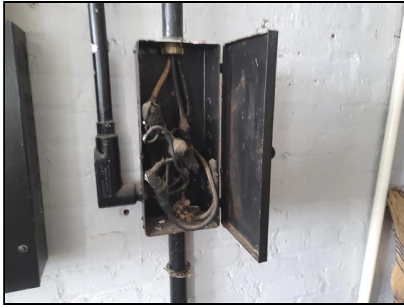
5.3 Item 2(Picture)

🔧 (2) Some of the electrical junction boxes had open wires and should be secured close to prevent electrical shock.<sup>31</sup>

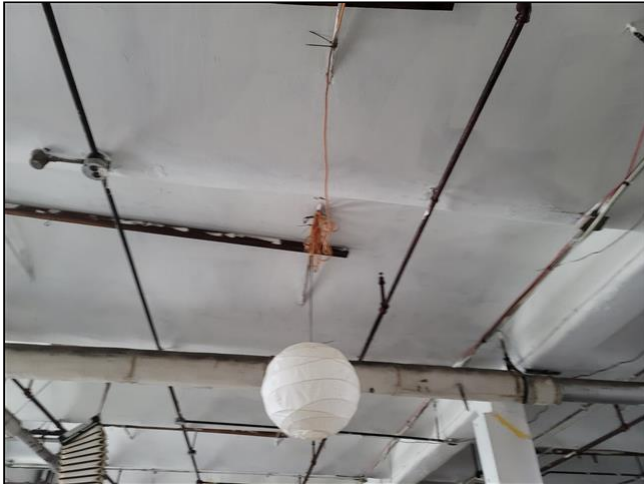
5.3 Item 3(Picture)

🔧 (3) Extension cords used as house wiring visible in the throughout the apartment at the time of the inspection is a potential fire hazard. The Inspector recommends removal of the extension cord and proper wiring be installed by a qualified electrical contractor.

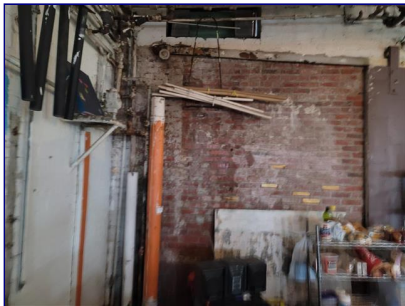
1.1 Item 2(Picture)

(2) Stains on the walls in the visible in many areas at the time of the inspection appeared to be the result of moisture intrusion. The moisture meter showed elevated moisture levels in the affected areas at the time of the inspection, indicating that the leakage has been recent. The Inspector recommends consultation with a qualified contractor to discuss options and costs for correction and repair.

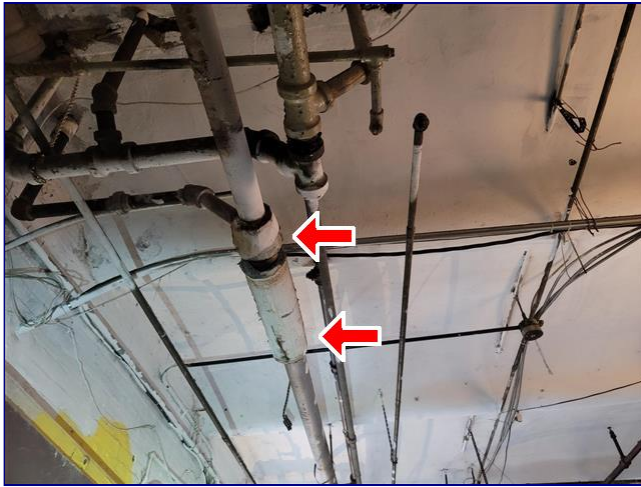
1.3 Item 1(Picture)

(1) Materials in the on the boiler distribution pipes throughout the home may contain asbestos. Asbestos has been classified as a known human carcinogen (a substance that causes cancer) by the U.S. Department of Health and Human Services, the EPA, and the International Agency for Research on Cancer. People who become ill from asbestos are usually those who are exposed to it on a regular basis, most often in a job where they work directly with the material or through substantial environmental contact. To cause health problems, asbestos must be in a form in which the fibers can be inhaled, such as when it is cut, torn, or sanded. The insulation on these pipes of concern had damage and deterioration that can be friable. The only way to know for certain whether asbestos is in a particular product or material is to have testing performed. A sample was taken and will be sent to a laboratory for testing.

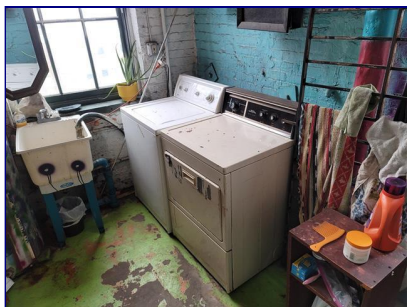
1.7 Item 1(Picture)

Laundry appliances were not functioning properly and should be repaired by a qualified technician.

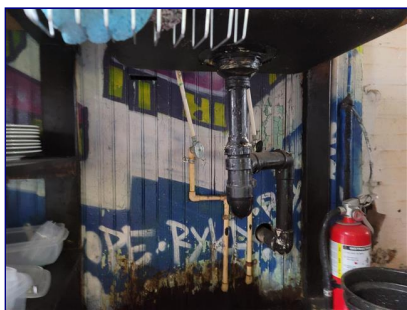
3.1 Item 1(Picture)

- ✎ (1) Leaking connections at the trap assembly beneath the kitchen sink should be repaired to avoid future/additional damage to the cabinet floor and possibly the wall/floor structures below. The Inspector recommends repair by a qualified plumbing contractor.

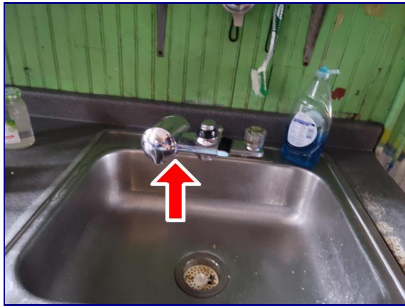
3.1 Item 2(Picture)

- ✎ (2) The kitchen sink faucet leaks when turned off.

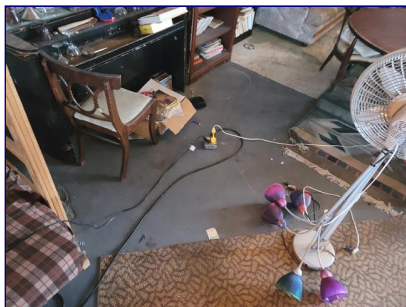
5.1 Item 1(Picture)

(1) The number of electrical receptacles in the home was inadequate and extension cords were used throughout the unit. This condition is potential fire hazard and should be corrected.

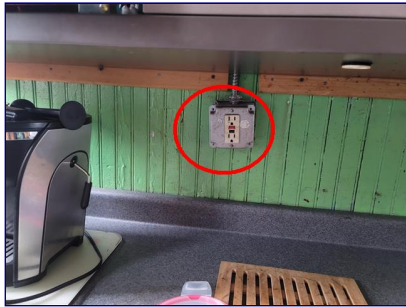
5.1 Item 8(Picture)

(3) Some electrical receptacles in the home were inoperable at the time of the inspection. The Inspector recommends service by a qualified electrical contractor.

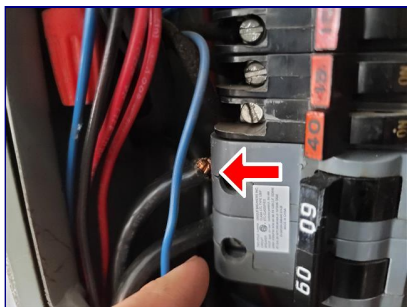
5.6 Item 1(Picture)

- 🔧 Strands from the service entrance wires were cut and may cause the the wires to overheat. The Inspector recommends evaluation and repair as necessary by a qualified licensed electrician.

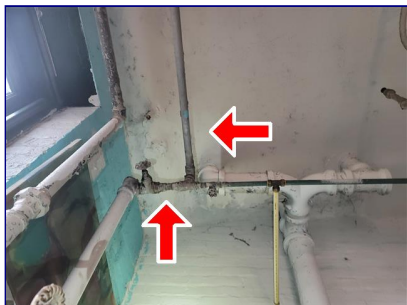
6.0 Item 1(Picture)

- (1) Some of the visible water distribution pipes were galvanized steel. These pipes are old, and of a material no longer installed for this purpose due to bore shrinkage from accumulation of interior corrosion that over time reduces water flow. These pipes may need to be replaced soon.
