Testimony of Indigo Null

SB100 – Actions to Repossess – Proof of Rental Licensure Hearing before

Inspection Report

Anna Velicky

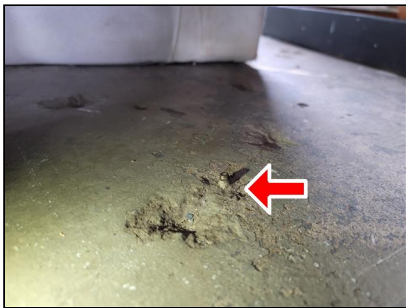
1.0 Item 1(Picture)

All floors were concrete and no flooring was installed. Many areas had metal bolts sticking out of floor which are a hazard.

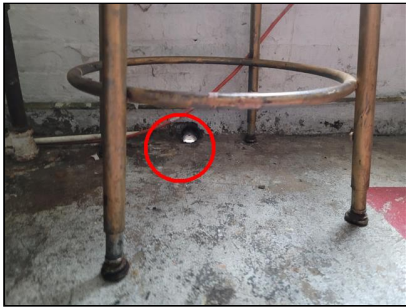
1.1 Item 1(Picture)

(1) Holes in the exterior walls were observed in many areas.

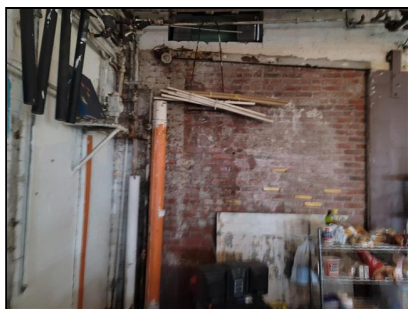
1.1 Item 2(Picture)

- 17
🔧 (2) Stains on the walls in the visible in many areas at the time of the inspection appeared to be the result of moisture intrusion. The moisture meter showed elevated moisture levels in the affected areas at the time of the inspection, indicating that the leakage has been recent. The Inspector recommends consultation with a qualified contractor to discuss options and costs for correction and repair.

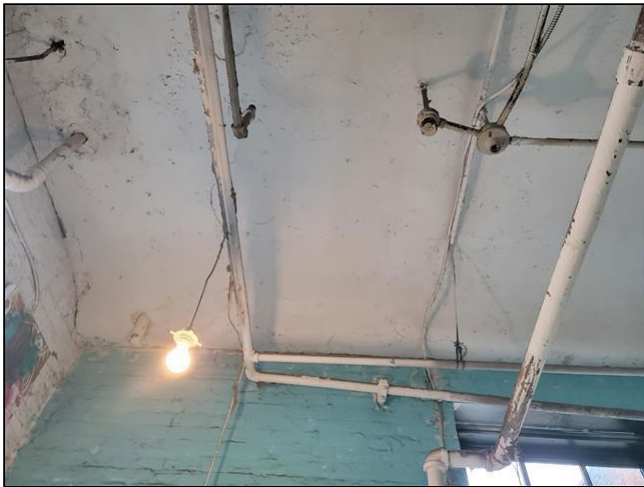
1.2 Item 1(Picture)

- 🔧 (1) Many interior light fixtures in the home were damaged or inoperable and extension cords with lighting was used instead. This condition is a potential fire or shock/electrocution hazard. The Inspector recommends repairs be performed by a qualified electrical contractor.

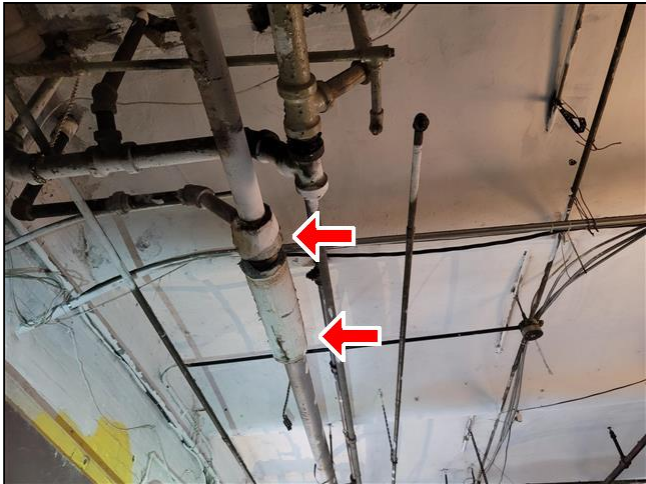
1.3 Item 1(Picture)

¹⁹
(1) Materials in the on the boiler distribution pipes throughout the home may contain asbestos. Asbestos has been classified as a known human carcinogen (a substance that causes cancer) by the U.S. Department of Health and Human Services, the EPA, and the International Agency for Research on Cancer. People who become ill from asbestos are usually those who are exposed to it on a regular basis, most often in a job where they work directly with the material or through substantial environmental contact. To cause health problems, asbestos must be in a form in which the fibers can be inhaled, such as when it is cut, torn, or sanded. The insulation on these pipes of concern had damage and deterioration that can be friable. The only way to know for certain whether asbestos is in a particular product or material is to have testing performed. A sample was taken and will be sent to a laboratory for testing.

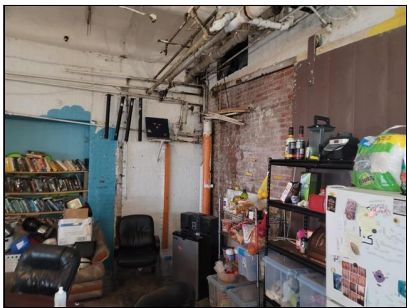
1.3 Item 8(Picture)

🔧 (2) Because this home was built before 1978, there is a good chance it has lead-based paint. In 1978, the federal government banned consumer uses of lead-containing paint as a potential health hazard, but some states banned it even earlier. Lead from paint, including lead-contaminated dust, is one of the most common causes of lead poisoning. Chipping, cracking, flaking and deteriorated paint was observed widespread throughout the building. All painted surfaces in the building should be repainted and repaired by a lead abatement contractor.

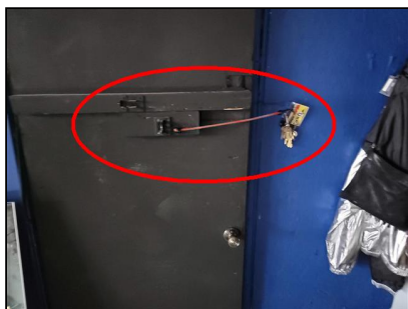
1.4 Item 1(Picture)

- 🔧 (1) Interior doors in the home were moderately damaged or deteriorated. This condition is a fire safety issue.

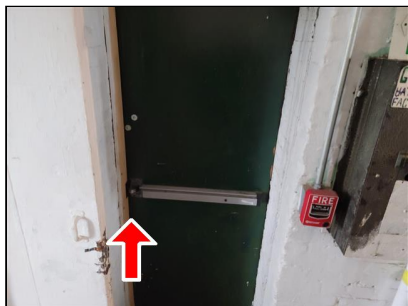
1.4 Item 3(Picture)

- 🔧 (2) The entry door did not have an operable locks and had sharp bolts sticking out. This condition is a fire hazard.

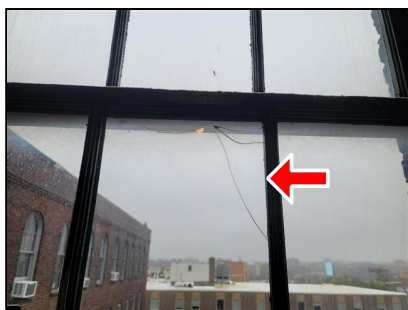
1.5 Item 1(Picture) bathroom

- 🔧 (1) One or more window in the unit had a cracked or broken pane.

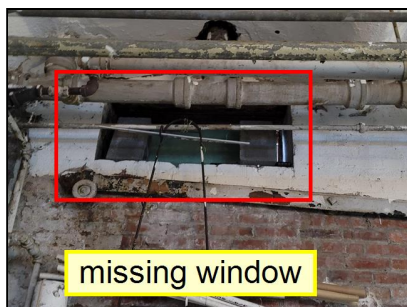
1.5 Item 2(Picture)

- 22
- ⚡ (2) The lower sash of many of the windows in the unit would not stay up when lifted and released, and fell with enough force to cause significant injury. The Inspector recommends replacement by a qualified contractor.
 - ⚡ (3) Windows in the home were generally old, deteriorated, had chipping paint and were inoperable. The Inspector recommends window replacement.
 - ⚡ (4) A window in the common area was boarded up with loose wood and cinder blocks allowing moisture and air leakage into the building.

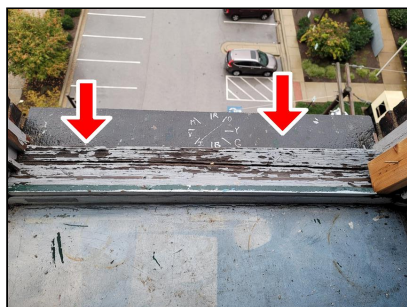
1.5 Item 3(Picture)

- ⚡ (5) Components of window sill exteriors were loose, damaged or deteriorated and needed maintenance to help prevent damage from moisture intrusion to the home materials, the exterior wall structure and to prevent development of microbial growth such as mold. All work should be performed by a qualified contractor.

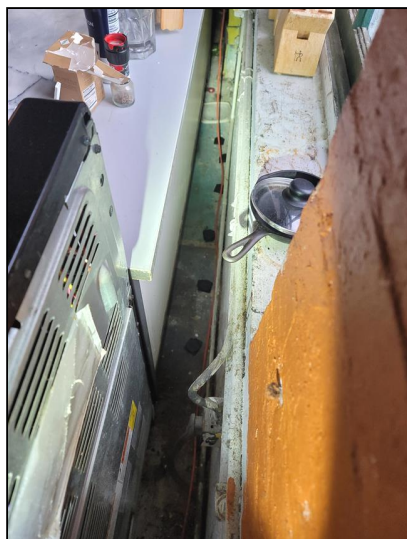
1.6 Item 1(Picture)

- ⚡ Signs of possible roach and pest infestation was observed and should be further evaluated and treated by a qualified pest control contractor.

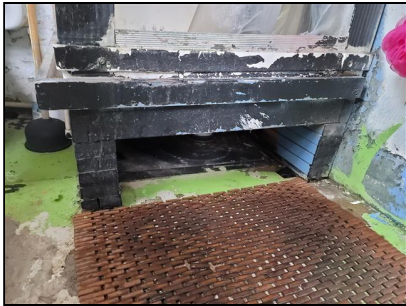
2.4 Item 2(Picture)

- (2) Water flow at the shower in the entry bathroom appeared to be inadequate. The Inspector recommends that you have this condition evaluated by a qualified plumbing contractor to determine the potential need and costs for correction.
- (3) Fungi growth was observed below the shower pan due to water entering from behind the shower walls. The Inspector recommends installing a new shower enclosure to prevent water leakage and mold growth. The mold growth should be remediated by a qualified professional.

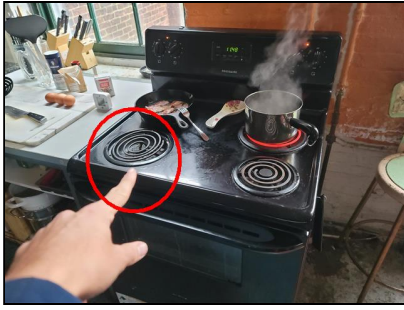
3.2 Item 1(Picture)

- 🔧 (2) The electric stove had one or more inoperable stove top burners. The Inspector recommends²⁷ service by a qualified technician.

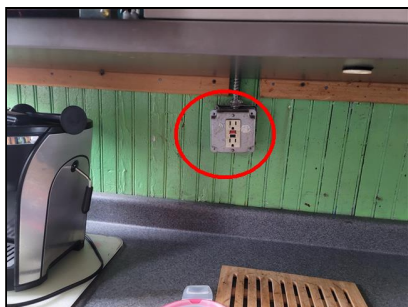
5.1 Item 8(Picture)

- 🔧 (3) Some electrical receptacles in the home were inoperable at the time of the inspection. The Inspector³⁰ recommends service by a qualified electrical contractor.

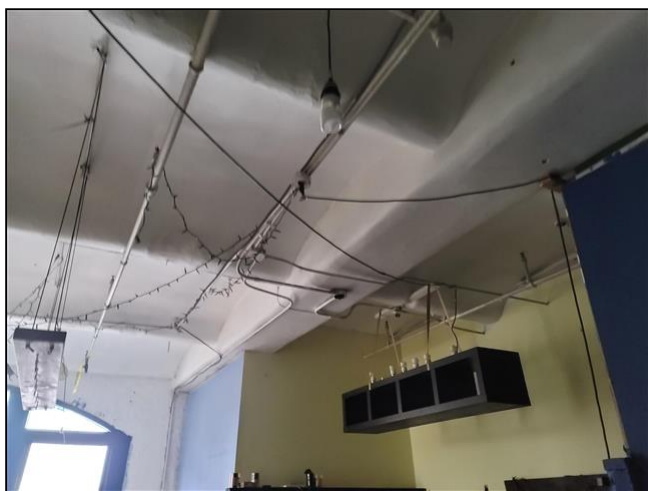
5.2 Item 1(Picture)

- 🔧 This unit did not have operable and enough light fixtures. Extension cords with lighting and string lights were used. This condition is a potential fire hazard.

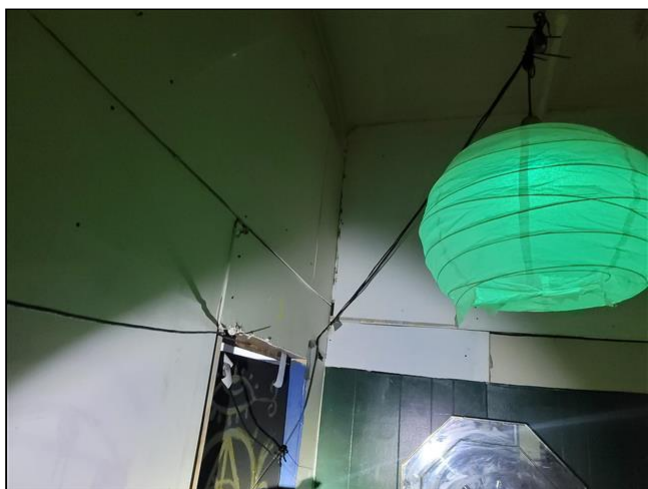
5.3 Item 1(Picture)

- 🔧 (1) One or more junction boxes were missing covers and energized electrical components were exposed to touch. This condition is an electrical shock/electrocution hazard.

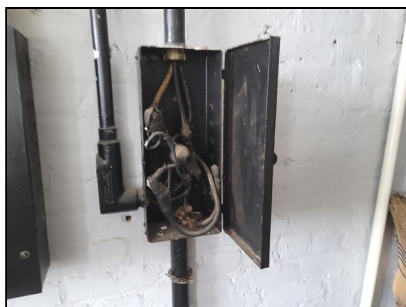
5.3 Item 2(Picture)

- 🔧 (2) Some of the electrical junction boxes had open wires and should be secured close to prevent electrical shock.³¹

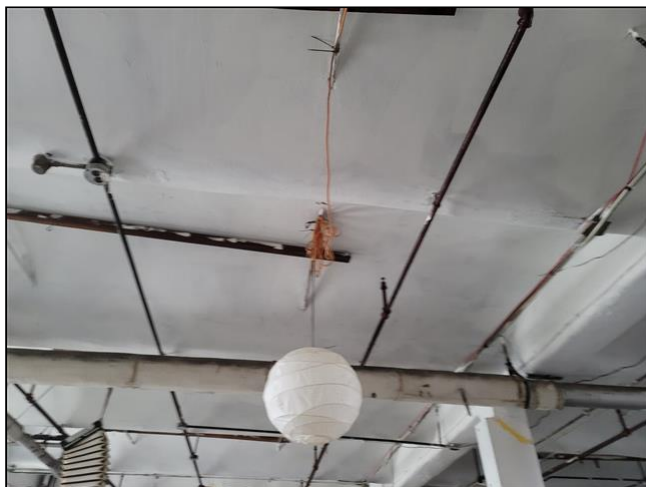
5.3 Item 3(Picture)

- 🔧 (3) Extension cords used as house wiring visible in the throughout the apartment at the time of the inspection is a potential fire hazard. The Inspector recommends removal of the extension cord and proper wiring be installed by a qualified electrical contractor.

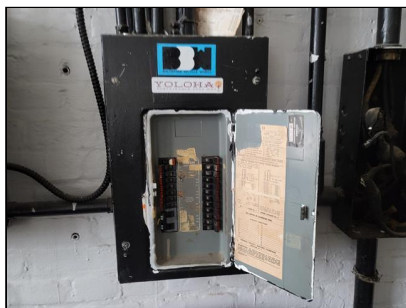
5.5 Item 1(Picture)

- 🔧 This sub-panel was made by Federal Pacific and was the Stab-lok model. Federal Pacific Stab-lok model sub-panels are reputed to have a high rate of circuit breaker failure which can result in a fire or shock/electrocution. One of the breakers was damaged and sparks when turned on. The Inspector recommends that you consult with a qualified electrical contractor concerning for replacing this sub-panel. Information about defective Federal Pacific Stab-lok panels is widely available on the internet.

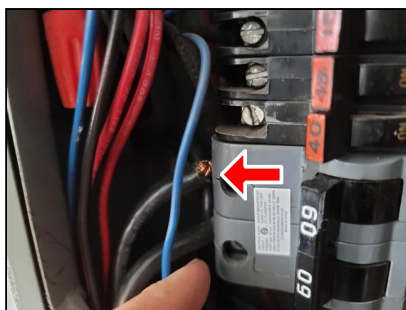
5.6 Item 1(Picture)

- 🔧 Strands from the service entrance wires were cut and may cause the the wires to overheat. The Inspector recommends evaluation and repair as necessary by a qualified licensed electrician.

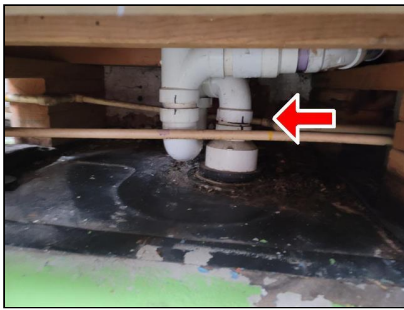
6.1 Item 1(Picture)

- ⚠ (1) Many traps were of a type called an "S-trap". S-traps are no longer allowed to be installed in new construction for safety reasons. A siphon can develop which empties the trap of water; a condition with the potential to allow toxic sewer gas to enter the living space. Although this type of trap may have been commonly considered safe at the time the home was originally constructed, as general knowledge of safe building practices has improved with the passage of time, building standards have changed to reflect current understanding. The Inspector recommends replacement of all such traps in the home by a qualified plumbing contractor.

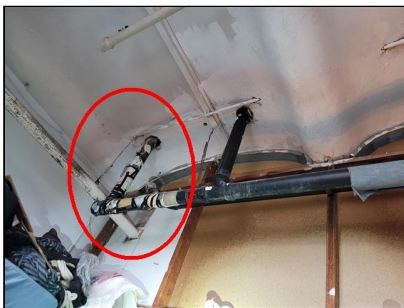
6.1 Item 3(Picture)

- ⚠ (2) Drain/waste pipes in the rear bedroom were damaged and had created unhealthy conditions at the time of the inspection. The Inspector recommends correction and disinfection by a qualified contractor.

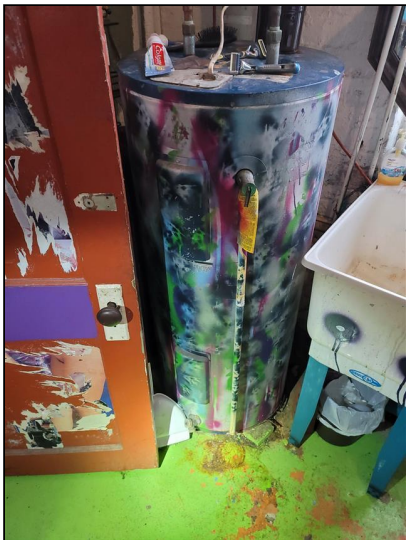
6.2 Item 1(Picture)

🔧 The pressure relief valve was leaking at the time of the inspection. Because the TPR valve is an important safety component it should be replaced by a qualified HVAC technician or plumbing contractor.

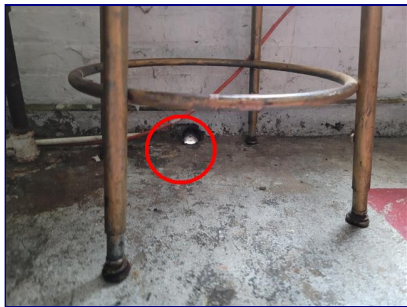
1.1 Item 1(Picture)

- (1) Holes in the exterior walls were observed in many areas.

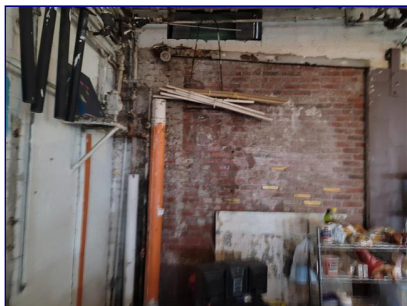
1.1 Item 2(Picture)

- (2) Stains on the walls in the visible in many areas at the time of the inspection appeared to be the result of moisture intrusion. The moisture meter showed elevated moisture levels in the affected areas at the time of the inspection, indicating that the leakage has been recent. The Inspector recommends consultation with a qualified contractor to discuss options and costs for correction and repair.

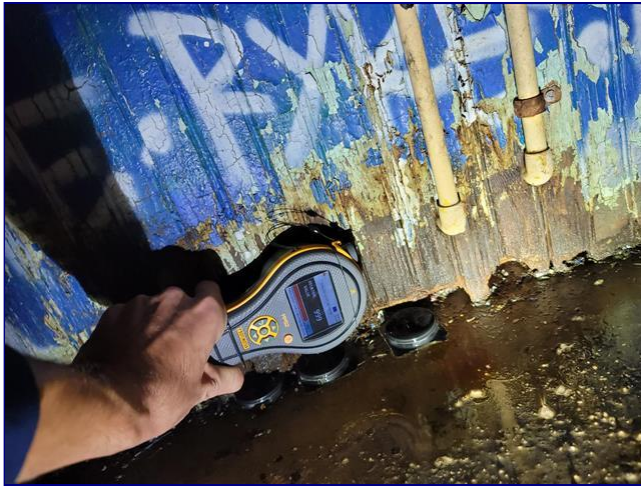
1.1 Item 9(Picture)

- (5) Stains on the walls in the kitchen below sink and behind the shower visible at the time of the inspection appeared to be the result of moisture intrusion. The moisture meter showed elevated moisture levels in the affected areas at the time of the inspection, indicating that the leakage has been recent. The Inspector recommends consultation with a qualified contractor to discuss options and costs for correction and repair to prevent mold growth and unhealthy conditions.

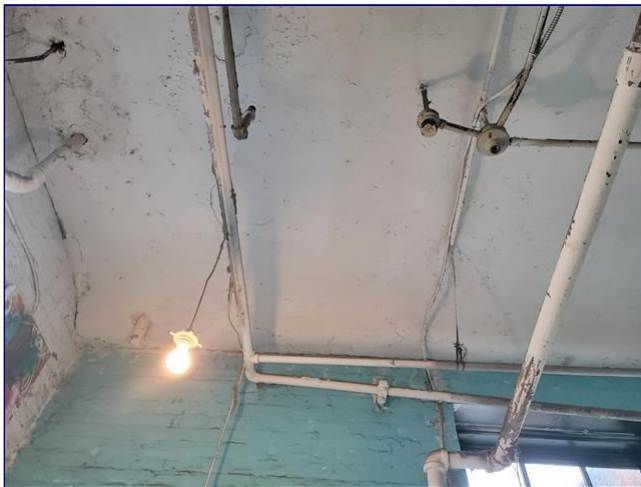
1.2 Item 1(Picture)

(1) Many interior light fixtures in the home were damaged or inoperable and extension cords with lighting was used instead. This condition is a potential fire or shock/electrocution hazard. The Inspector recommends repairs be performed by a qualified electrical contractor.

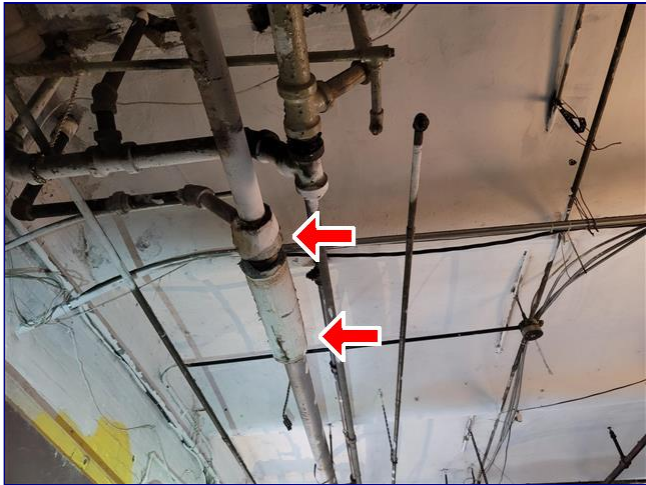
1.3 Item 1(Picture)

(1) Materials in the on the boiler distribution pipes throughout the home may contain asbestos. Asbestos has been classified as a known human carcinogen (a substance that causes cancer) by the U.S. Department of Health and Human Services, the EPA, and the International Agency for Research on Cancer. People who become ill from asbestos are usually those who are exposed to it on a regular basis, most often in a job where they work directly with the material or through substantial environmental contact. To cause health problems, asbestos must be in a form in which the fibers can be inhaled, such as when it is cut, torn, or sanded. The insulation on these pipes of concern had damage and deterioration that can be friable. The only way to know for certain whether asbestos is in a particular product or material is to have testing performed. A sample was taken and will be sent to a laboratory for testing.

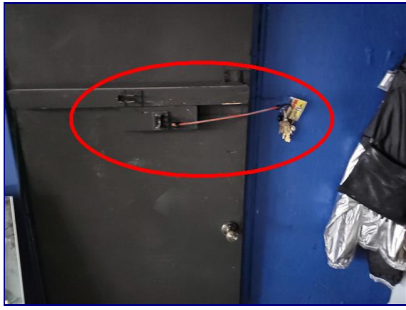
1.4 Item 1(Picture)

(1) Interior doors in the home were moderately damaged or deteriorated. This condition is a fire safety issue.

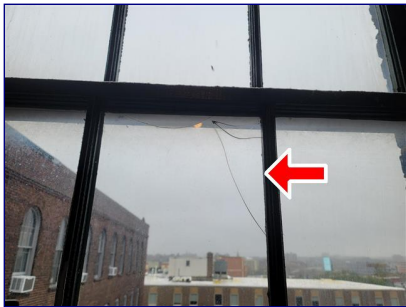
1.5 Item 1(Picture) bathroom

(1) One or more window in the unit had a cracked or broken pane.

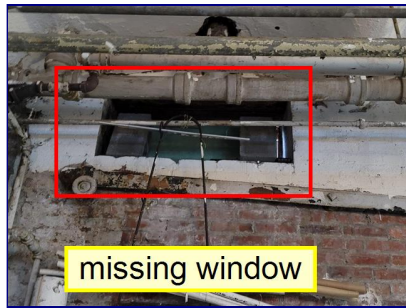
1.5 Item 2(Picture)

(4) A window in the common area was boarded up with loose wood and cinder blocks allowing moisture and air leakage into the building.

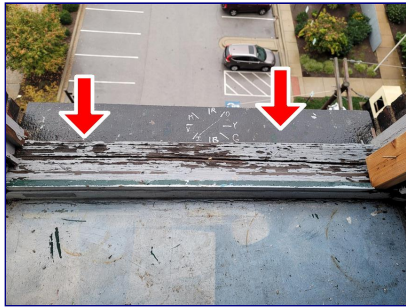
1.5 Item 3(Picture)

(5) Components of window sill exteriors were loose, damaged or deteriorated and needed maintenance to help prevent damage from moisture intrusion to the home materials, the exterior wall structure and to prevent development of microbial growth such as mold. All work should be performed by a qualified contractor.

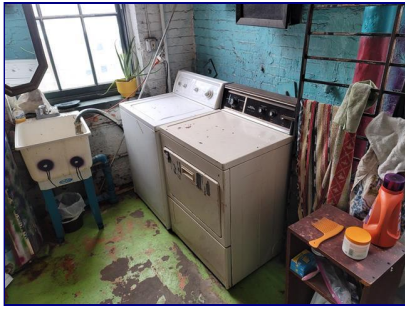
1.7 Item 1(Picture)

Laundry appliances were not functioning properly and should be repaired by a qualified technician.

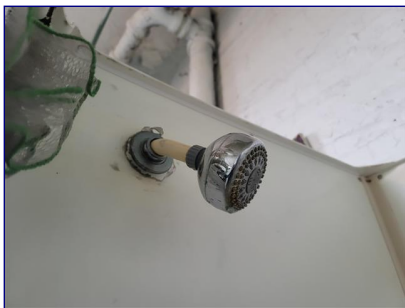
2.4 Item 1(Picture)

(1) In the bathroom, the showerhead connection leaked when the shower was operated. The inspector recommends service by a qualified plumbing contractor.

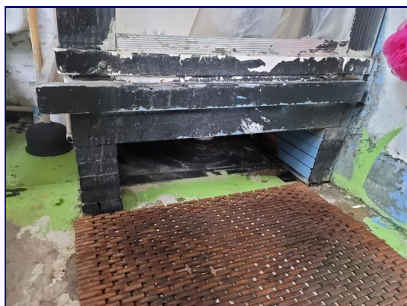
2.4 Item 2(Picture)

- 45
- ⚡ (2) Water flow at the shower in the entry bathroom appeared to be inadequate. The Inspector recommends that you have this condition evaluated by a qualified plumbing contractor to determine the potential need and costs for correction.
 - ⚡ (3) Fungi growth was observed below the shower pan due to water entering from behind the shower walls. The Inspector recommends installing a new shower enclosure to prevent water leakage and mold growth. The mold growth should be remediated by a qualified professional.

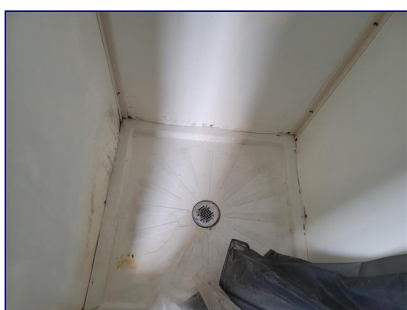
2.4 Item 5(Picture)

- ⚡ (4) In the bathroom, the shower enclosure was old and deteriorated.

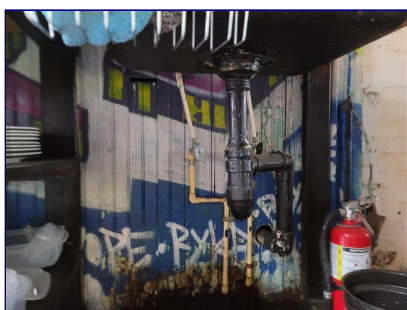
3.1 Item 1(Picture)

- ⚡ (1) Leaking connections at the trap assembly beneath the kitchen sink should be repaired to avoid future/additional damage to the cabinet floor and possibly the wall/floor structures below. The Inspector recommends repair by a qualified plumbing contractor.

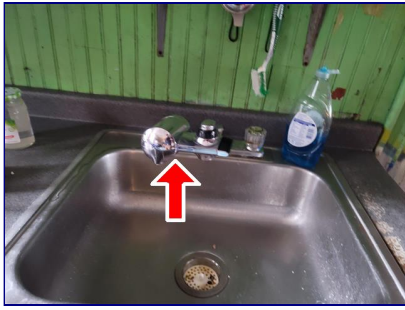
3.1 Item 2(Picture)

- ⚡ (2) The kitchen sink faucet leaks when turned off.

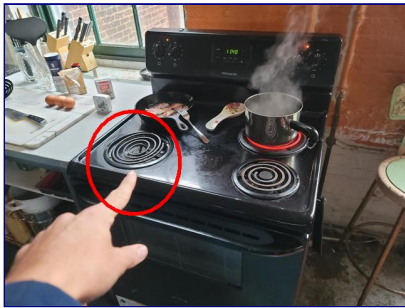
3.2 Item 1(Picture)

(2) The electric stove had one or more inoperable stove top burners. The Inspector recommends service by a qualified technician.

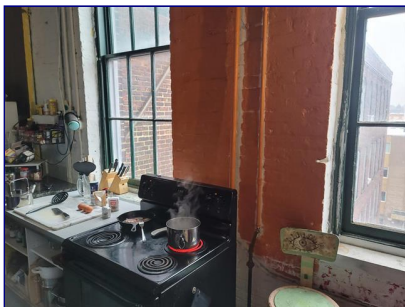
3.3 Item 1(Picture)

No range hood or exhaust system was installed at the time of the inspection. The Inspector recommends that an exhaust hood or air filtration system be installed to prevent possible moisture damage and grease accumulation on walls and ceiling adjacent to the range. All work should be performed by a qualified contractor.

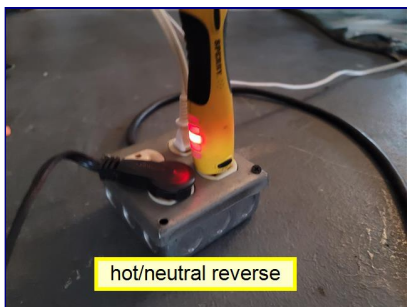
5.1 Item 6(Picture)

(2) Some electrical receptacles in this unit were improperly wired and should be corrected by a⁴⁸ qualified electrical contractor to prevent a fire hazard.

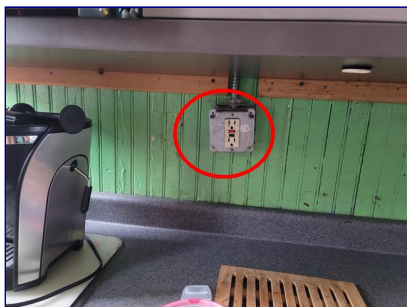
5.1 Item 8(Picture)

(3) Some electrical receptacles in the home were inoperable at the time of the inspection. The Inspector recommends service by a qualified electrical contractor.
