## Testimony of Indigo Null

### HB0036 – Real Property – Actions to Repossess – Proof of Rental Licensure

## Inspection Report

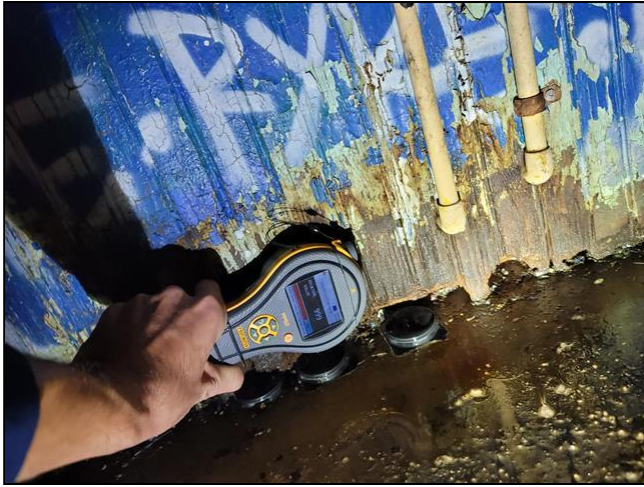
1.1 Item 9(Picture)

- 🔧 (5) Stains on the walls in the kitchen below sink and behind the shower visible at the time of the inspection appeared to be the result of moisture intrusion. The moisture meter showed elevated moisture levels in the affected areas at the time of the inspection, indicating that the leakage has been recent. The Inspector recommends consultation with a qualified contractor to discuss options and costs for correction and repair to prevent mold growth and unhealthy conditions.

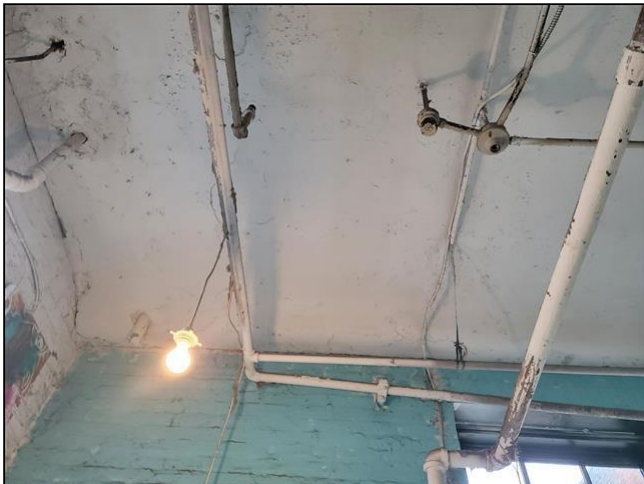
1.2 Item 1(Picture)

- 🔧 (1) Many interior light fixtures in the home were damaged or inoperable and extension cords with lighting was used instead. This condition is a potential fire or shock/electrocution hazard. The Inspector recommends repairs be performed by a qualified electrical contractor.

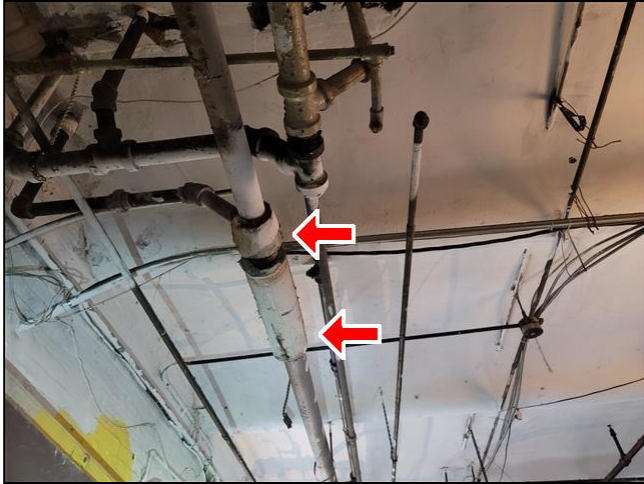
1.3 Item 1(Picture)

(1) Materials in the on the boiler distribution pipes throughout the home may contain asbestos. Asbestos has been classified as a known human carcinogen (a substance that causes cancer) by the U.S. Department of Health and Human Services, the EPA, and the International Agency for Research on Cancer. People who become ill from asbestos are usually those who are exposed to it on a regular basis, most often in a job where they work directly with the material or through substantial environmental contact. To cause health problems, asbestos must be in a form in which the fibers can be inhaled, such as when it is cut, torn, or sanded. The insulation on these pipes of concern had damage and deterioration that can be friable. The only way to know for certain whether asbestos is in a particular product or material is to have testing performed. A sample was taken and will be sent to a laboratory for testing.

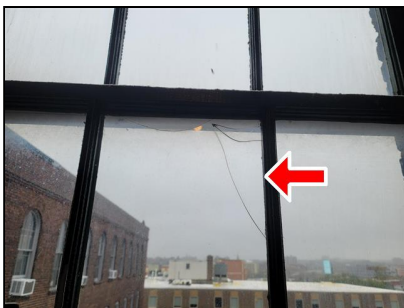
1.5 Item 1(Picture) bathroom

🔧 (1) One or more window in the unit had a cracked or broken pane.

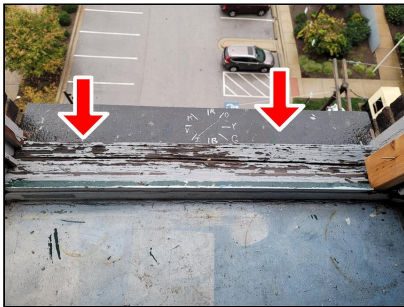
1.5 Item 3(Picture)

- (5) Components of window sill exteriors were loose, damaged or deteriorated and needed maintenance to help prevent damage from moisture intrusion to the home materials, the exterior wall structure and to prevent development of microbial growth such as mold. All work should be performed by a qualified contractor.

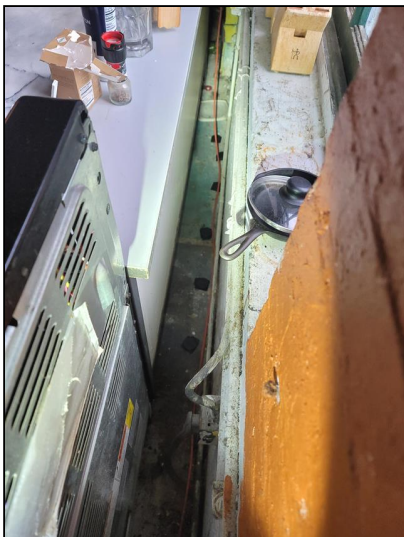
1.6 Item 1(Picture)

- Signs of possible roach and pest infestation was observed and should be further evaluated and treated by a qualified pest control contractor.

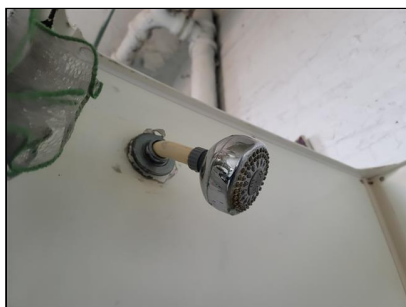
2.4 Item 1(Picture)

- ⚡ (1) In the bathroom, the showerhead connection leaked when the shower was operated. The inspector recommends service by a qualified plumbing contractor.

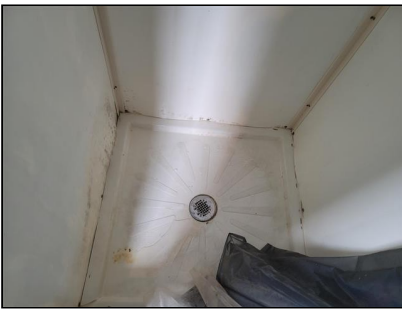
2.4 Item 5(Picture)

- ⚠ (4) In the bathroom, the shower enclosure was old and deteriorated.

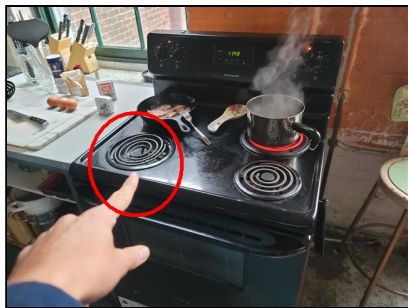
3.2 Item 1(Picture)

(2) The electric stove had one or more inoperable stove top burners. The Inspector recommends<sup>27</sup> service by a qualified technician.

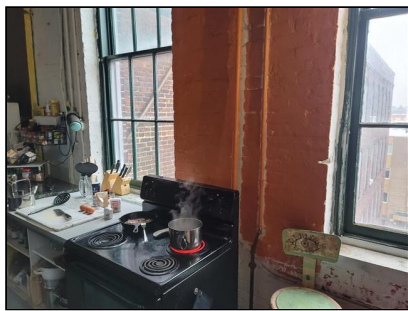
3.3 Item 1(Picture)

No range hood or exhaust system was installed at the time of the inspection. The Inspector recommends that an exhaust hood or air filtration system be installed to prevent possible moisture damage and grease accumulation on walls and ceiling adjacent to the range. All work should be performed by a qualified contractor.

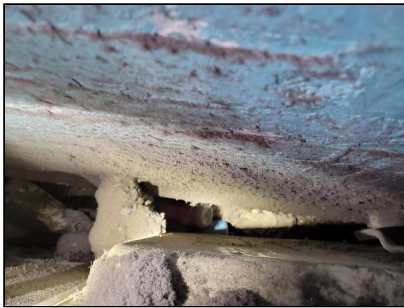
4.0 Item 1(Picture)

- ✎ No vent connection was provided for the dryer. Lack of proper dryer venting to the exterior may result in excessively high humidity levels that can damage home materials or components and may encourage the growth of microbes such as mold. Lack of proper dryer venting can also result in the accumulation of lint in the home. Lint is combustible and its accumulation is a potential fire hazard and a possible health hazard from the inhalation of particulates. The Inspector recommends proper installation of an Underwriter's Laboratory (UL)-approved dryer vent for safety reasons. Dryer vents should be cleaned annually to ensure that safe conditions continue to exist. All work should be performed by a qualified contractor.

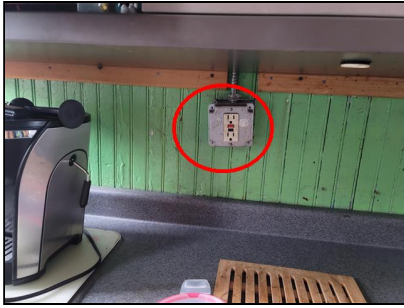
5.1 Item 8(Picture)

🔧 (3) Some electrical receptacles in the home were inoperable at the time of the inspection. The Inspector<sup>30</sup> recommends service by a qualified electrical contractor.

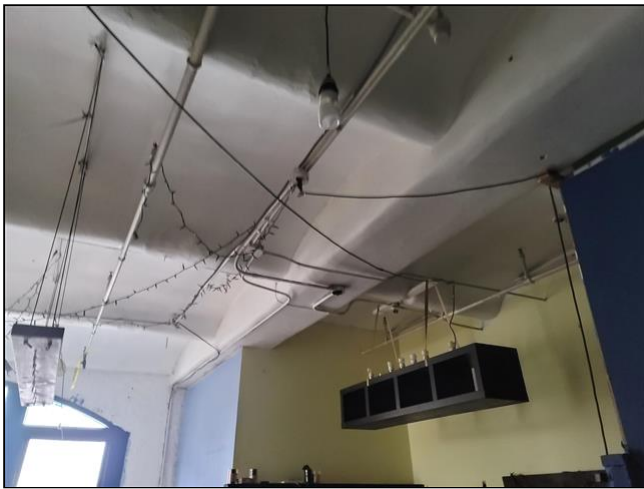
5.2 Item 1(Picture)

🔧 This unit did not have operable and enough light fixtures. Extension cords with lighting and string lights were used. This condition is a potential fire hazard.

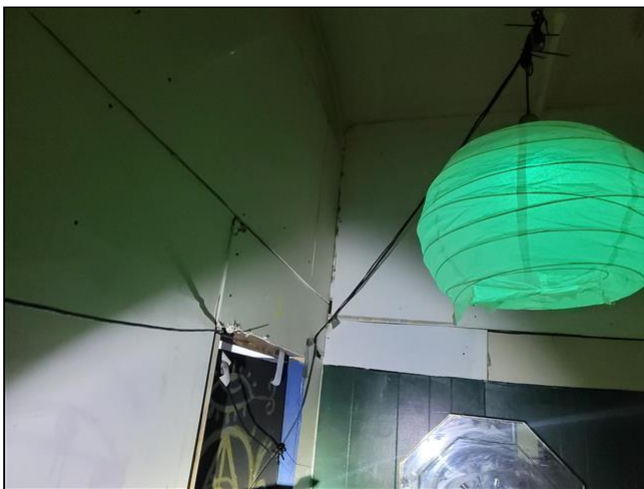
5.3 Item 1(Picture)

🔧 (1) One or more junction boxes were missing covers and energized electrical components were exposed to touch. This condition is an electrical shock/electrocution hazard.

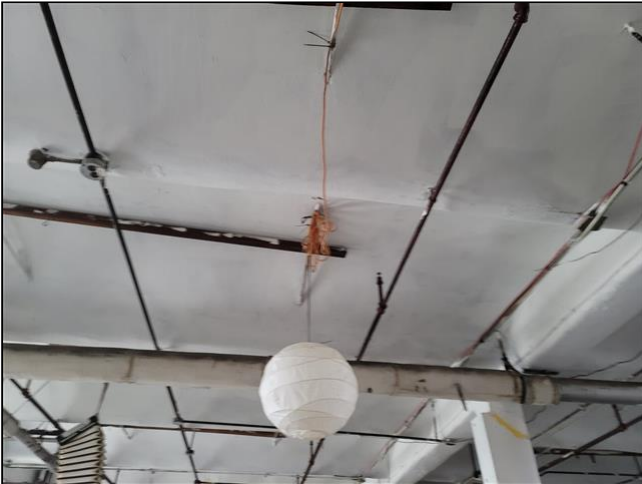
5.3 Item 3(Picture)

🔧 (3) Extension cords used as house wiring visible in the throughout the apartment at the time of the inspection is a potential fire hazard. The Inspector recommends removal of the extension cord and proper wiring be installed by a qualified electrical contractor.

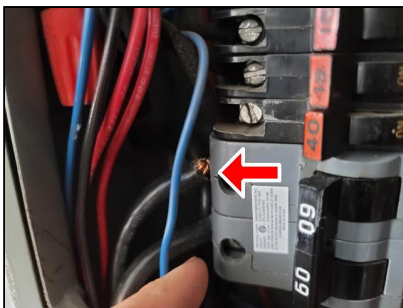
5.6 Item 1(Picture)

Strands from the service entrance wires were cut and may cause the the wires to overheat. The Inspector recommends evaluation and repair as necessary by a qualified licensed electrician.

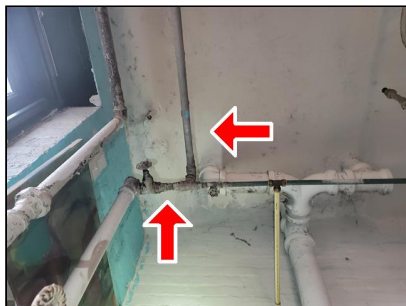
6.0 Item 1(Picture)

- (1) Some of the visible water distribution pipes were galvanized steel. This pipes are old, and of a material no longer installed for this purpose due to bore shrinkage from accumulation of interior corrosion that over time reduces water flow. These pipes may need to be replaced soon.

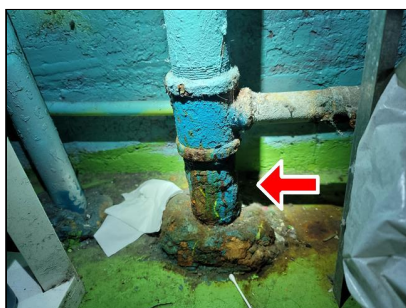
6.0 Item 3(Picture)

- (2) Actively leaking, heavily-corroded water distribution pipes visible in the bathroom should be repaired by a qualified plumbing contractor to avoid damage to home materials or the development of conditions which encourage the growth of microbes such as mold.

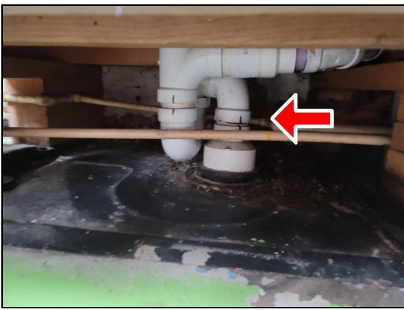
6.1 Item 1(Picture)

(1) Many traps were of a type called an "S-trap". S-traps are no longer allowed to be installed in new construction for safety reasons. A siphon can develop which empties the trap of water; a condition with the potential to allow toxic sewer gas to enter the living space. Although this type of trap may have been commonly considered safe at the time the home was originally constructed, as general knowledge of safe building practices has improved with the passage of time, building standards have changed to reflect current understanding. The Inspector recommends replacement of all such traps in the home by a qualified plumbing contractor.

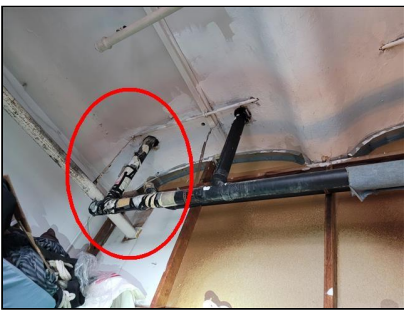
6.1 Item 3(Picture)

(2) Drain/waste pipes in the rear bedroom were damaged and had created unhealthy conditions at the time of the inspection. The Inspector recommends correction and disinfection by a qualified contractor.

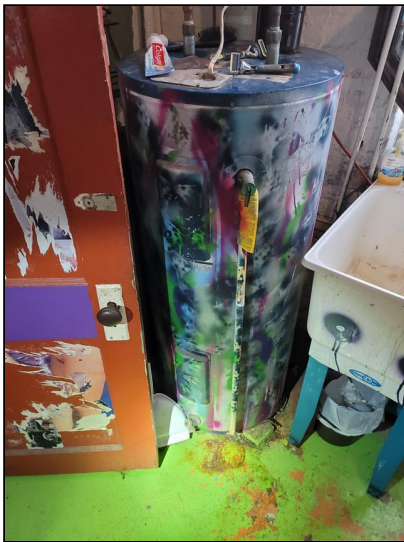
6.2 Item 1(Picture)

⚡ The pressure relief valve was leaking at the time of the inspection. Because the TPR valve is an important safety component it should be replaced by a qualified HVAC technician or plumbing contractor.

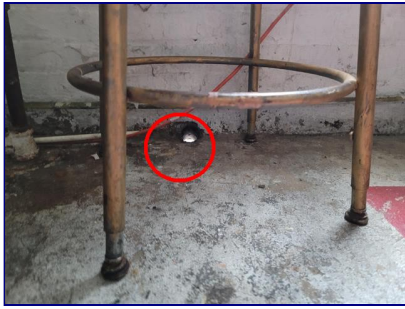
1.1 Item 1(Picture)

(1) Holes in the exterior walls were observed in many areas.

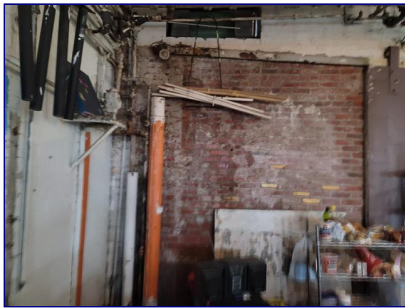
1.1 Item 2(Picture)

(2) Stains on the walls in the visible in many areas at the time of the inspection appeared to be the result of moisture intrusion. The moisture meter showed elevated moisture levels in the affected areas at the time of the inspection, indicating that the leakage has been recent. The Inspector recommends consultation with a qualified contractor to discuss options and costs for correction and repair.

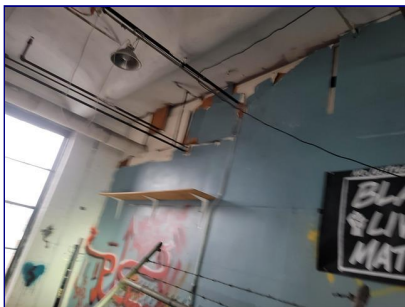
1.1 Item 7(Picture)

(4) Walls in the exhibited moderate damage or deterioration and were poorly installed.

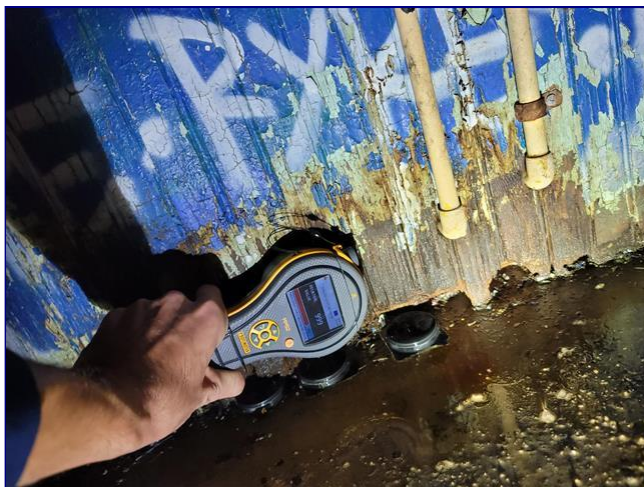
1.1 Item 9(Picture)

(5) Stains on the walls in the kitchen below sink and behind the shower visible at the time of the inspection appeared to be the result of moisture intrusion. The moisture meter showed elevated moisture levels in the affected areas at the time of the inspection, indicating that the leakage has been recent. The Inspector recommends consultation with a qualified contractor to discuss options and costs for correction and repair to prevent mold growth and unhealthy conditions.

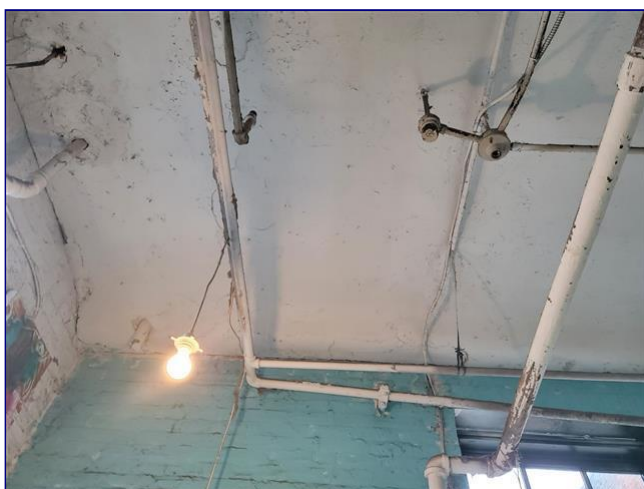
1.2 Item 1(Picture)

(1) Many interior light fixtures in the home were damaged or inoperable and extension cords with lighting was used instead. This condition is a potential fire or shock/electrocution hazard. The Inspector recommends repairs be performed by a qualified electrical contractor.

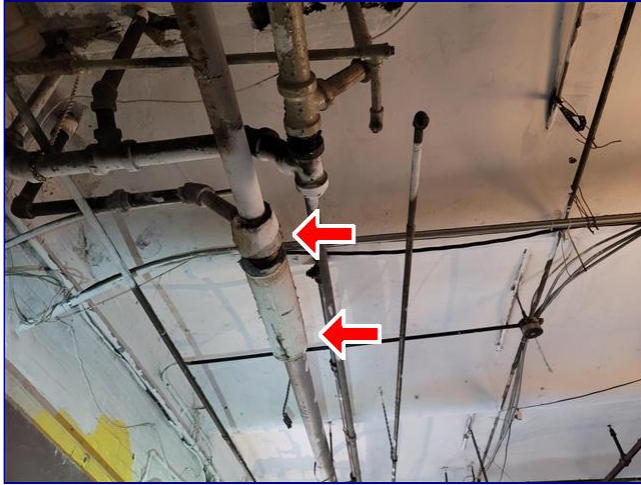
1.3 Item 1(Picture)

(1) Materials in the on the boiler distribution pipes throughout the home may contain asbestos. Asbestos has been classified as a known human carcinogen (a substance that causes cancer) by the U.S. Department of Health and Human Services, the EPA, and the International Agency for Research on Cancer. People who become ill from asbestos are usually those who are exposed to it on a regular basis, most often in a job where they work directly with the material or through substantial environmental contact. To cause health problems, asbestos must be in a form in which the fibers can be inhaled, such as when it is cut, torn, or sanded. The insulation on these pipes of concern had damage and deterioration that can be friable. The only way to know for certain whether asbestos is in a particular product or material is to have testing performed. A sample was taken and will be sent to a laboratory for testing.

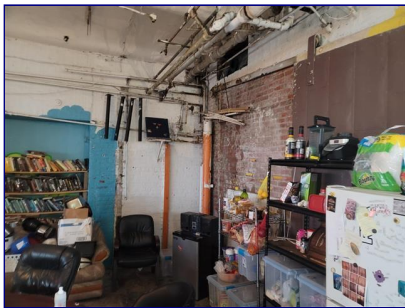
1.3 Item 8(Picture)

(2) Because this home was built before 1978, there is a good chance it has lead-based paint. In 1978, the federal government banned consumer uses of lead-containing paint as a potential health hazard, but some states banned it even earlier. Lead from paint, including lead-contaminated dust, is one of the most common causes of lead poisoning. Chipping, cracking, flaking and deteriorated paint was observed widespread throughout the building. All painted surfaces in the building should be repainted and repaired by a lead abatement contractor.

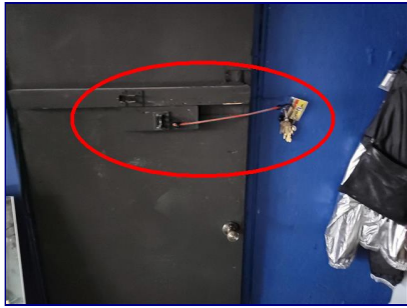
1.4 Item 1(Picture)

(1) Interior doors in the home were moderately damaged or deteriorated. This condition is a fire safety issue.

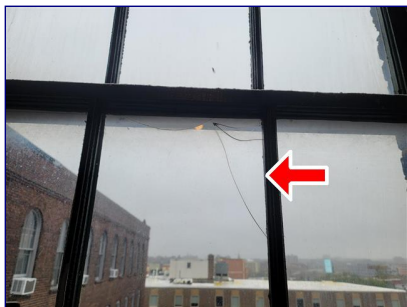
1.5 Item 1(Picture) bathroom

(1) One or more window in the unit had a cracked or broken pane.

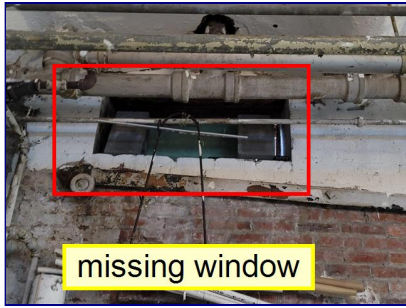
1.5 Item 2(Picture)

(4) A window in the common area was boarded up with loose wood and cinder blocks allowing moisture and air leakage into the building.

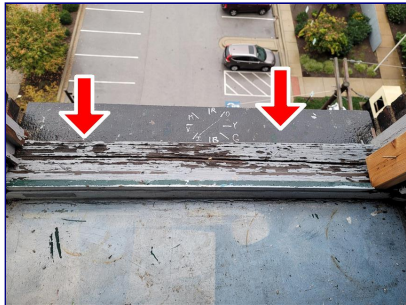
1.5 Item 3(Picture)

(5) Components of window sill exteriors were loose, damaged or deteriorated and needed maintenance to help prevent damage from moisture intrusion to the home materials, the exterior wall structure and to prevent development of microbial growth such as mold. All work should be performed by a qualified contractor.

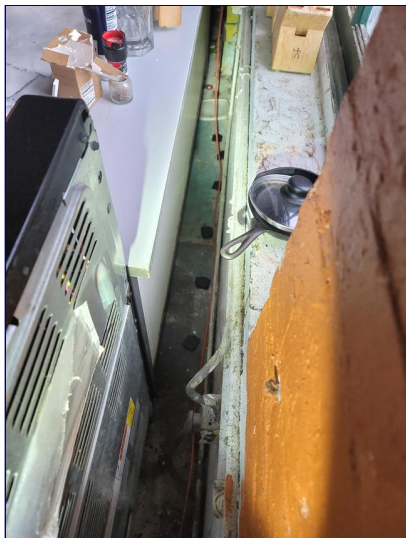
1.6 Item 1(Picture)

Signs of possible roach and pest infestation was observed and should be further evaluated and treated by a qualified pest control contractor.

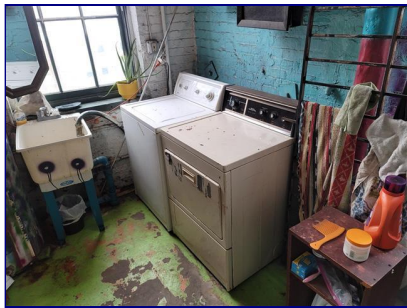
1.7 Item 1(Picture)

Laundry appliances were not functioning properly and should be repaired by a qualified technician.

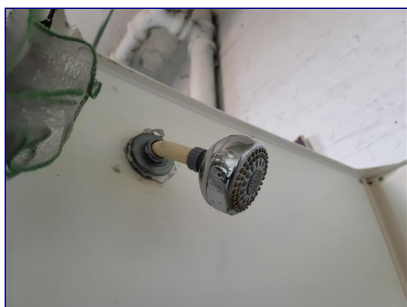
2.4 Item 1(Picture)

- ✎ (1) In the bathroom, the showerhead connection leaked when the shower was operated. The inspector recommends service by a qualified plumbing contractor.

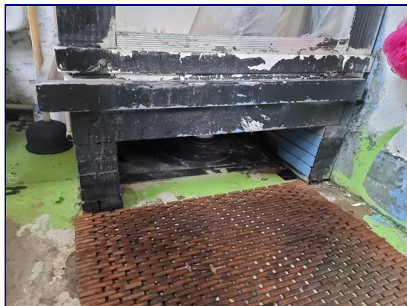
2.4 Item 2(Picture)

- ⚡ (2) Water flow at the shower in the entry bathroom appeared to be inadequate. The Inspector<sup>45</sup> recommends that you have this condition evaluated by a qualified plumbing contractor to determine the potential need and costs for correction.
- ⚡ (3) Fungi growth was observed below the shower pan due to water entering from behind the shower walls. The Inspector recommends installing a new shower enclosure to prevent water leakage and mold growth. The mold growth should be remediated by a qualified professional.

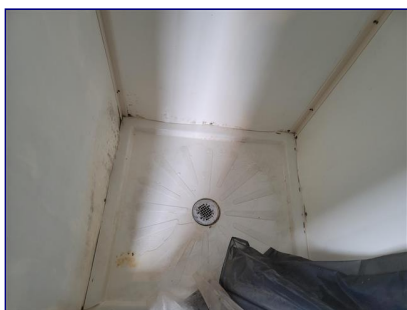
2.4 Item 5(Picture)

- ⚡ (4) In the bathroom, the shower enclosure was old and deteriorated.

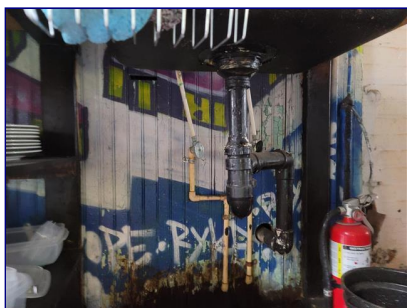
3.1 Item 1(Picture)

- ⚡ (1) Leaking connections at the trap assembly beneath the kitchen sink should be repaired to avoid future/additional damage to the cabinet floor and possibly the wall/floor structures below. The Inspector recommends repair by a qualified plumbing contractor.

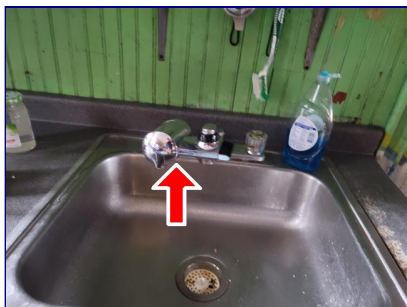
3.1 Item 2(Picture)

- ⚡ (2) The kitchen sink faucet leaks when turned off.

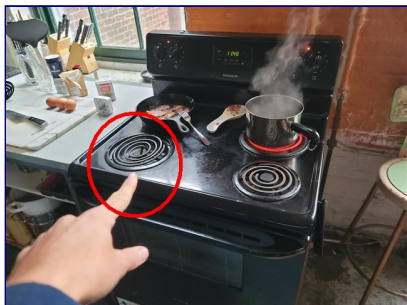
3.2 Item 1(Picture)

- 🔧 (1) The range was not fastened to the floor. A child standing on the open oven door could overturn the range. This condition is a life-safety issue. The Inspector recommends installation of an approved anti-tip device by a qualified contractor.
- 🔧 (2) The electric stove had one or more inoperable stove top burners. The Inspector recommends service by a qualified technician.

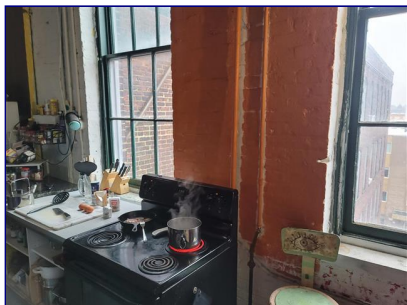
3.3 Item 1(Picture)

- 🔧 No range hood or exhaust system was installed at the time of the inspection. The Inspector recommends that an exhaust hood or air filtration system be installed to prevent possible moisture damage and grease accumulation on walls and ceiling adjacent to the range. All work should be performed by a qualified contractor.

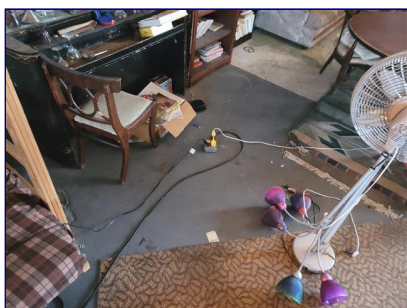
5.1 Item 1(Picture)

(1) The number of electrical receptacles in the home was inadequate and extension cords were used throughout the unit. This condition is potential fire hazard and should be corrected.

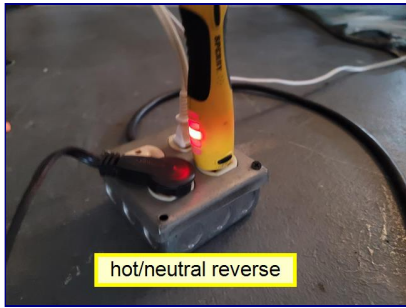
5.1 Item 6(Picture)

- (2) Some electrical receptacles in this unit were improperly wired and should be corrected by a qualified electrical contractor to prevent a fire hazard.<sup>48</sup>

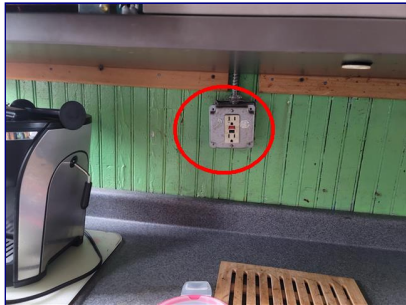
5.1 Item 8(Picture)

- (3) Some electrical receptacles in the home were inoperable at the time of the inspection. The Inspector recommends service by a qualified electrical contractor.

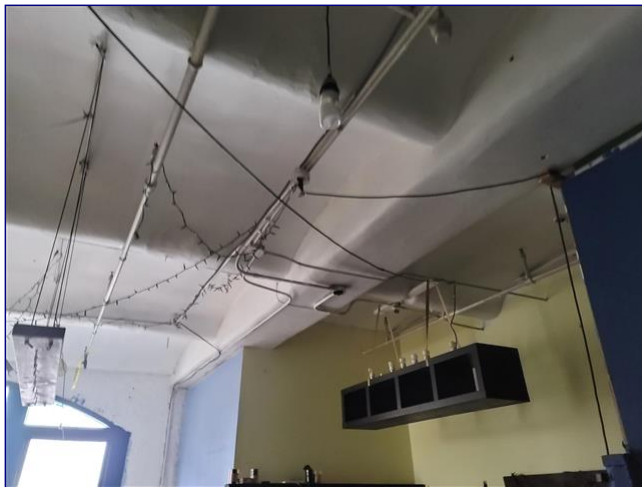
5.2 Item 1(Picture)

- This unit did not have operable and enough light fixtures. Extension cords with lighting and string lights were used. This condition is a potential fire hazard.

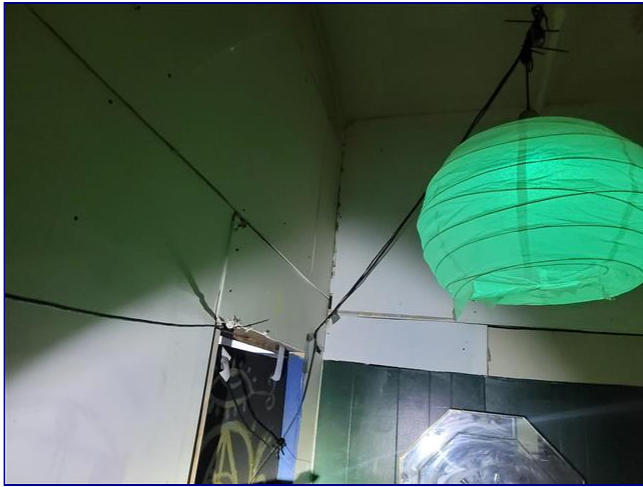
5.3 Item 1(Picture)

- (1) One or more junction boxes were missing covers and energized electrical components were exposed to touch. This condition is an electrical shock/electrocution hazard.

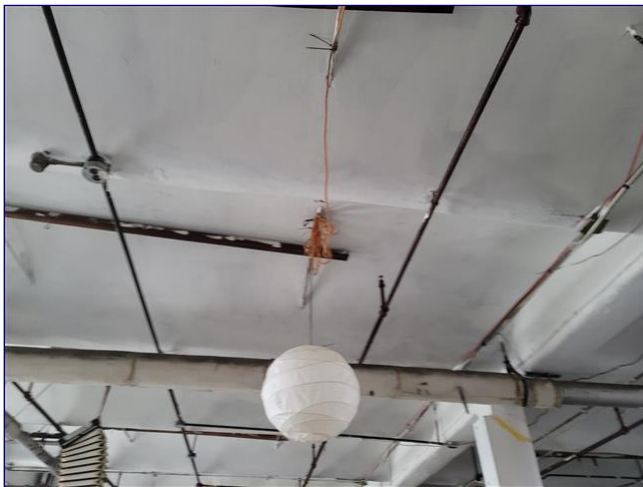
5.3 Item 3(Picture)

(3) Extension cords used as house wiring visible in the throughout the apartment at the time of the inspection is a potential fire hazard. The Inspector recommends removal of the extension cord and proper wiring be installed by a qualified electrical contractor.
