Building Explosion and Fire  
Silver Spring, Maryland  
August 10, 2016

**Accident Report**

NTSB/PAR-19/01  
PB2019-100722

# Pipeline Accident Report

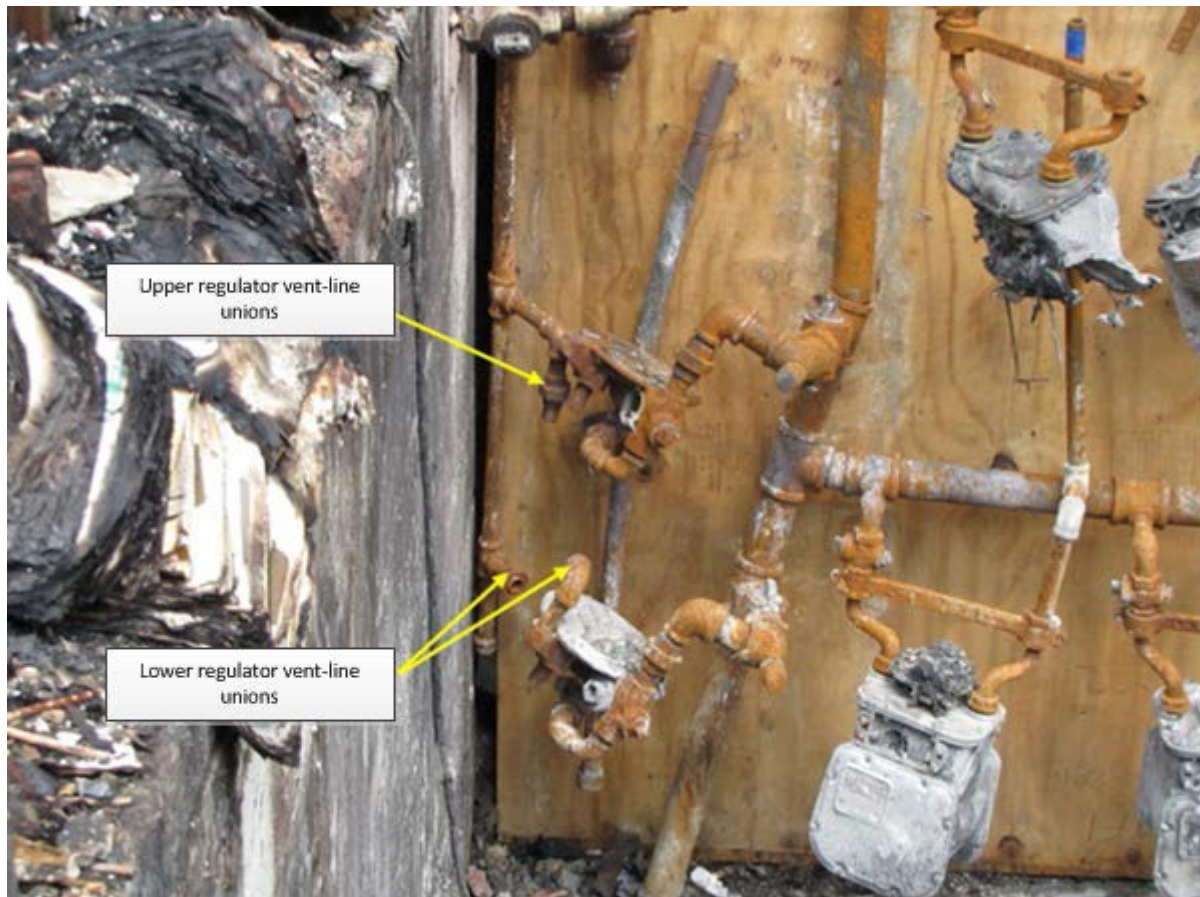
NTSB focused on the gas service equipment and appliances in the meter room because the ATF's investigation ruled out all other potential fuel sources in the room and the evidence indicates that the explosion originated in the meter room. During the inspection of the basement level of building 8701, NTSB investigators found burned and damaged components of the gas meter assembly, which included the mercury service regulators. A detailed inspection revealed that the vent line connection to the upper mercury service regulator was fractured below the coupling/union assembly, and the lower mercury pressure regulator was not connected to the regulator vent line at the coupling/union assembly, as shown in figure 5.<sup>24</sup>

**Figure 5.** Portions of mercury service regulators and gas meters in building 8701 showing heat/fire/explosion damage and the unconnected lower regulator vent line.

The NTSB concludes that without a requirement that technicians verify the connection of vent lines for indoor service regulators, such vent lines could inadvertently be left open following service work. Therefore, the NTSB recommends that WG revise its procedures and field forms to require technicians to verify the integrity of vent lines following the testing of indoor service regulators throughout the WG network.

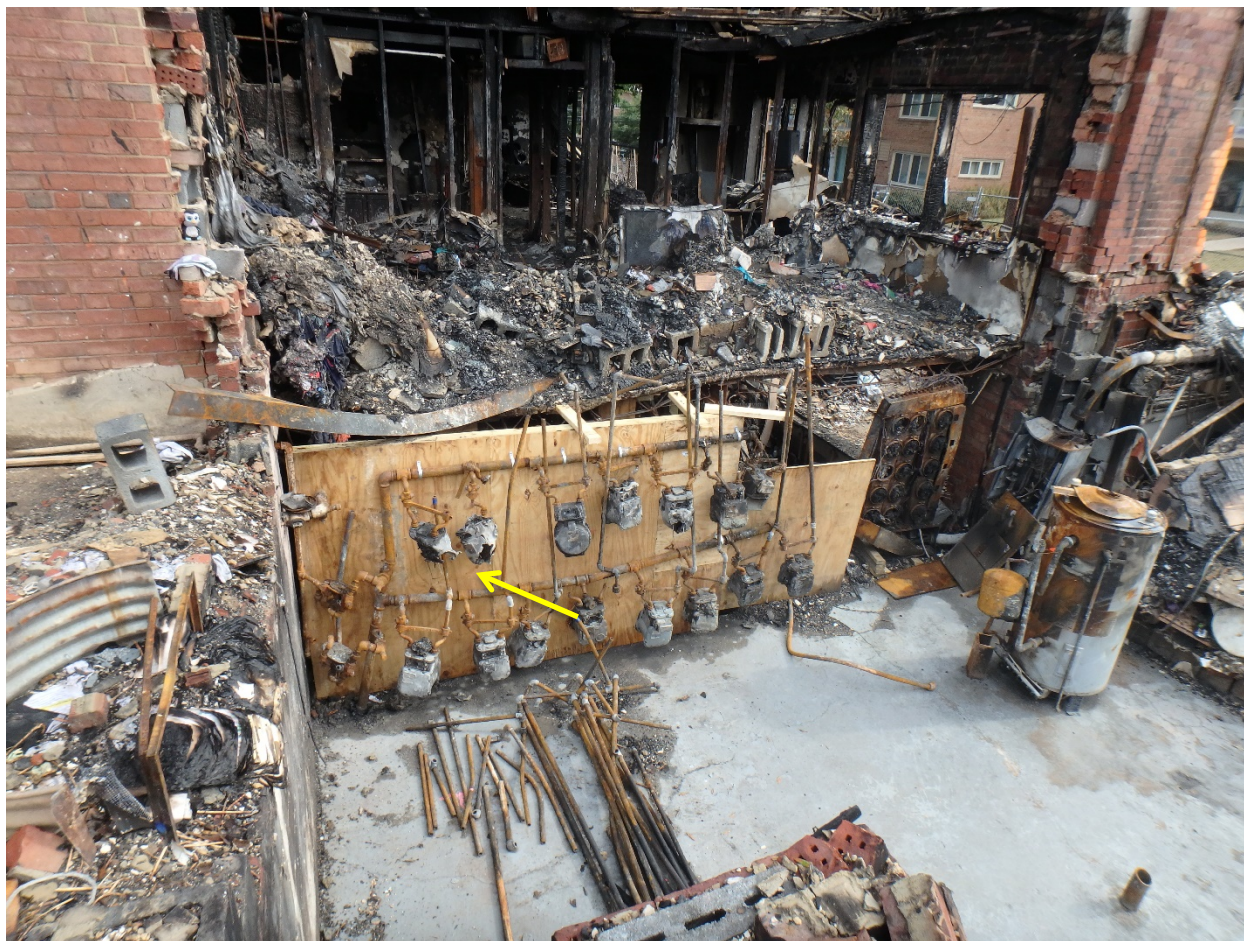
ATF reconstructed the natural gas meter rack, piping, electric meters, and water heater. The gas meters on the upper row of the meter rack near the regulators showed significant fire and heat damage, particularly when compared with the gas meters farther away from the point of the explosion at the west wall. (See figure 6.) The water heater showed significant fire and heat damage and was found in the northeast quadrant of the meter room, about 6 feet from the nearest customer gas meter. The water heater was placed by ATF at its pre-explosion location.

**Figure 6.** Building 8701 after debris removal and ATF reconstruction. The first two gas meters (designated with a yellow arrow) show substantially more heat/fire damage than other meters. (Photograph provided by ATF.)

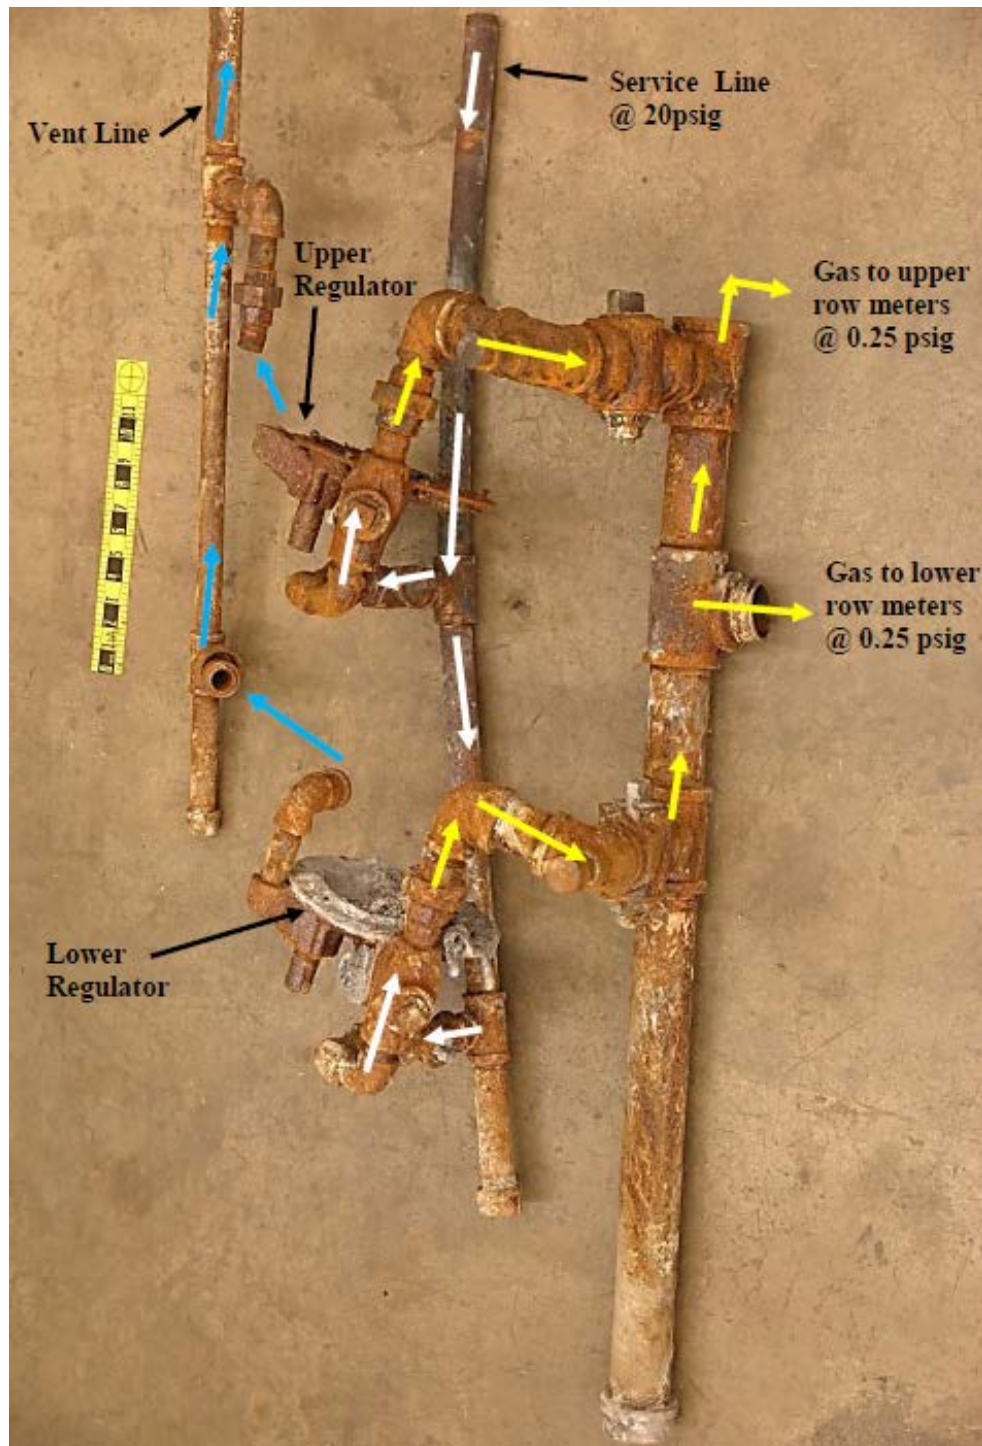
**Figure 10.** Mercury service regulators, service line, jurisdictional pipeline, and vent line after the accident.

Investigators from the NTSB Materials Laboratory performed a compositional alloy analysis on the mercury service regulators from the affected buildings and determined that the body was made from a ferrous alloy, and the top cover and metal tags were made from an aluminum alloy. The melting temperature of a typical aluminum alloy is about 1,220°F

(Moses 1978). The top cover and 2-inch diameter plug for the upper and lower gas regulator assemblies were both melted from exposure to heat from the fire.<sup>28</sup> Based on this observation, the temperature in the general area of the gas regulator assemblies reached at least 1,220°F. This also explains why mercury was not found in the reservoir cups of the upper and lower gas regulator assemblies. Mercury exists as a liquid at room temperature and has a boiling point of about 674°F, where it evaporates. The mercury most likely evaporated as a result of heat exposure from the fire.

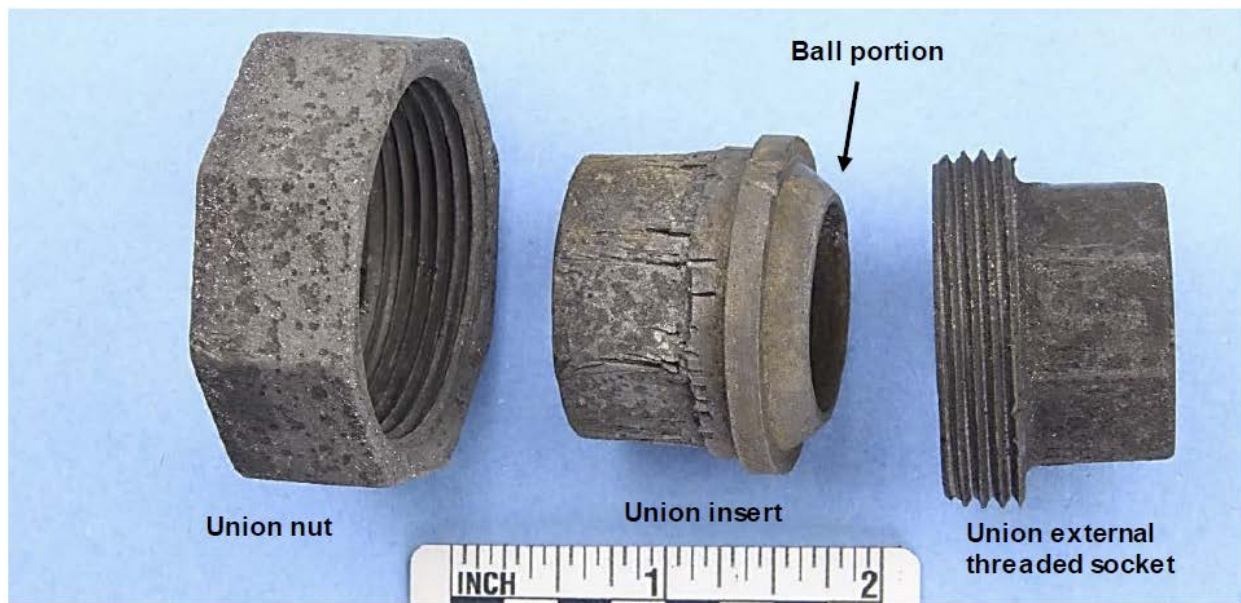
Figure 13 shows the union assembly components after cleaning. The external threads of the socket contained two dents; and the crown portion of the first two full external threads of the socket showed minor deformation.<sup>30</sup> The external threaded socket showed no evidence of major deformation. On one side of the nut, the crown portion of the first three internal threads showed evidence of minor metal flow deformation; and NTSB investigators observed similar deformation on an isolated area of only one thread on the diametrically opposite side. When mating threads are pulled apart by force, fracture or deformation by shear of the threads can also be expected.<sup>31</sup> However, NTSB investigators observed no evidence of deformation or fracture of the threads in the nut and corresponding mating threads on the socket (compare figures 12 and 13 for thread damage). Had the force of the explosion, falling debris, or a building collapse caused the disconnection of the lower union assembly, there would be evidence of mechanical damage or deformation through a significant portion of the engaged threads, as seen with the threaded nipple for the upper regulator union assembly.

**Figure 13.** Photograph of the disassembled union assembly for the accident lower gas regulator after cleaning.

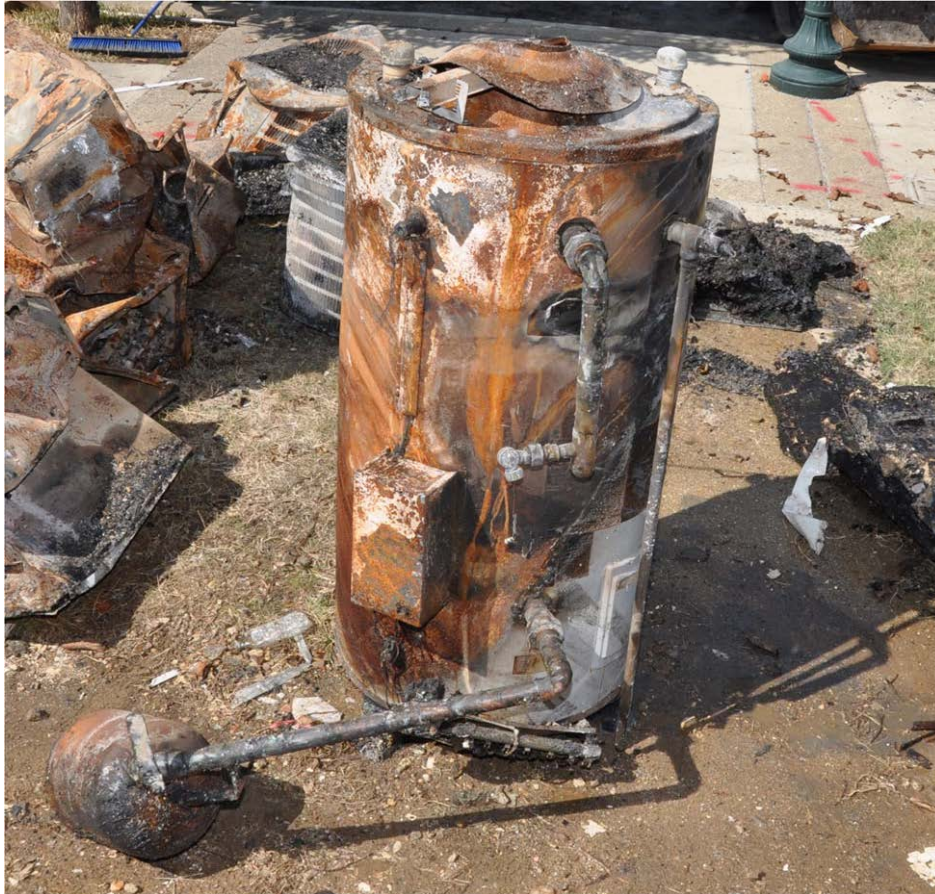
In a postaccident examination, NTSB investigators observed that nearly half of the water heater was covered with a U-shaped pattern of thermal damage. Visual examination of the water heater by investigators showed no evidence of bulging or significant body deformation.<sup>36</sup> (See figure 14.)

**Figure 14.** Hot water heater at the accident scene after the explosion. (Photograph provided by ATF.)

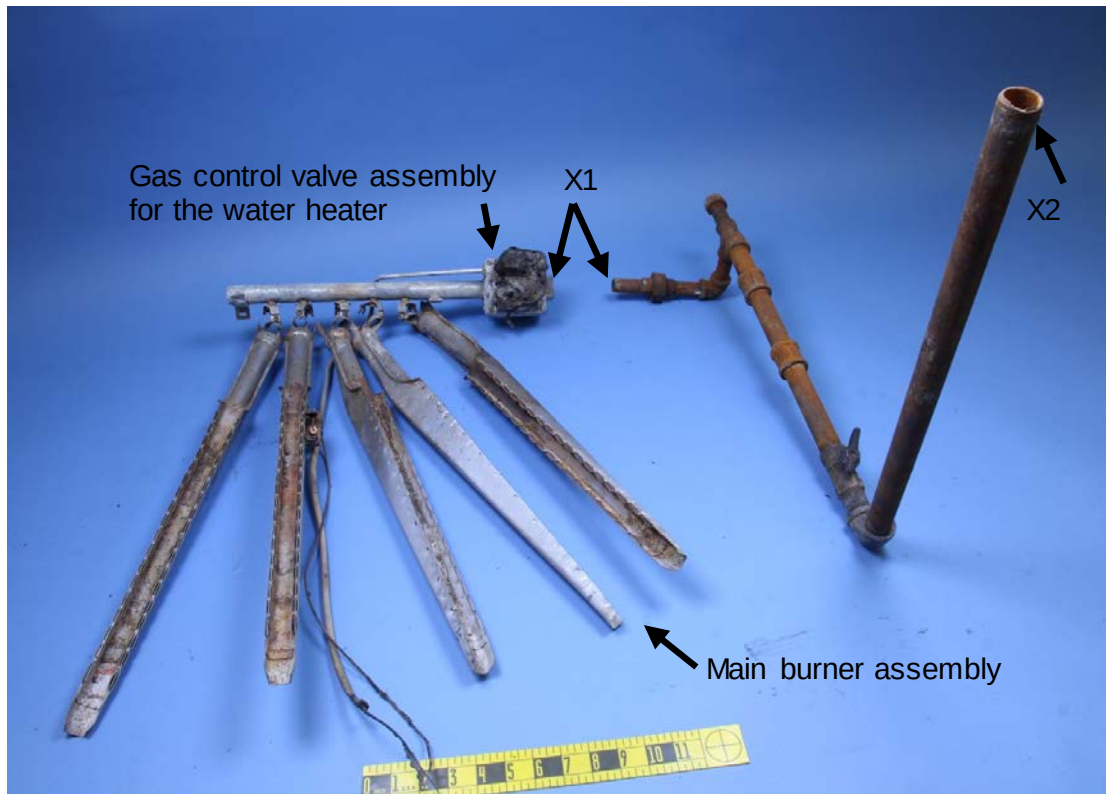
showed evidence consistent with an overstress separation.<sup>37</sup> Therefore, the NTSB concludes that the gas piping to the water heater was most likely separated at the control valve due to overstress forces resulting from the explosion. Furthermore, the NTSB concludes that the water heater did not fail prior to the explosion and was not the source of the natural gas release in the meter room.

**Figure 15.** The main burner assembly, including the separated pipe and the gas control valve assembly. The arrows labeled X1 and X2 indicate the pipe segment fractures at the threaded portion.
