Collington Branch – The Need for Stream Restoration

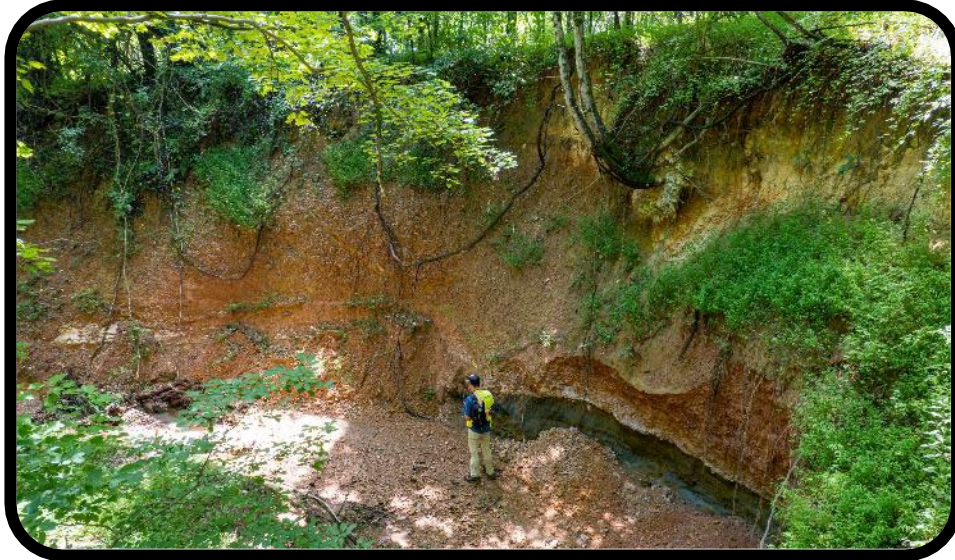
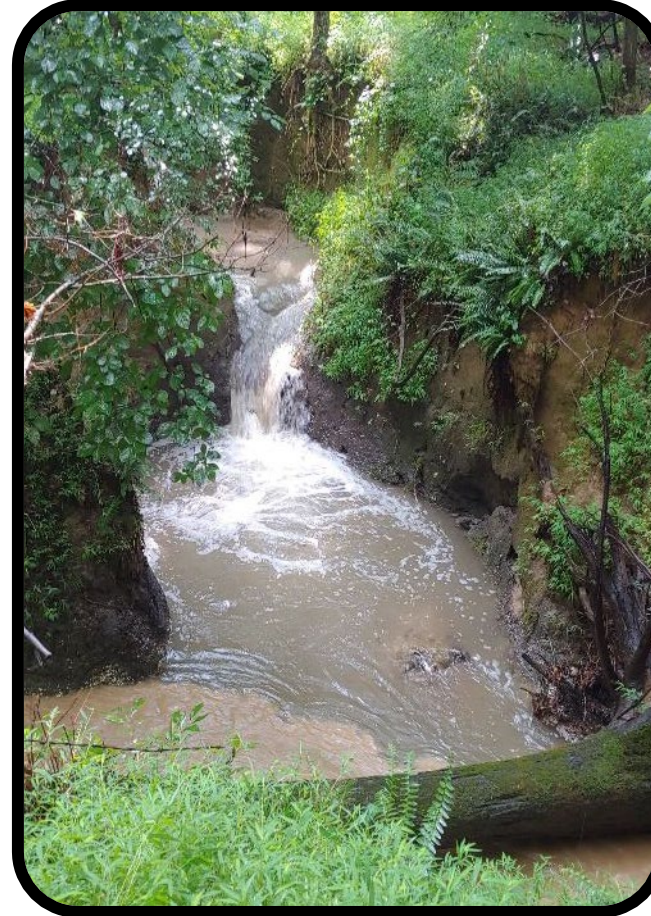
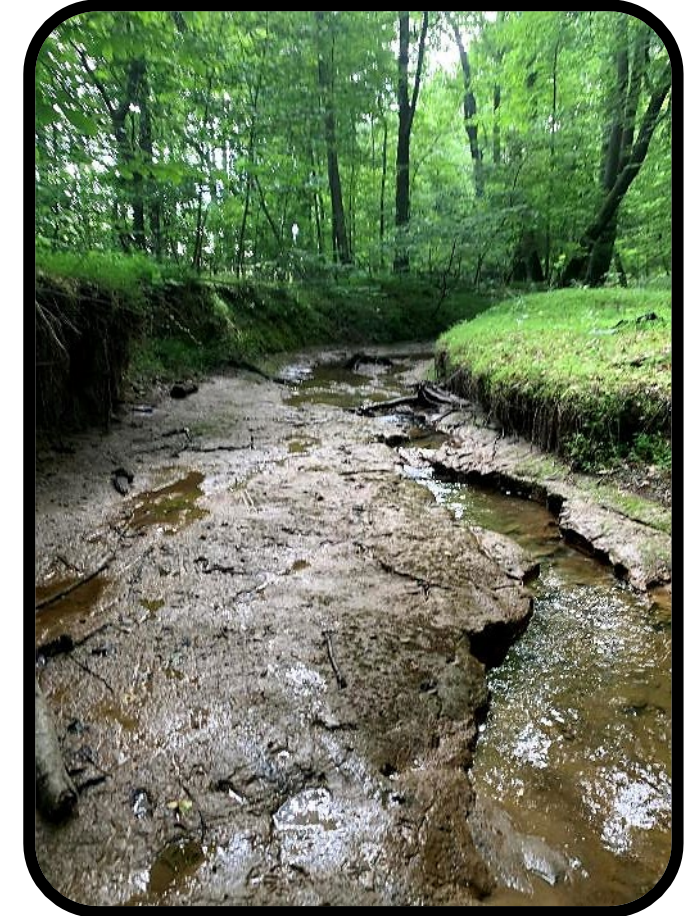
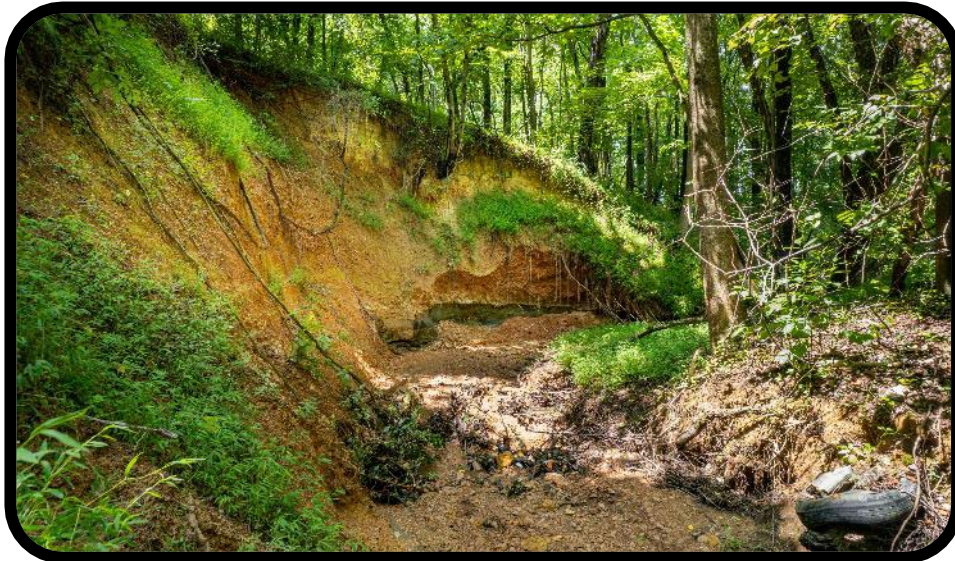
The photos show pre-restoration conditions, demonstrating the clear need for stream restoration. This project will include upland stormwater management components.

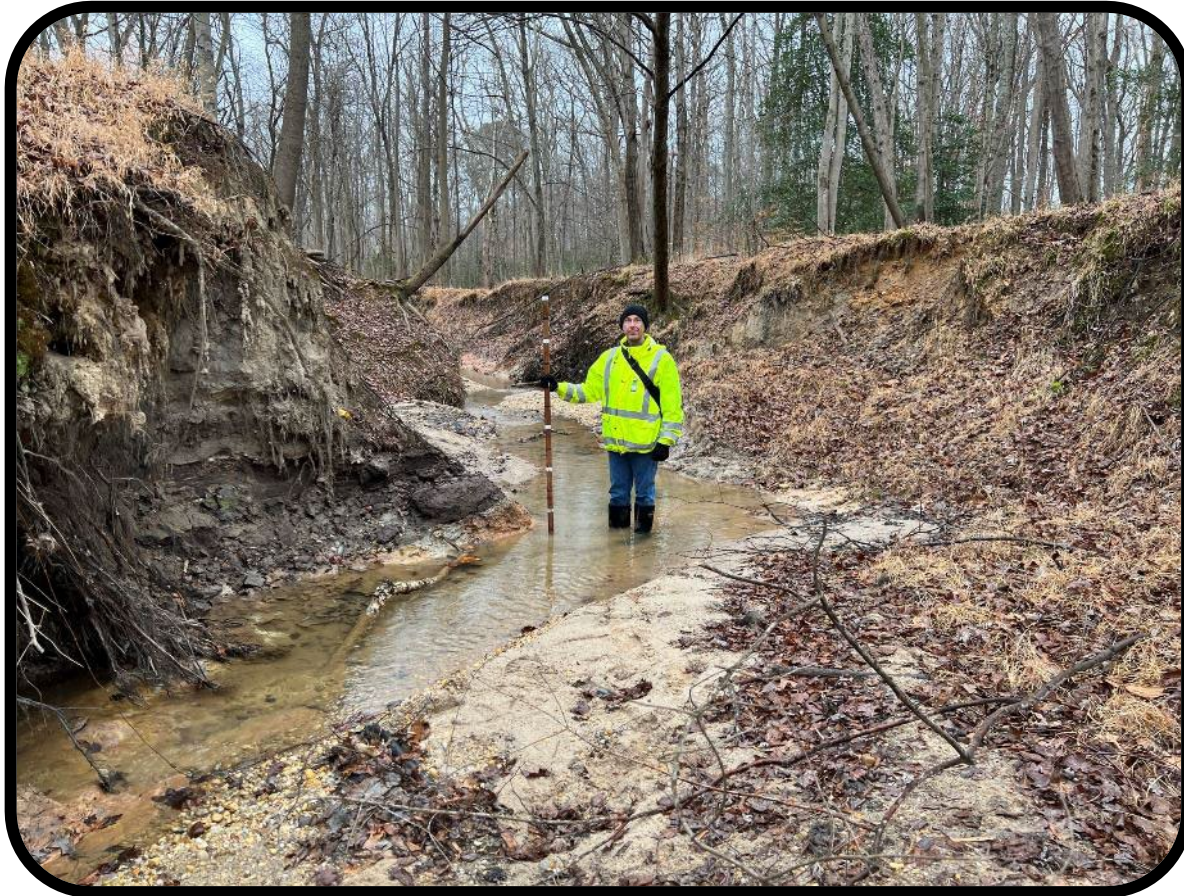
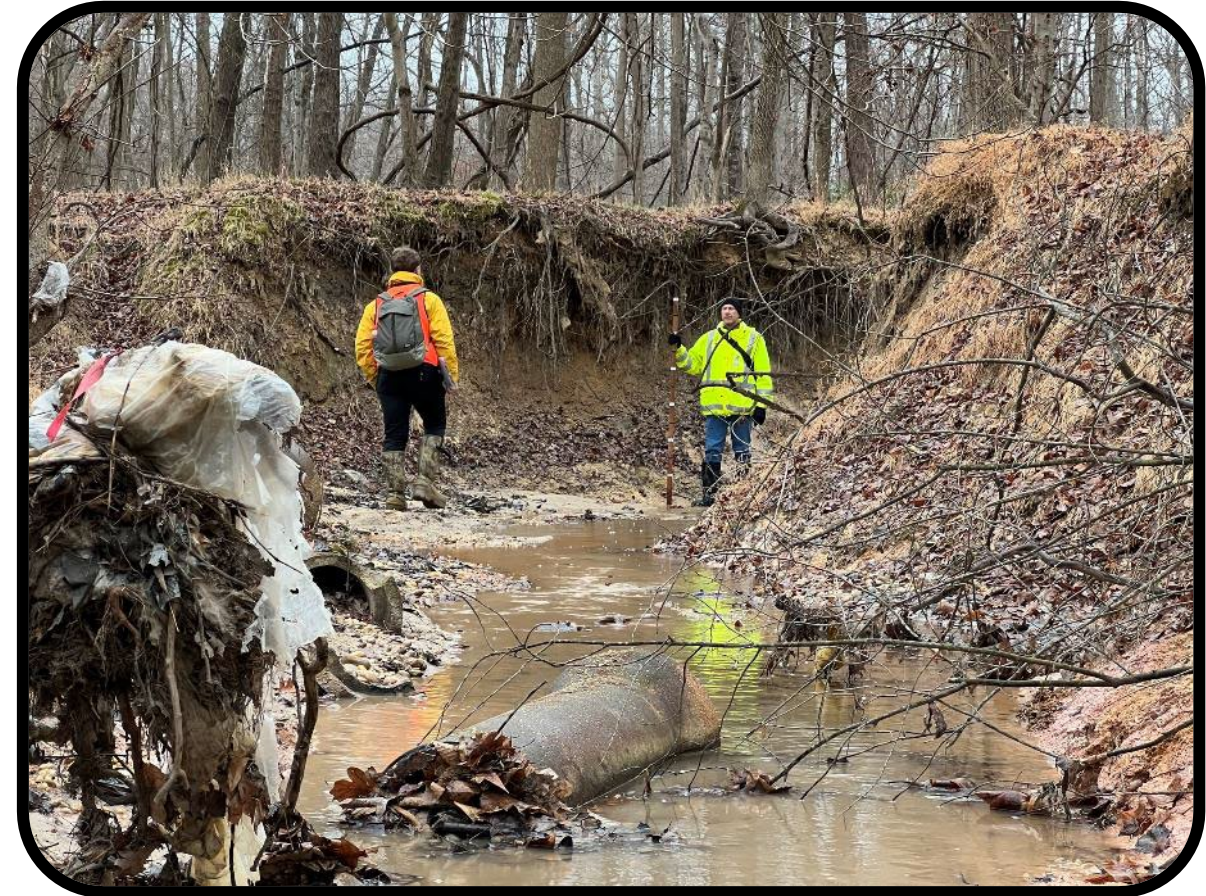
Little Paint Branch Tributary Stream Restoration – The Need for Stream Restoration

The photos show pre-restoration conditions, demonstrating the clear need for stream restoration including deeply incised stream banks. This project will include upland stormwater management components.

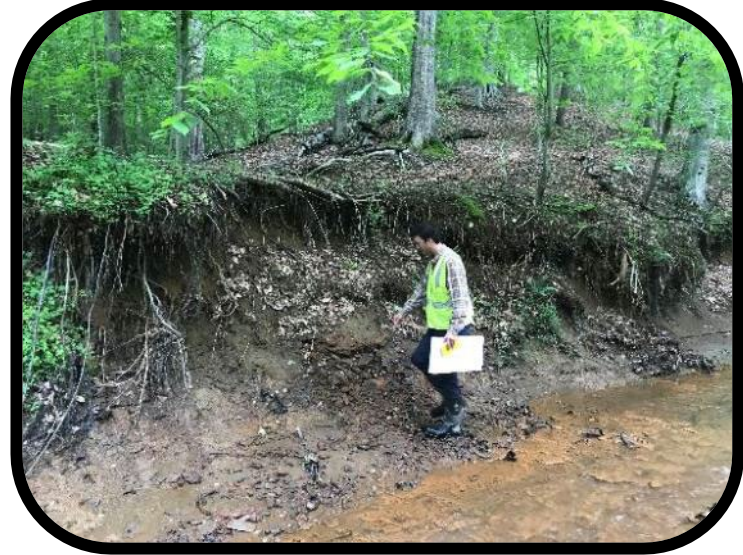
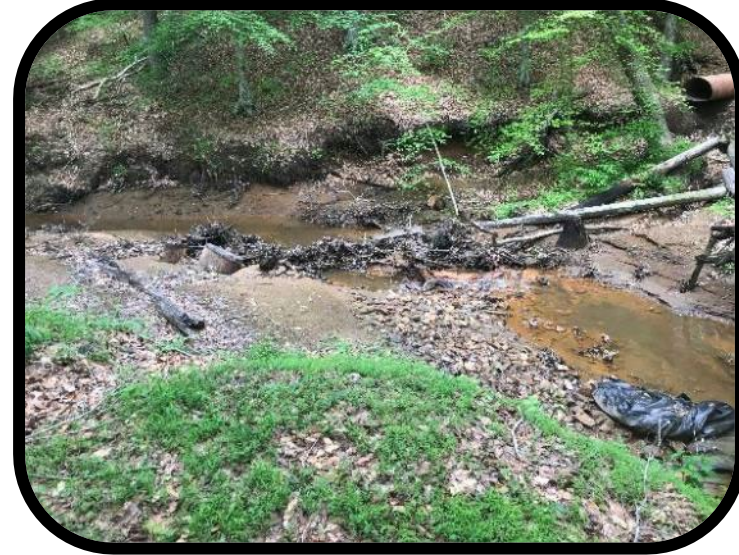
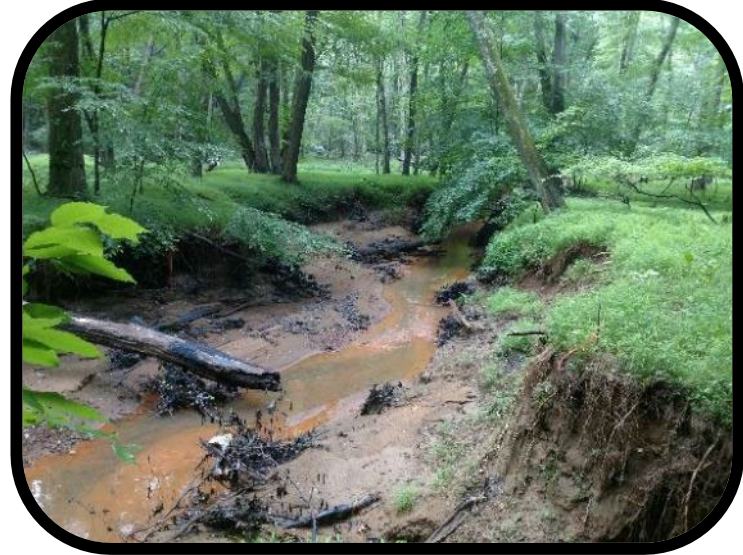
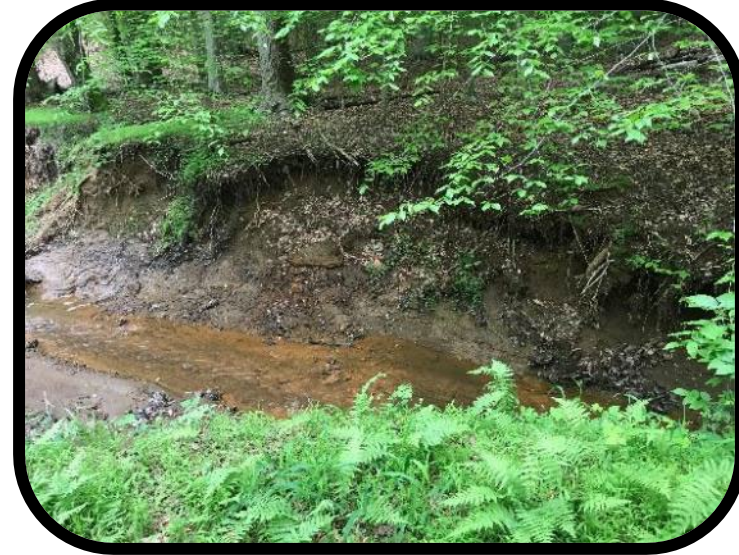
Bacon Ridge Branch Stream Restoration – Pre-Restoration Conditions

These photos demonstrate the severely degraded condition of these streams and the need for restoration.

Note the deep incision and vertical banks. Streams were actively eroding from both bed incision and bank widening, due to intensive historic land use.

The large headcuts destroyed one critical pedestrian bridge used for access and severely threatened two others. The conditions also posed a safety hazard to the camp run on-site.

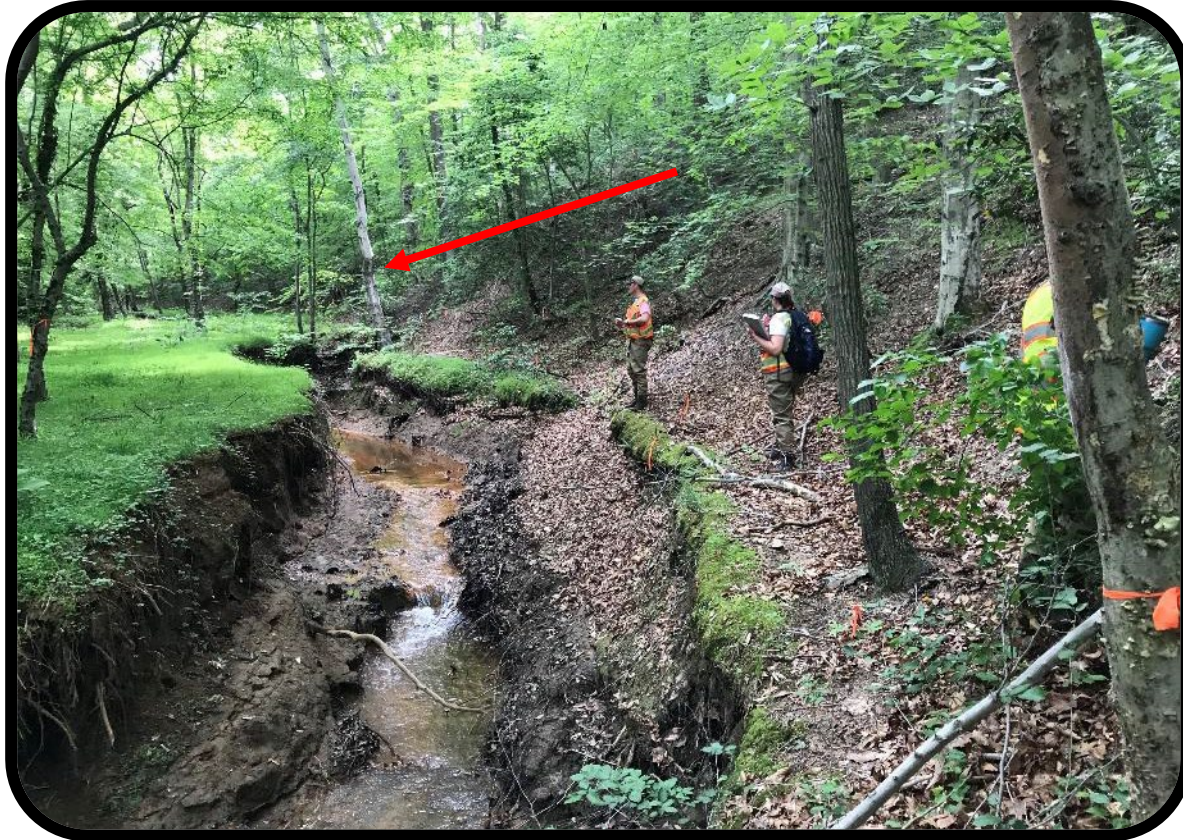
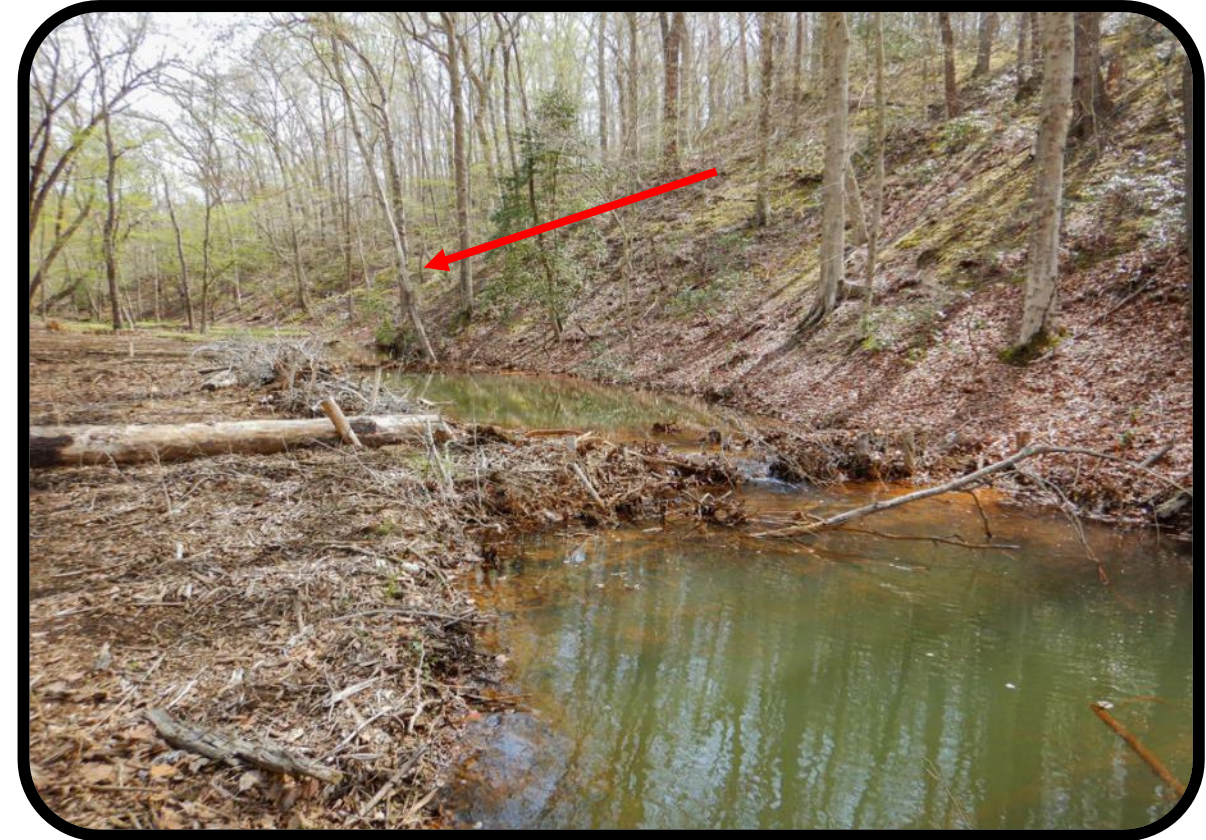
Bacon Ridge Branch Stream Restoration

Photos depict the stream system before (left) and after (right) restoration. The restoration corrected deep incisions and reconnected the stream to its floodplain. This project uplifted water quality, restored a large forested floodplain (hydrology and vegetation), provided educational opportunities, and restored breeding habitat for yellow perch.

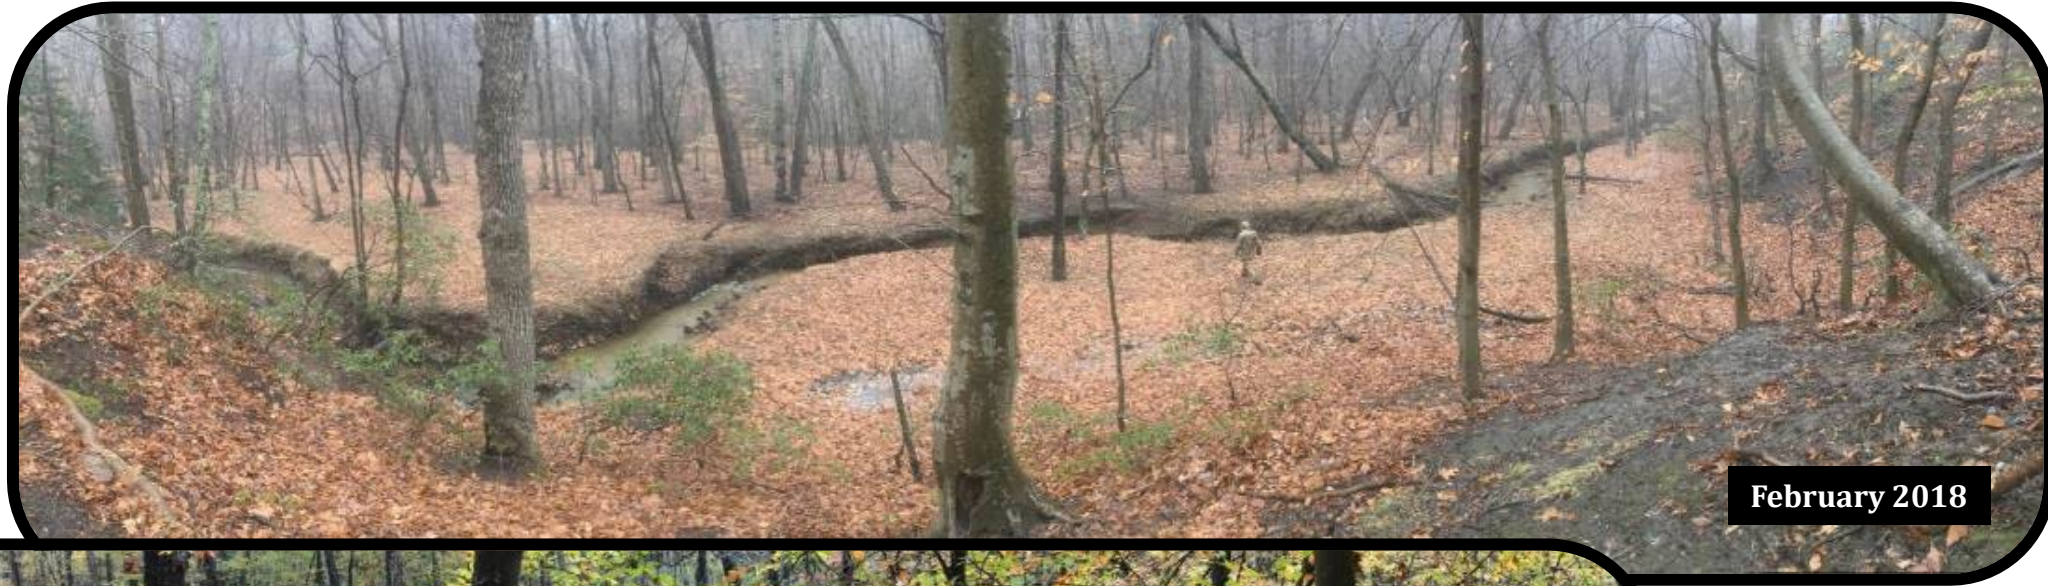
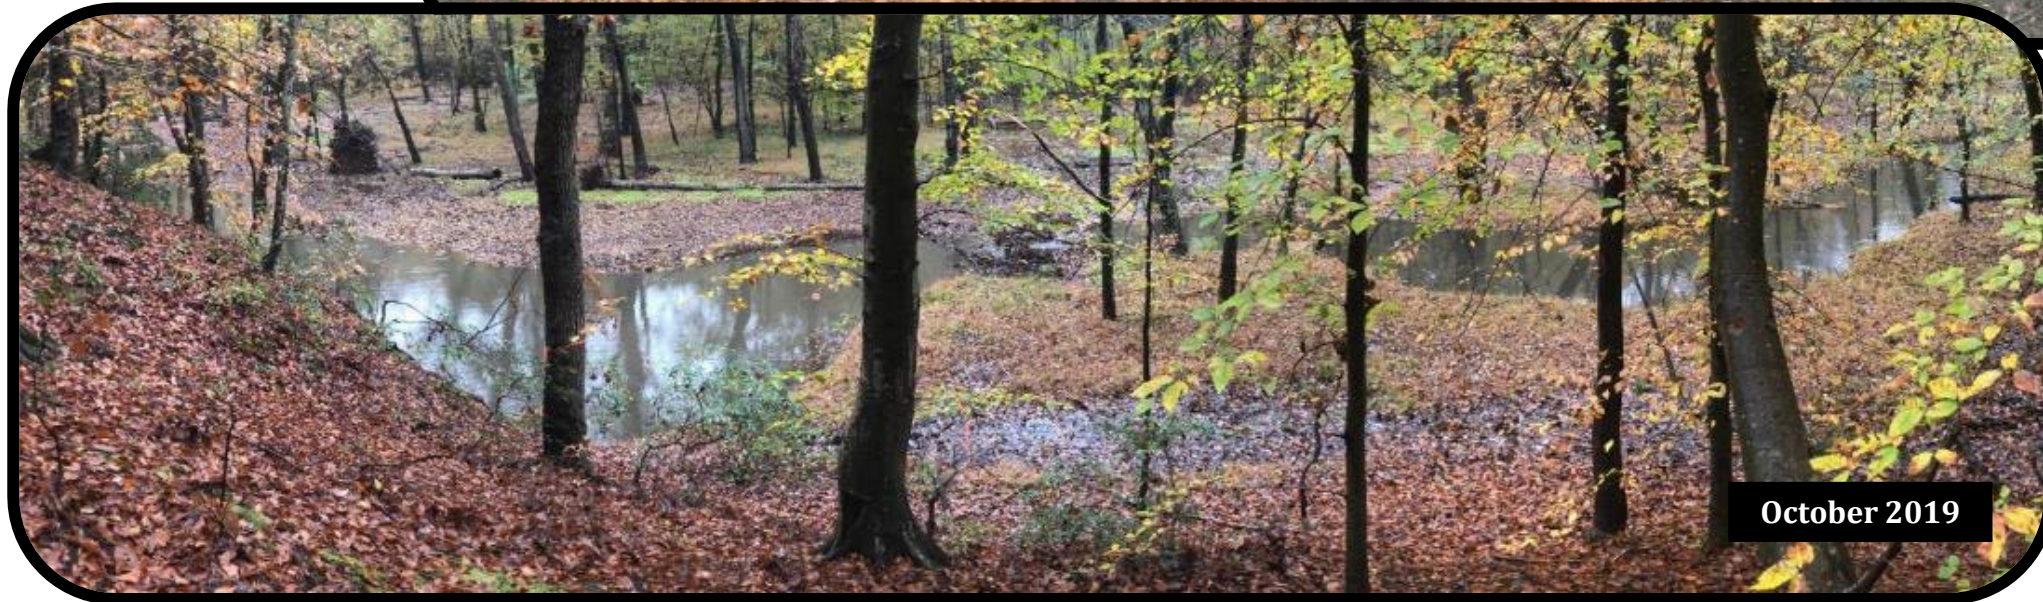
Bacon Ridge Branch Stream Restoration

These photos show the stream corridor before (top) and after (bottom) restoration. The stream was realigned and reconnected with its floodplain.

Note the surgical construction technique that maximized tree conservation and forest restoration.

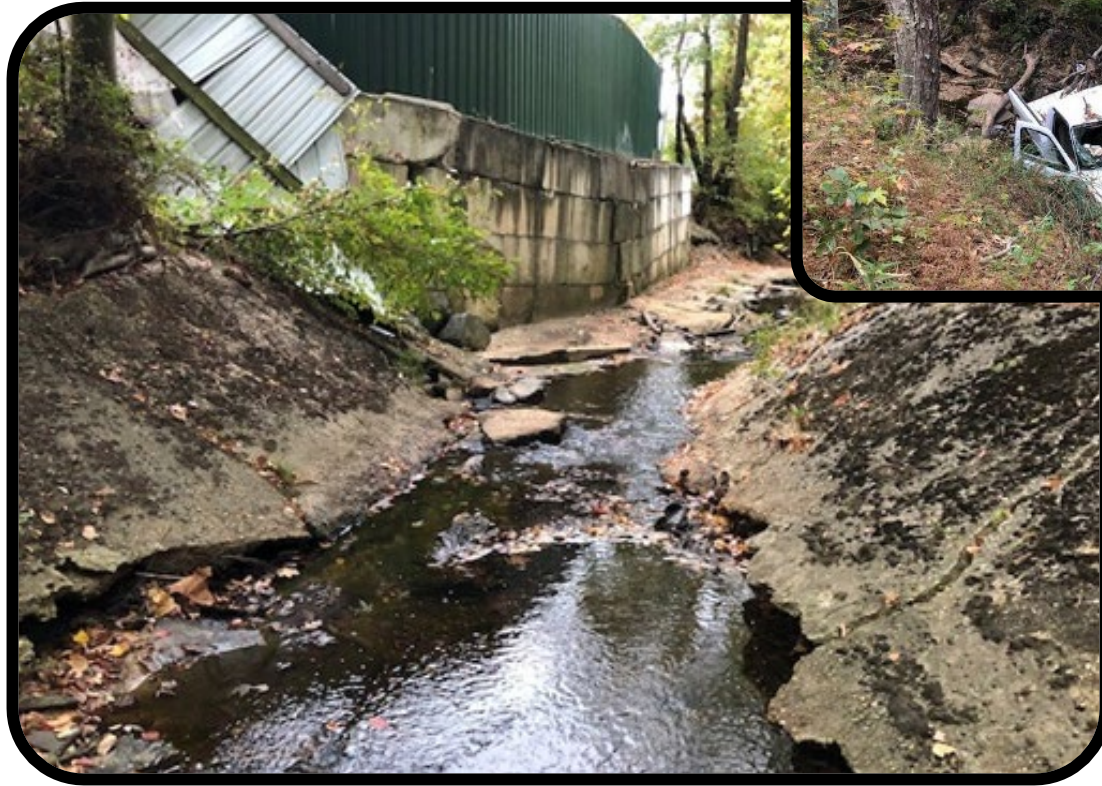
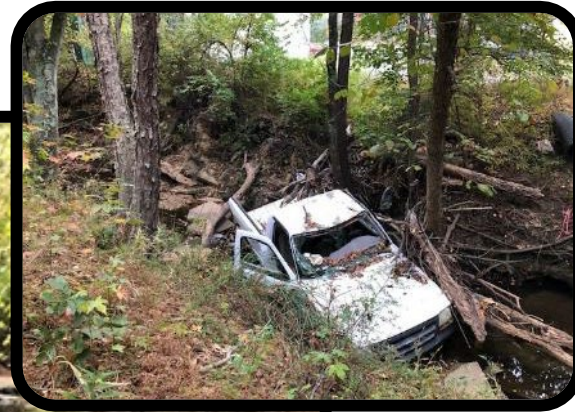
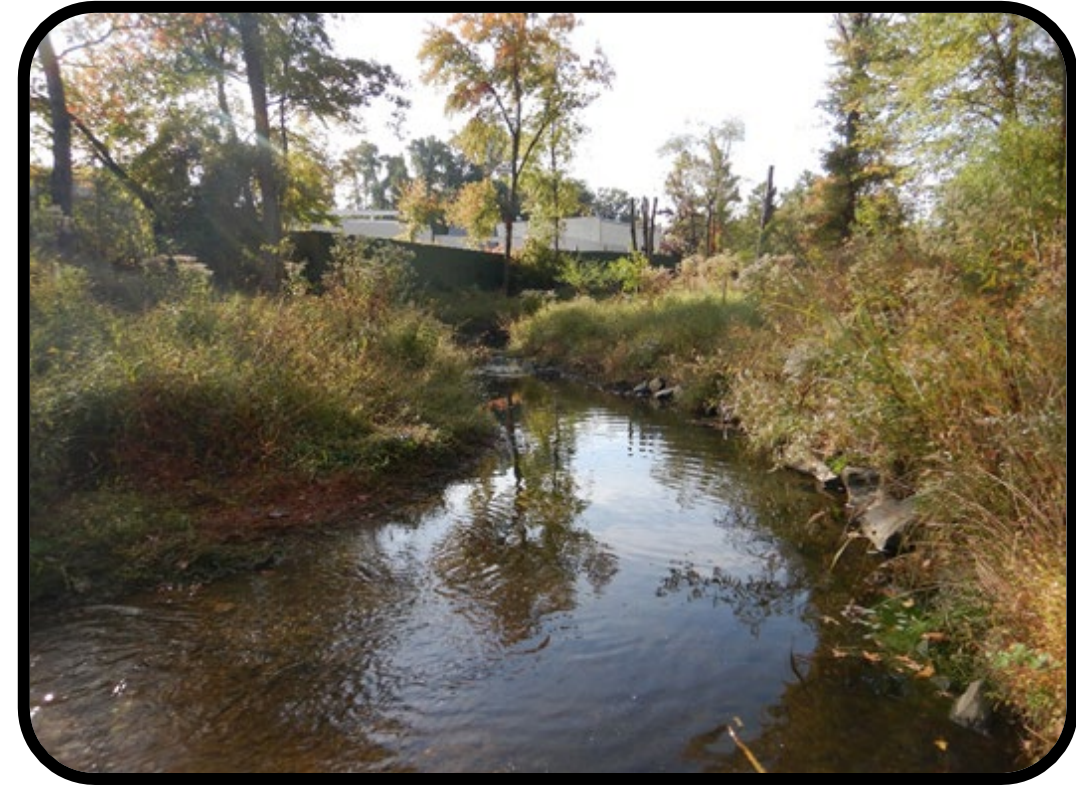
Tinkers Creek Stream Restoration

Photos show this stream reach before (left) and after (right) restoration. The truck shown was removed along with tons of other garbage and debris. The stream was stabilized, realigned, and restored habitat structure and function.

The project protected built infrastructure and reduced the flood surface elevation in the project corridor.

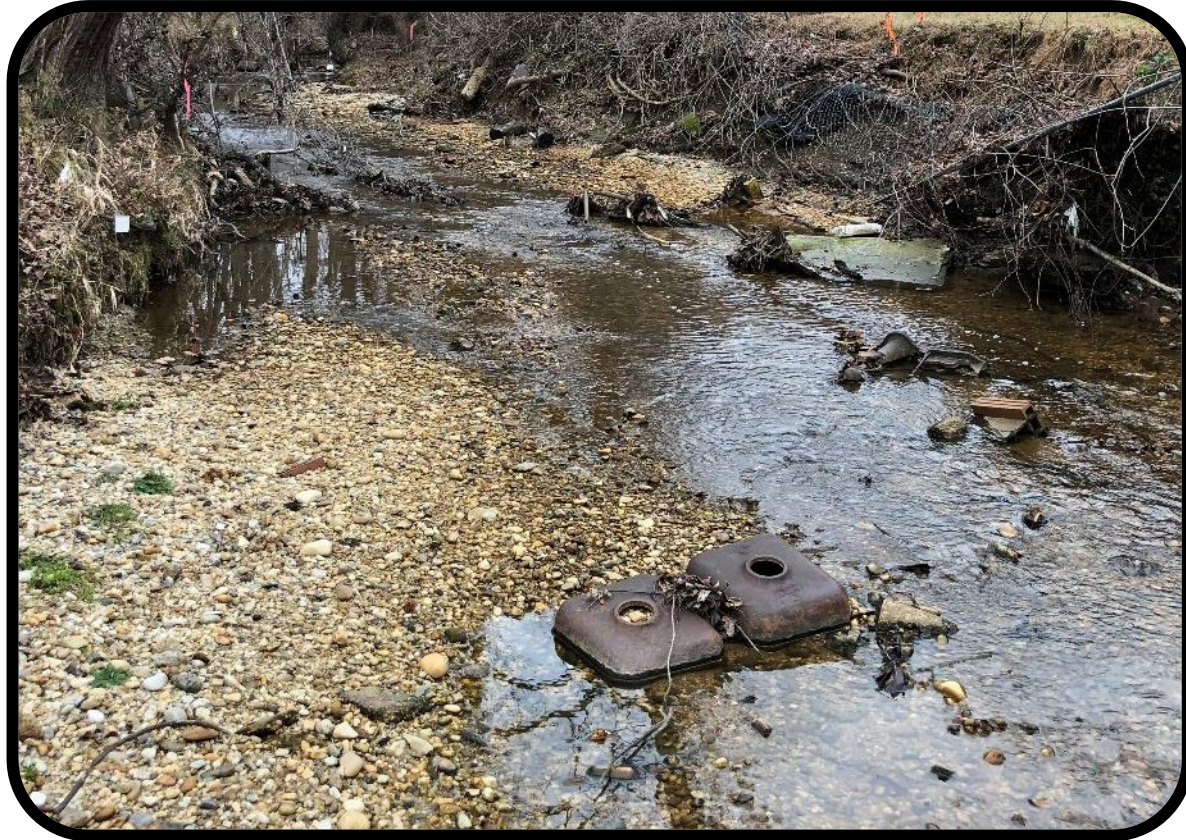
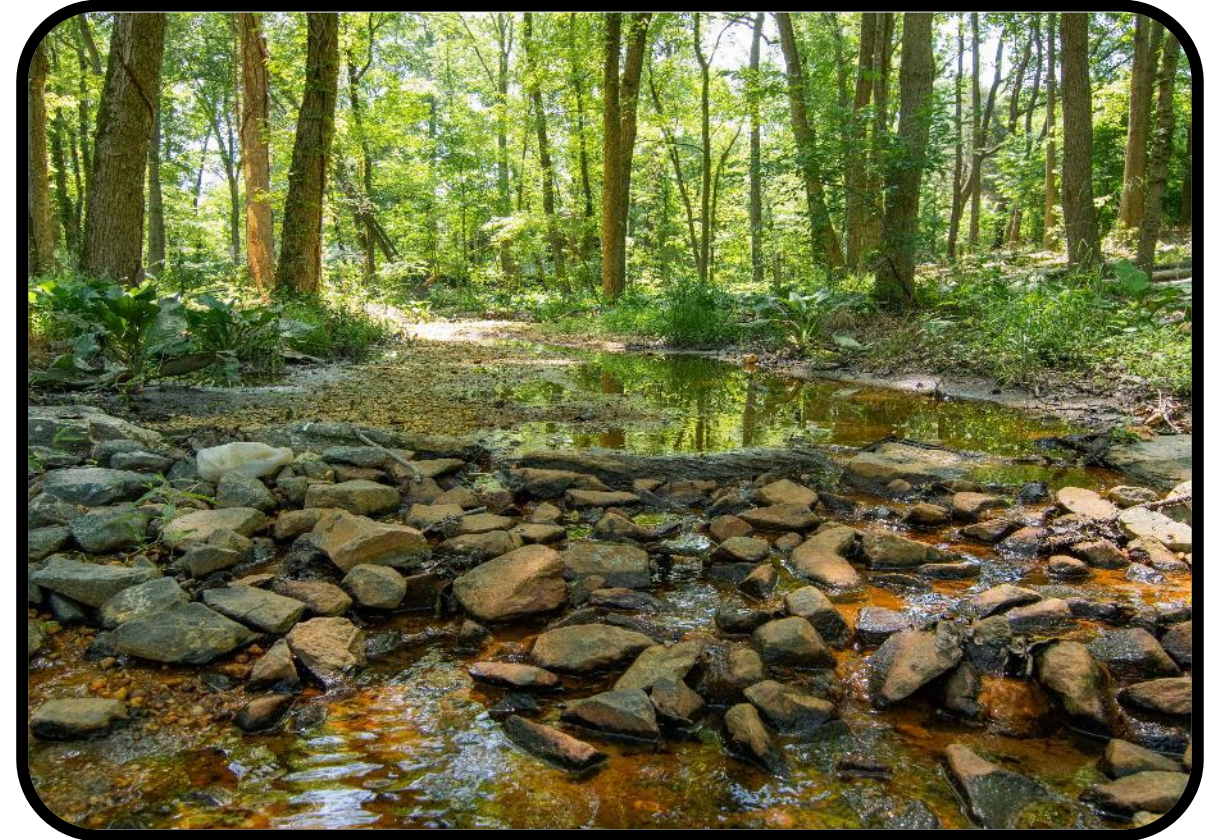
Tinkers Creek Stream Restoration

Photos depict the stream system before (left) and after (right) restoration. The restoration reduced planned impacts and installed a grade control to reduce erosion. The channel aggraded upstream as a result and is now functioning as a stable wetland complex.

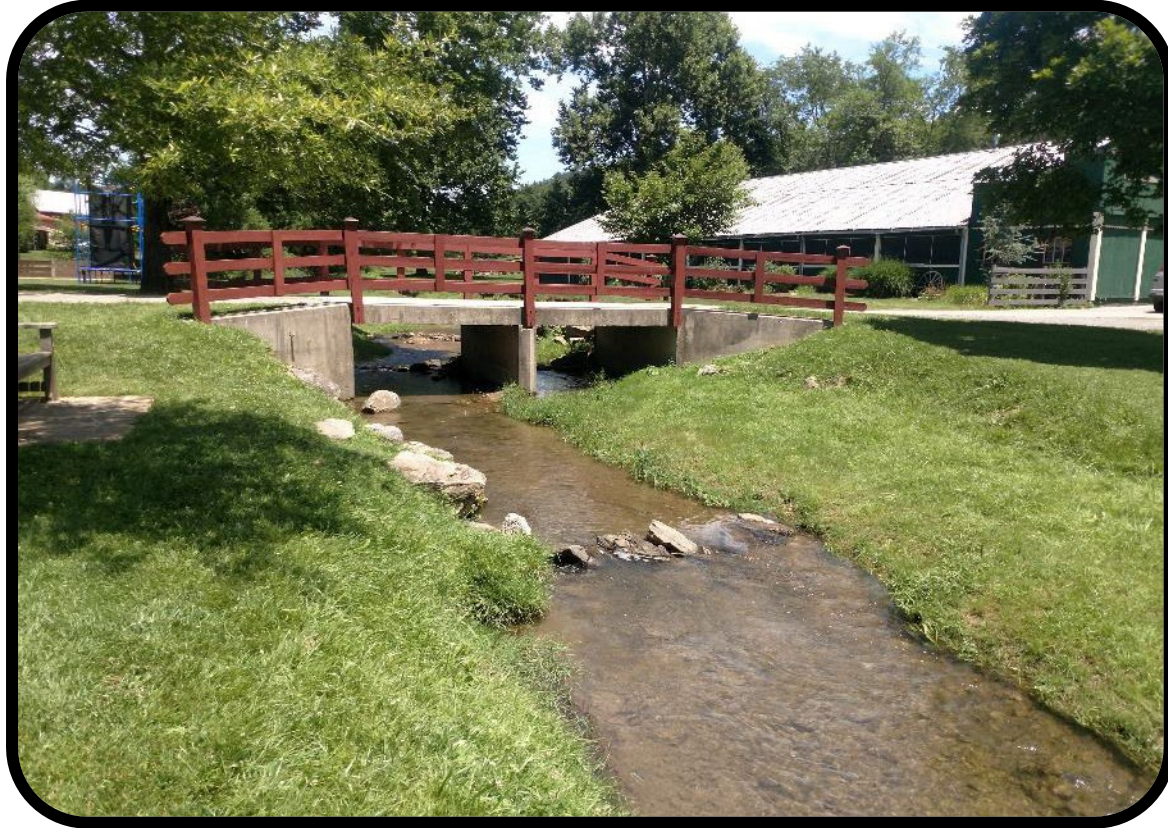
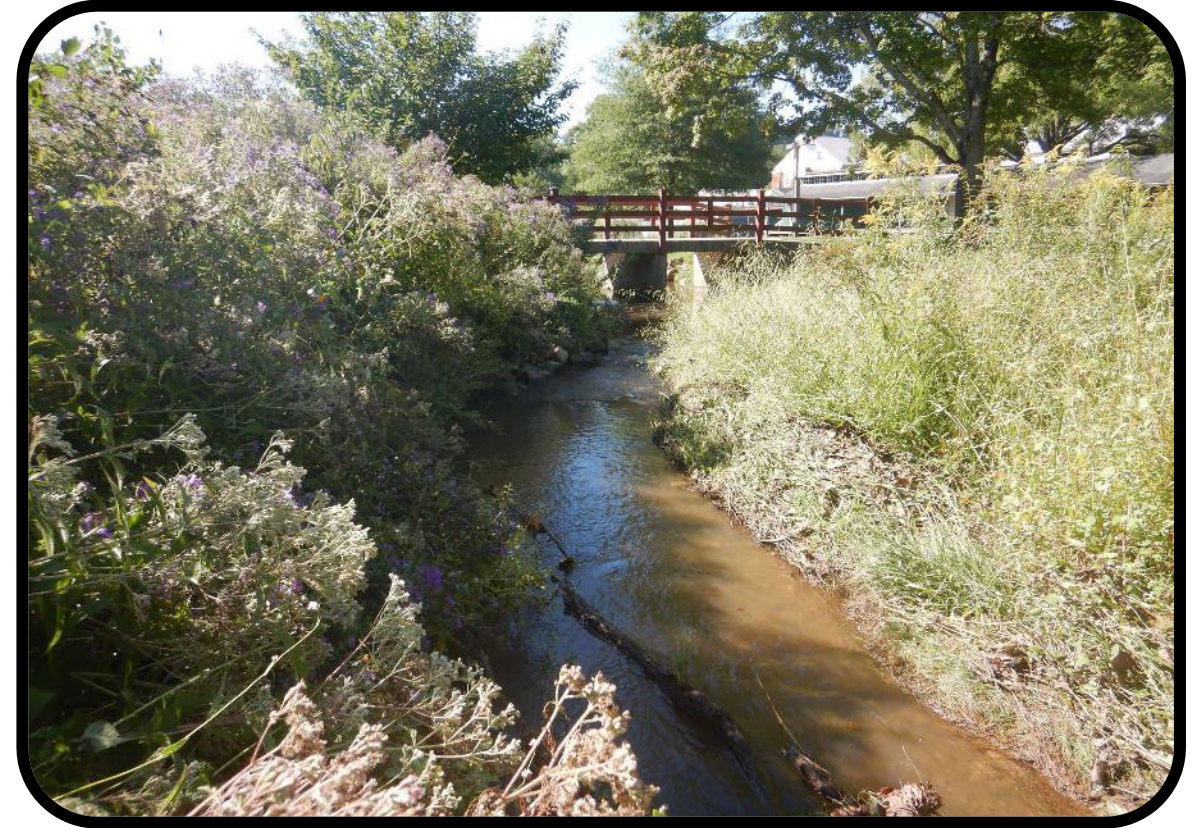
Muddy Creek Stream Restoration

Photos depict the stream system before (left) and after (right) restoration. The restoration stabilized the stream, preventing further degradation that threatened on-site historic structures. The project provided flood attenuation, aquatic and terrestrial habitat improvements, and educational opportunities for this children's camp.

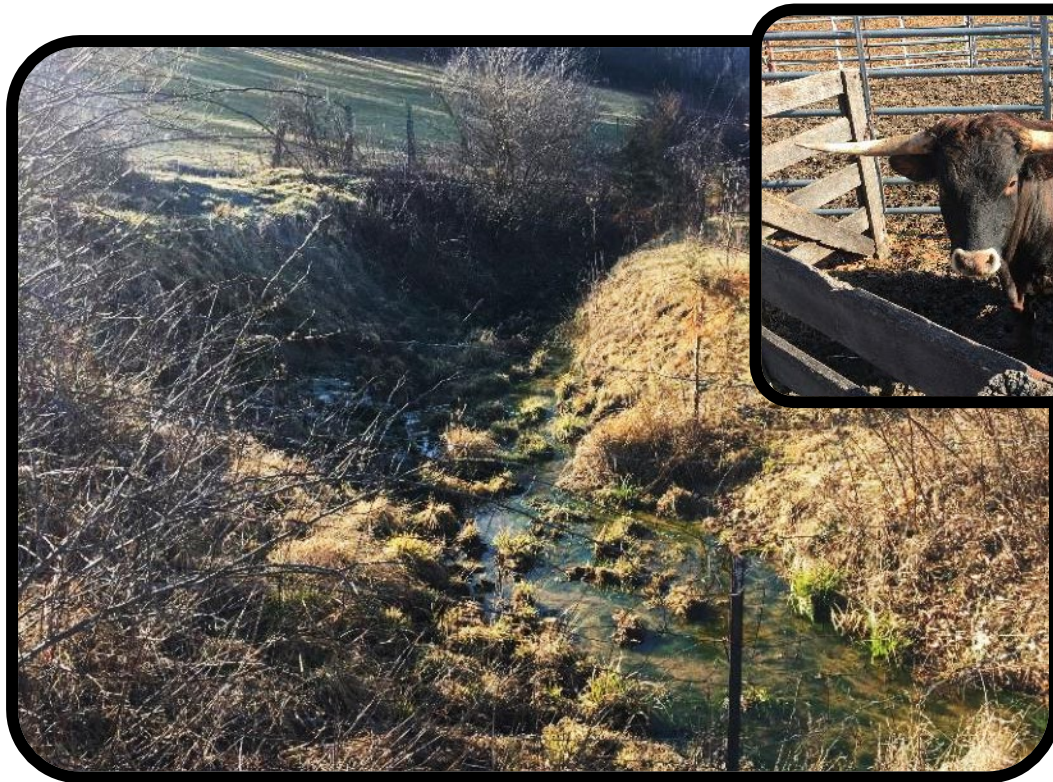
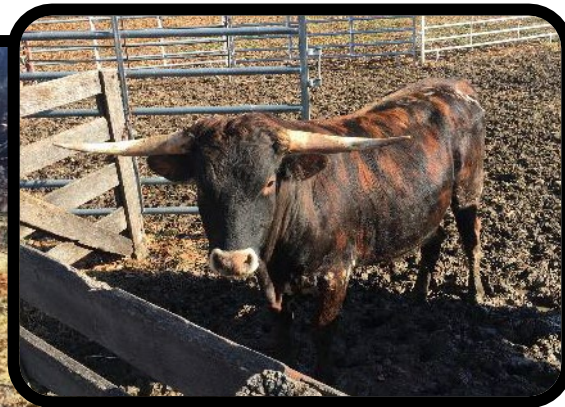
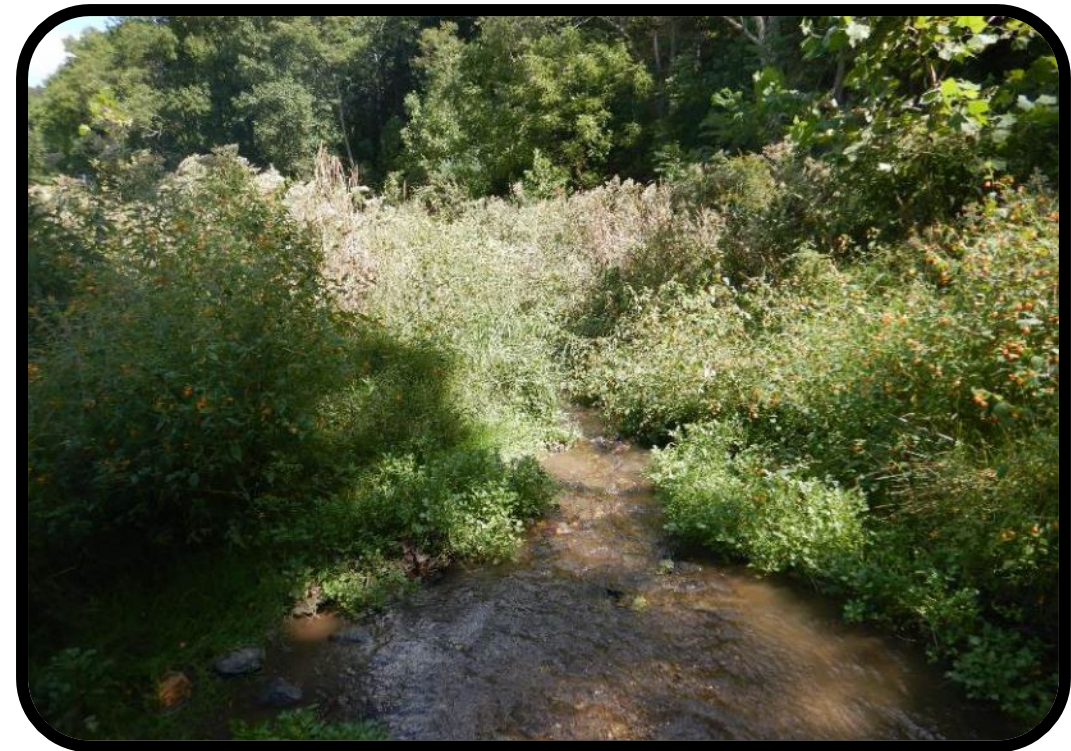
Muddy Creek Stream Restoration

Photos depict the stream system before (left) and after (right) restoration. The restoration provided flood attenuation and habitat improvements for a population of a Federally listed (endangered) species of reptile and breeding populations of brook and brown trout. Longhorn cattle activity degraded the stream and wetland complex. Cattle fencing around the stream excluded livestock impacts from threatening the protected species and degrading the restored system. The project restored forested habitat and integrated it with the surrounding forest.

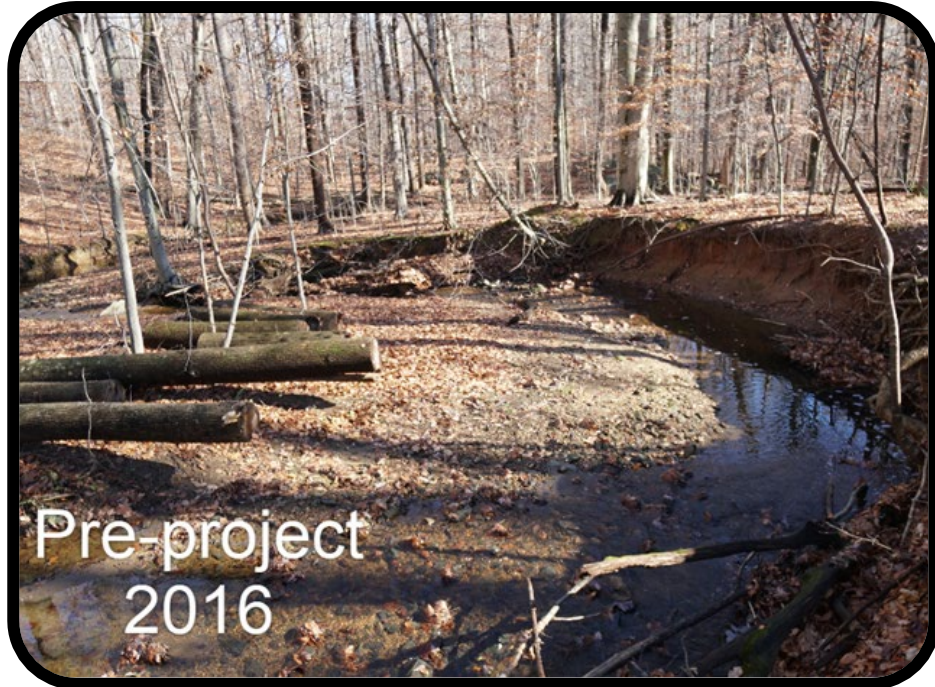
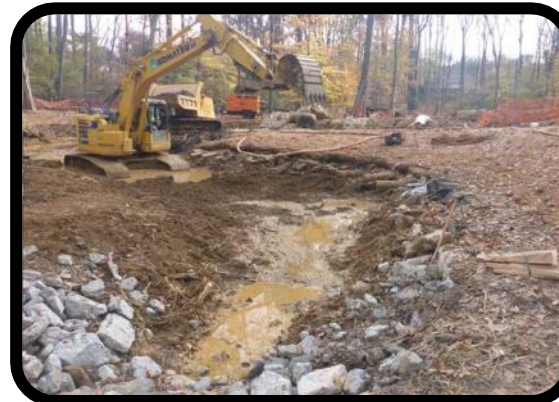
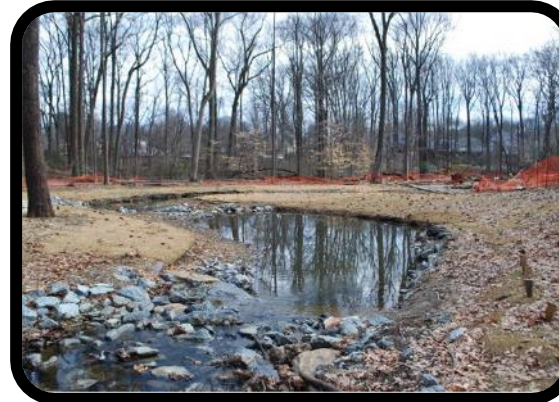
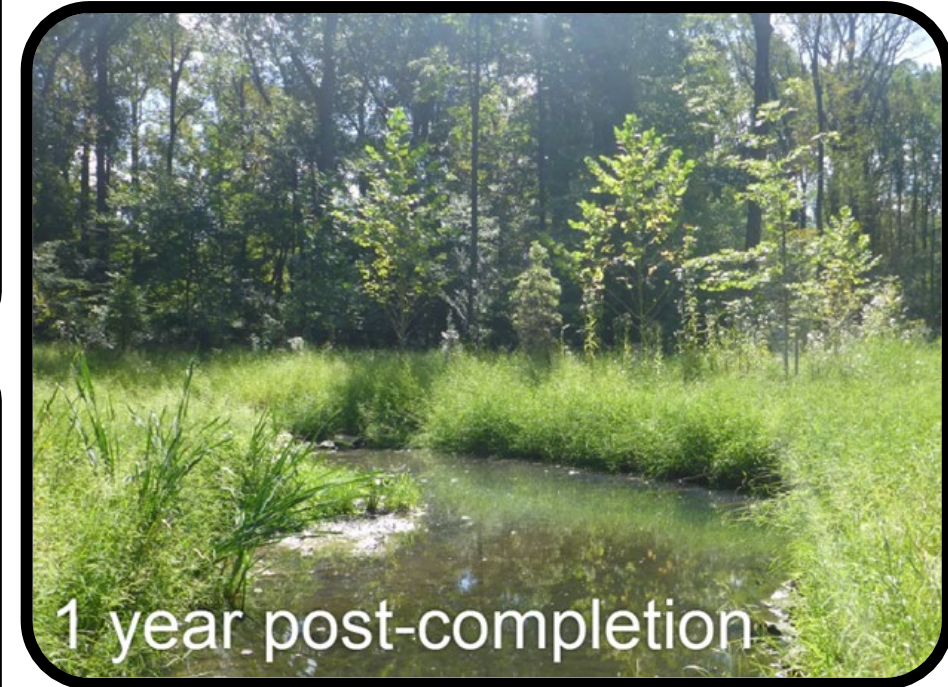
Upper Watts Branch Stream Restoration

Photos depict the stream system before (left), during (middle), and after (right) restoration. This stream restoration project in Rockville, MD addressed severe erosion and significant tree loss due to undermining and is now flourishing ecologically.

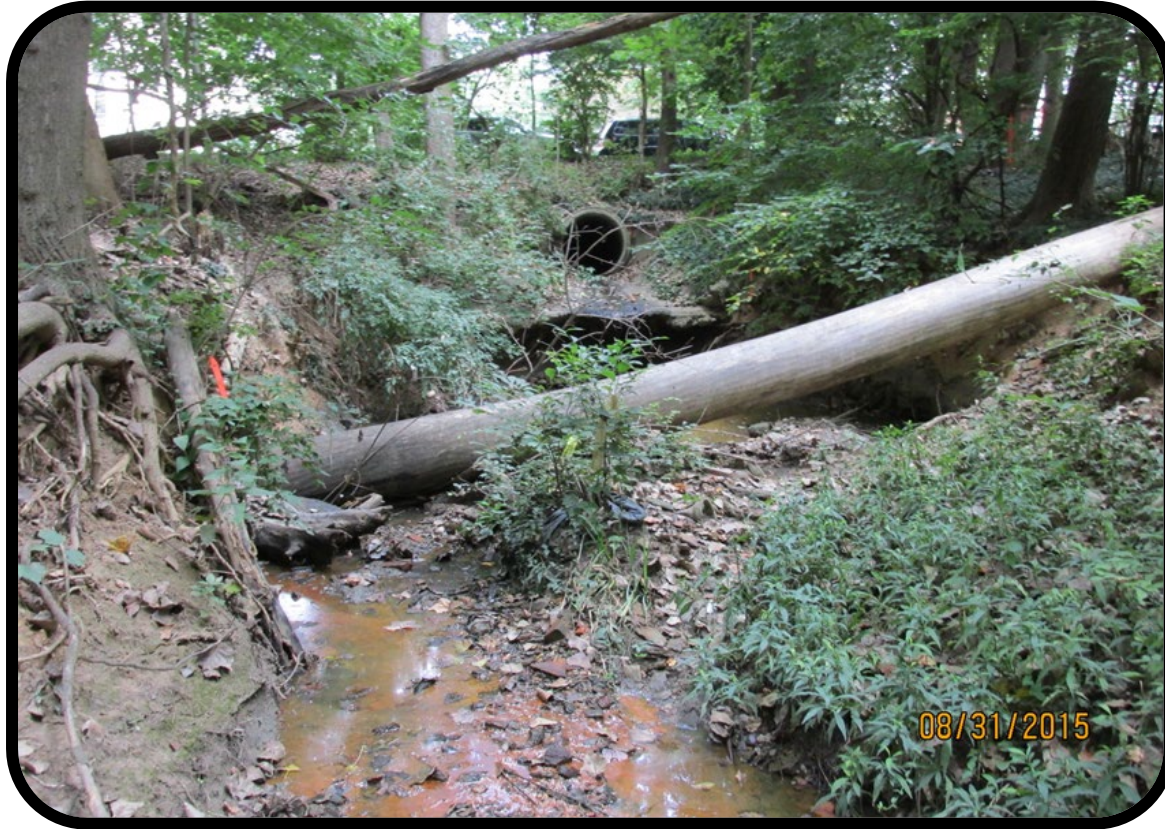
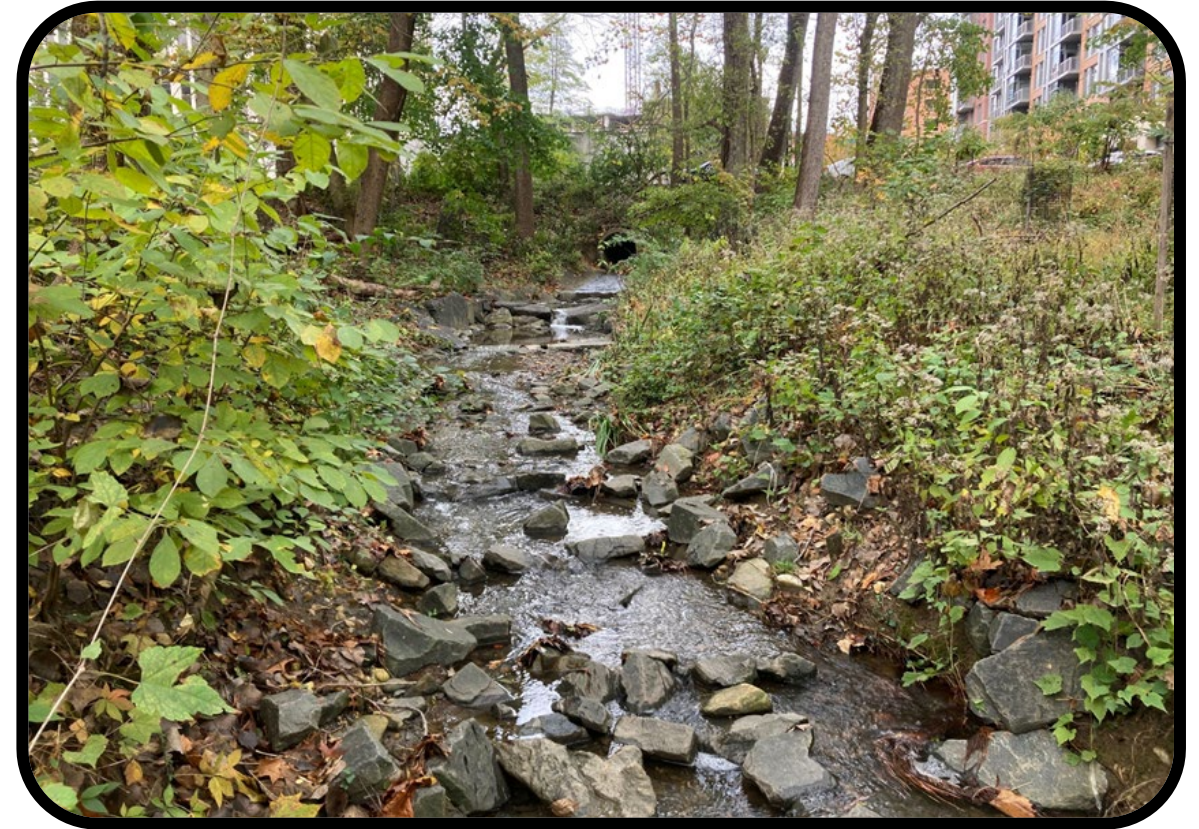
Stream Restoration

Photos depict the stream system before (left) and 4 years after (right) restoration. Prior to restoration, the stream was actively eroding and disconnected from the floodplain. Restoration stabilized the stream bed and banks and reconnected the floodplain.
