Collington Branch – The Need for Stream Restoration

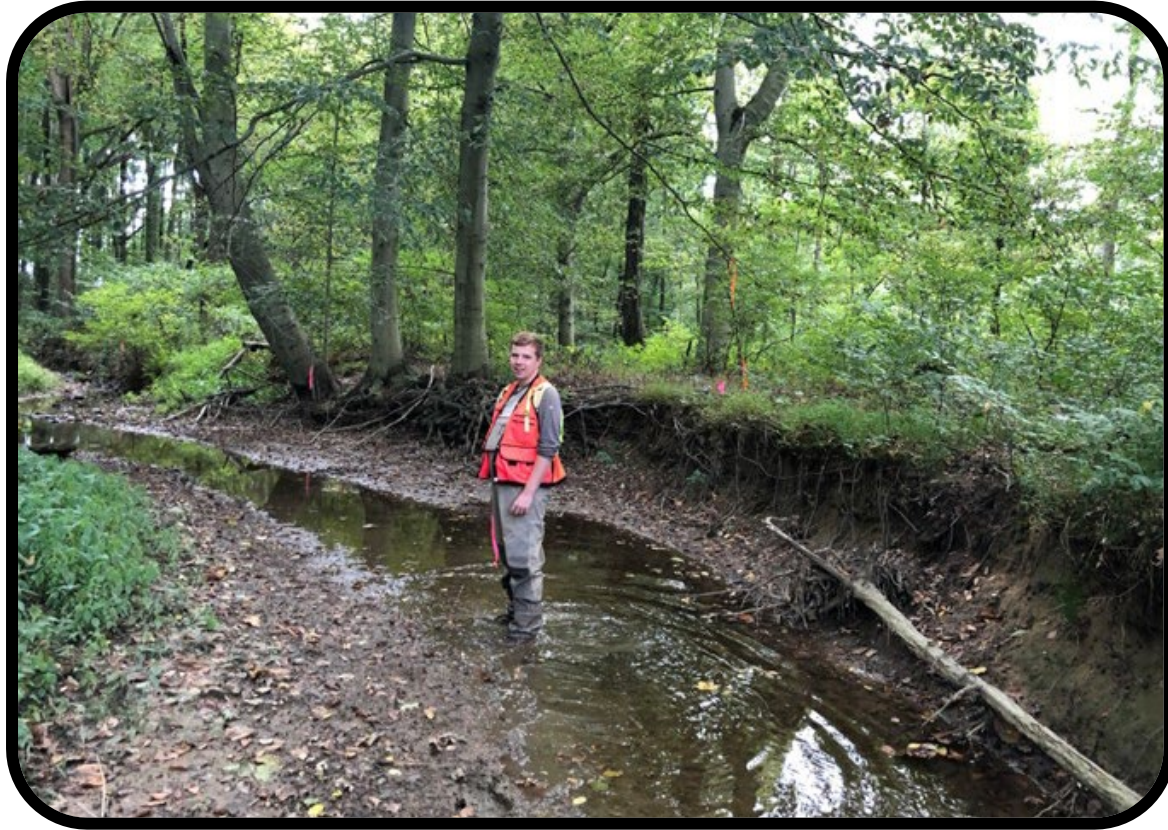
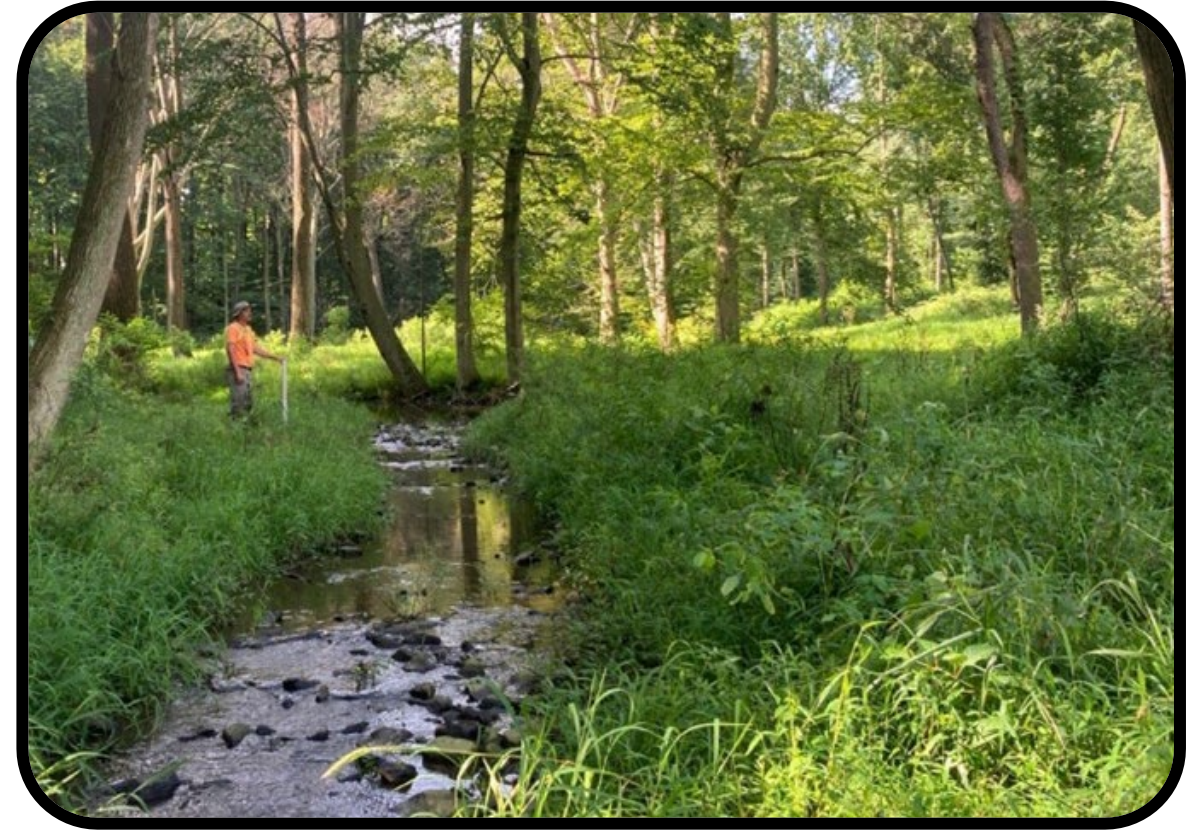
Stream Restoration

Photos depict the stream system before (left) and 2 years after (right) restoration. Prior to restoration, the stream was actively eroding and disconnected from the floodplain. Restoration stabilized the stream bed and banks and reconnected the floodplain.

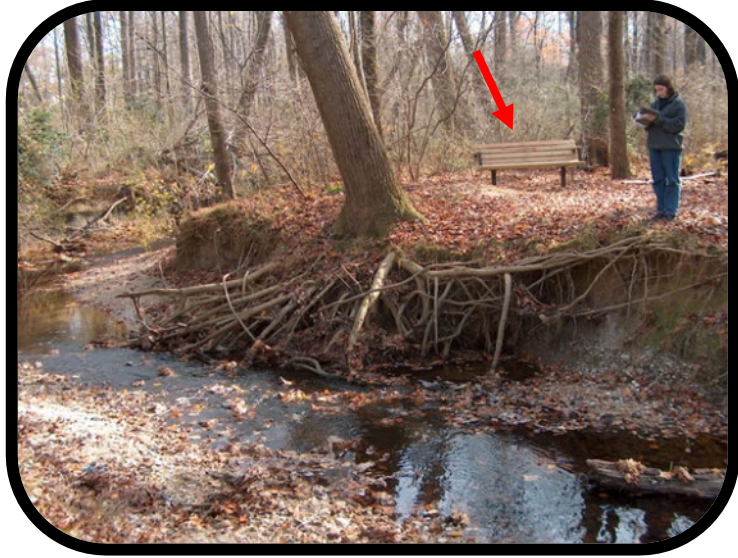
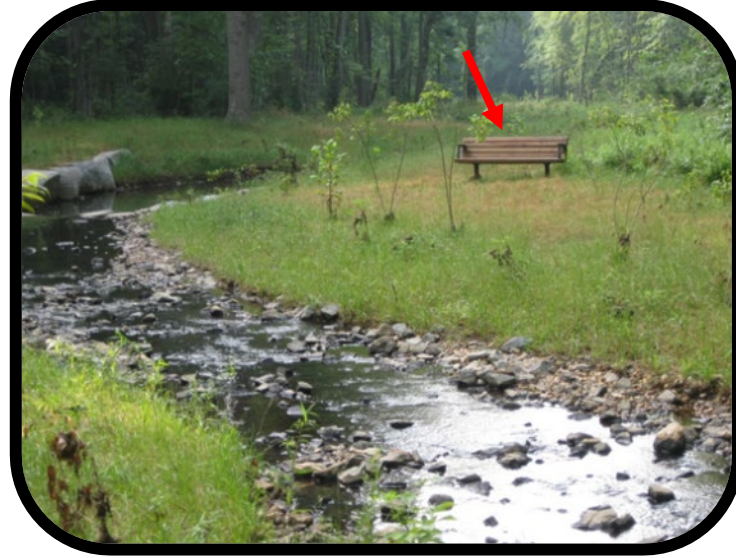
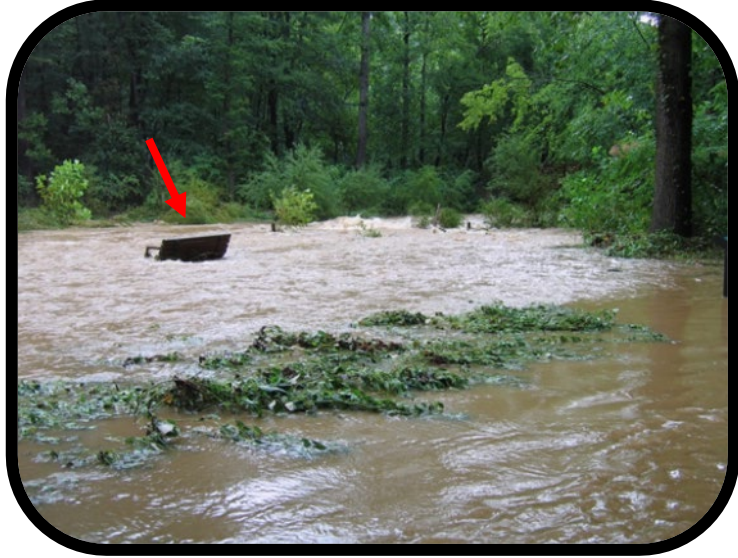
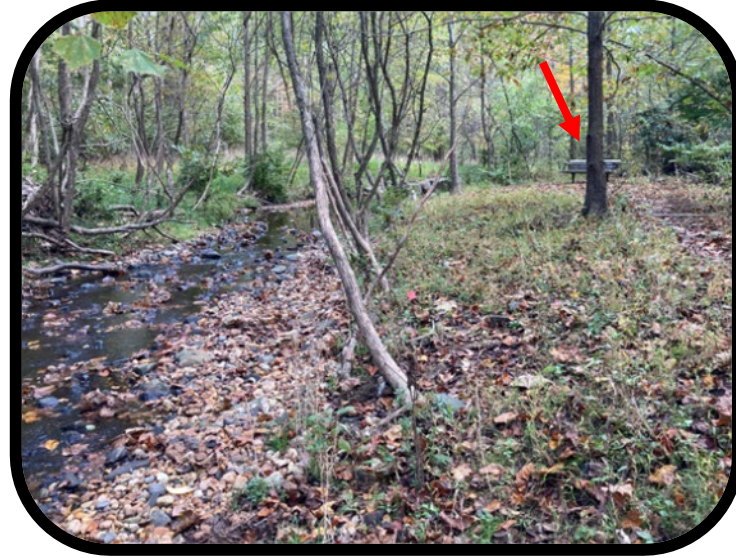
Stream Restoration

Photos depict the stream system before and after restoration. Prior to restoration (top left), the stream was deeply incised with actively eroding banks that undercut and threatened mature trees.

Restoration stabilized the stream bed and banks by raising the channel invert, thus reconnecting the stream to its floodplain, as seen 9 months after restoration (top right). The stream restoration provided resiliency to the system during storm events (bottom left), attenuating flooding in the area with the newly reconnected floodplain. Twelve years after construction, the stream is fully functioning within the forested system and planted trees and live stakes are mature enough to provide shade and cover (bottom right).

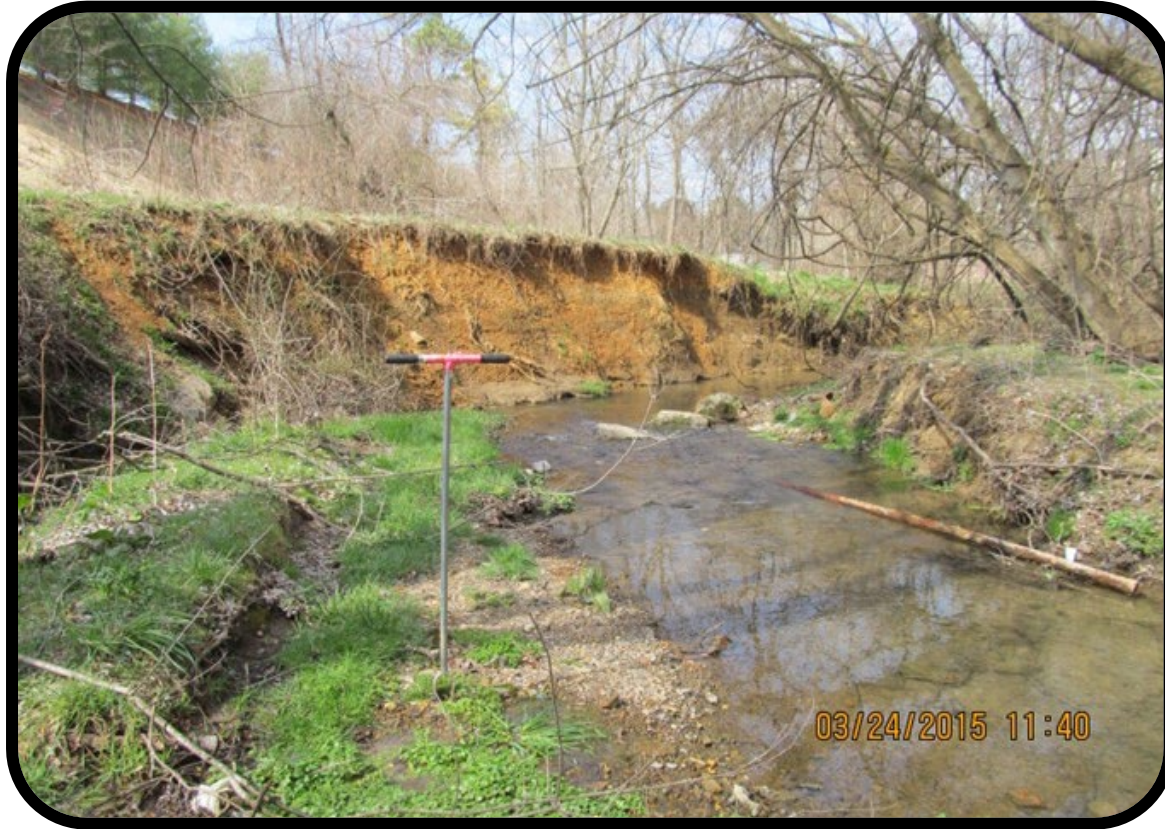
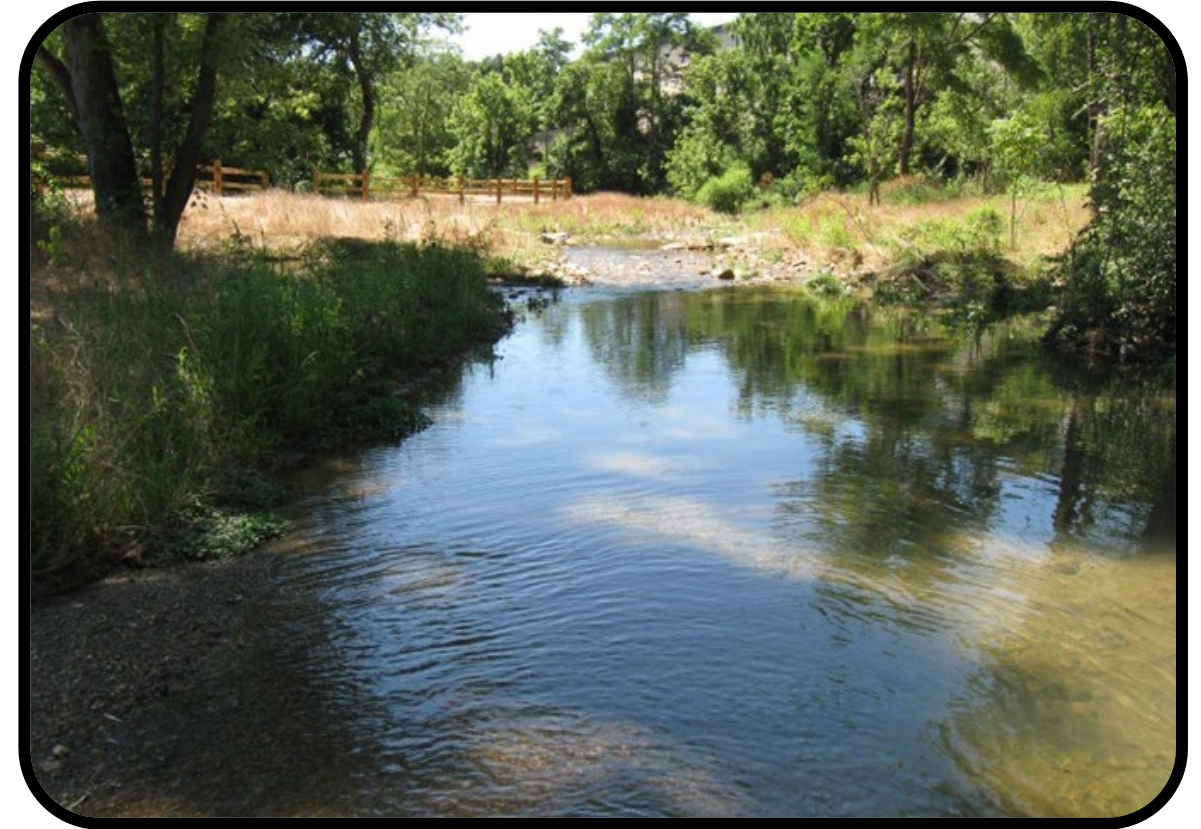
Stream Restoration

Photos depict the stream system before (left) and 1 year after (right) restoration. Prior to restoration, the stream was highly eroded and disconnected from the floodplain. Active erosion exposed essential utilities and threatened a public trail. Restoration stabilized the stream bed and banks, reconnected the floodplain, and protected local amenities.

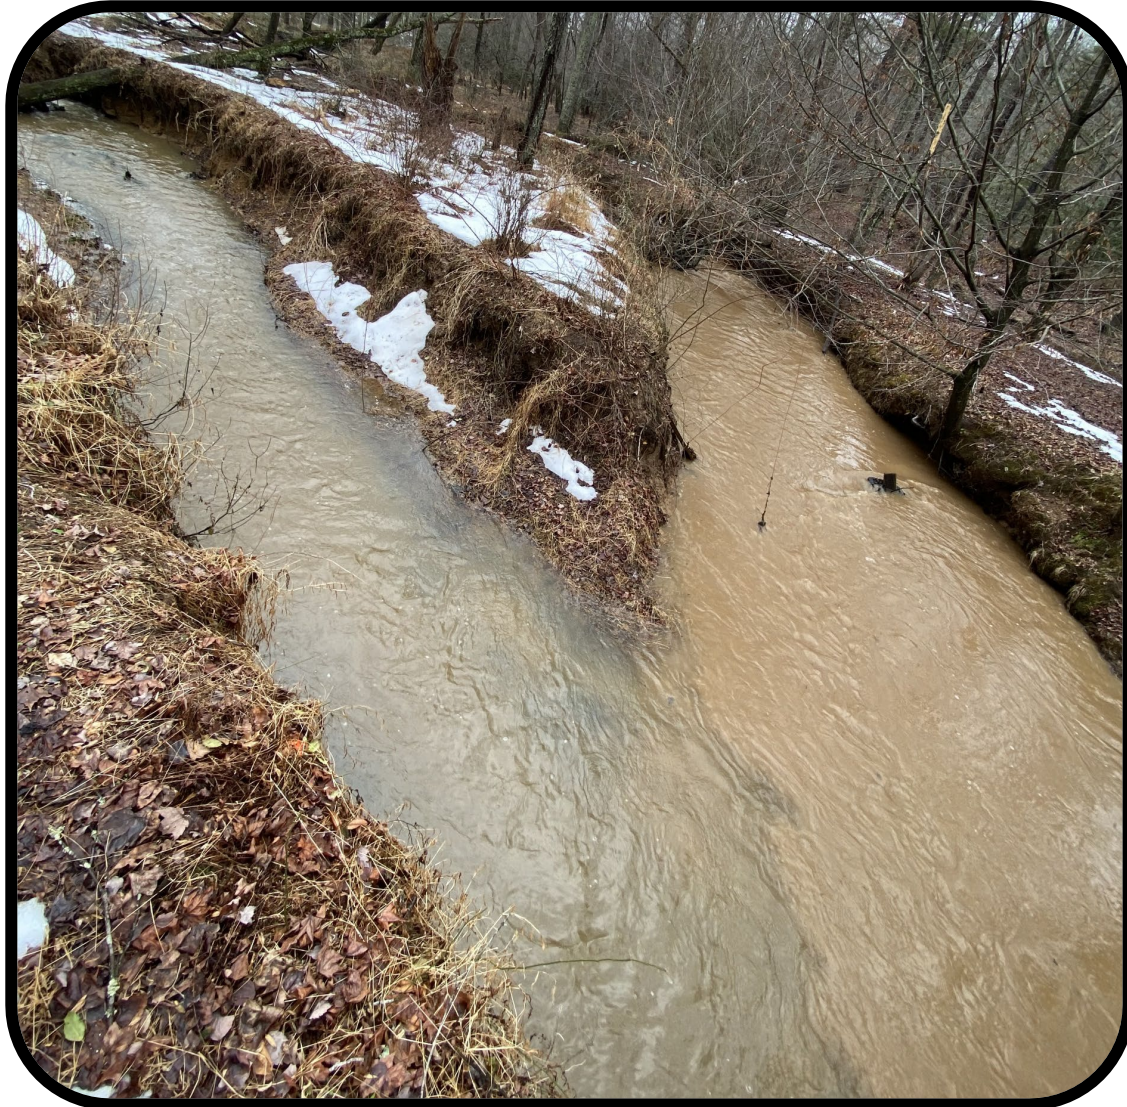
Downstream – Jabez Branch Stream Restoration

Photo taken February 20, 2026 after a rain event at the confluence of Jabez Branch.

The restored reach (left) is visibly clearer than the unrestored mainstem of Jabez Branch (right), highlighting the volume of sediment reduction provided by the restoration project, completed in 2024.

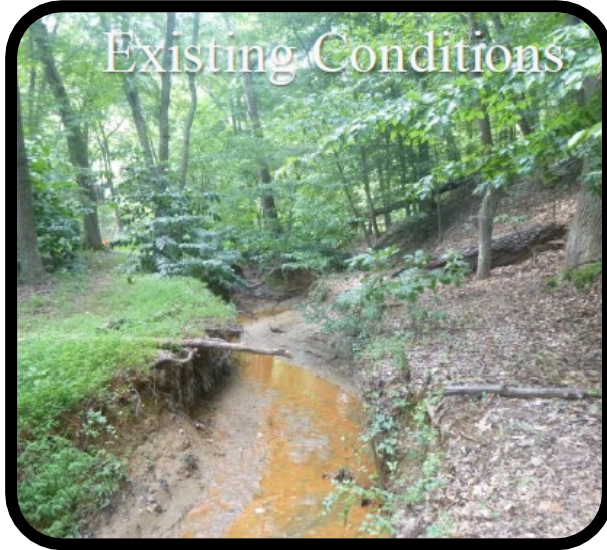
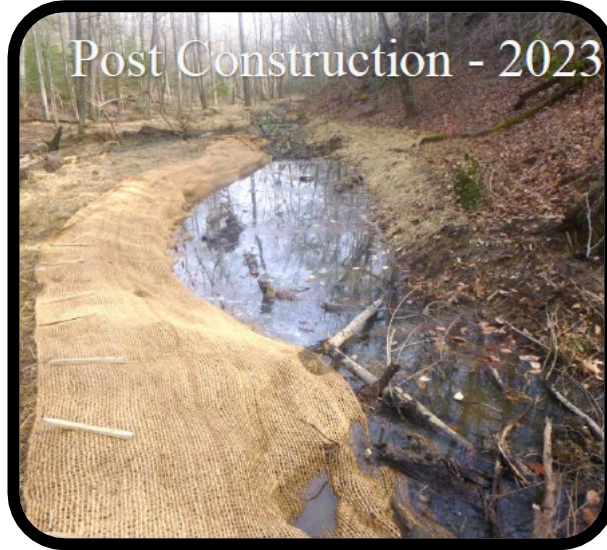
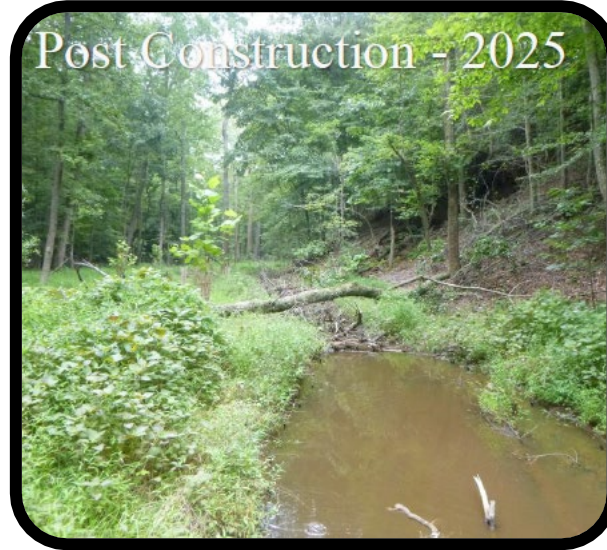
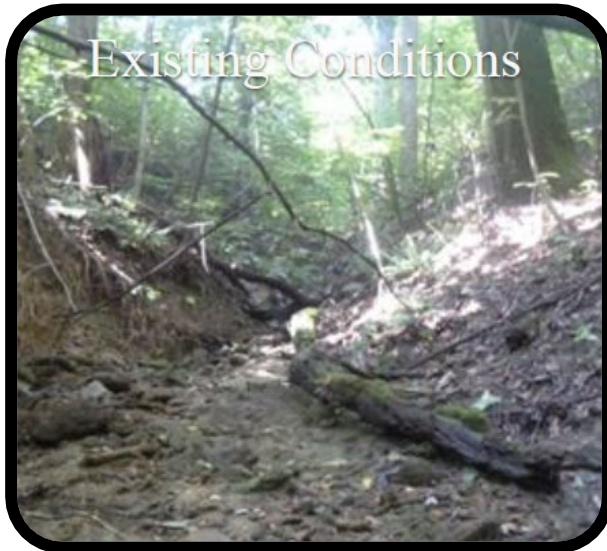
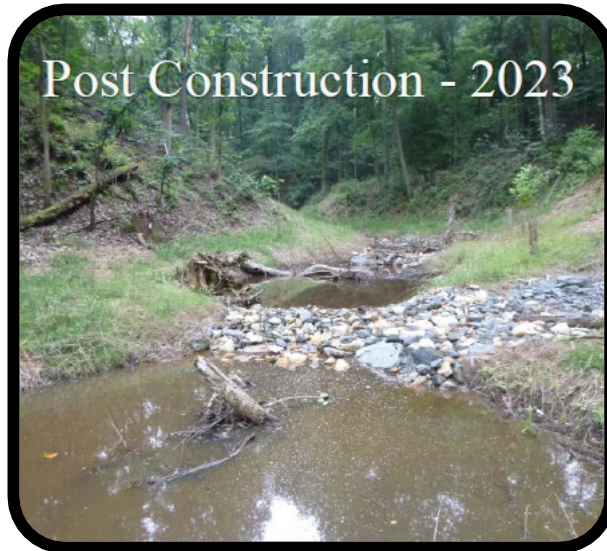
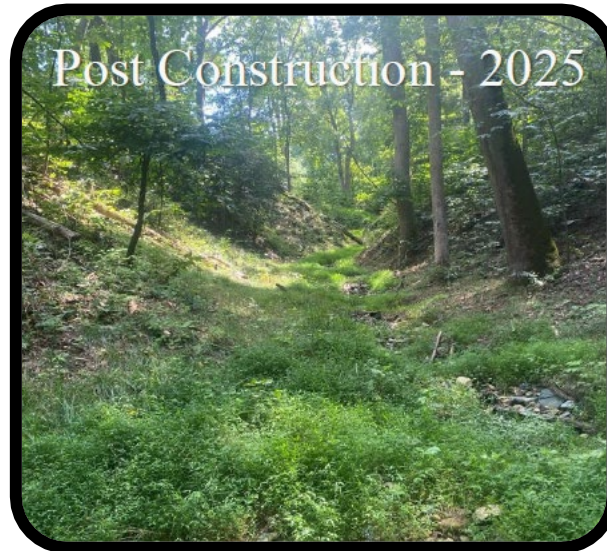
Broad Creek Stream Restoration

Photos depict the stream system before (left) and after (middle) construction, as well as 2 years after completion (right). This project restored 2,000 linear feet of stream and 0.5 acres of wetland in Annapolis, MD.

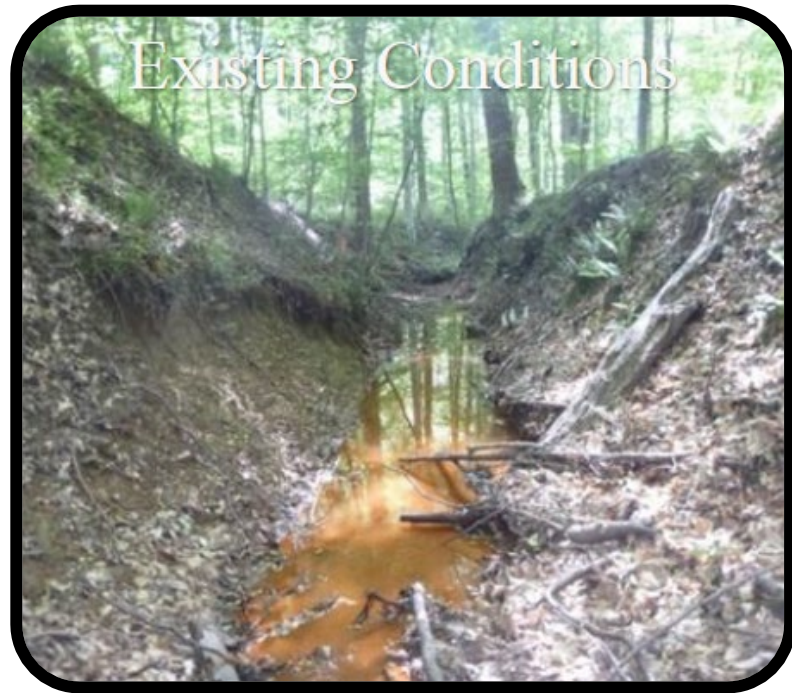
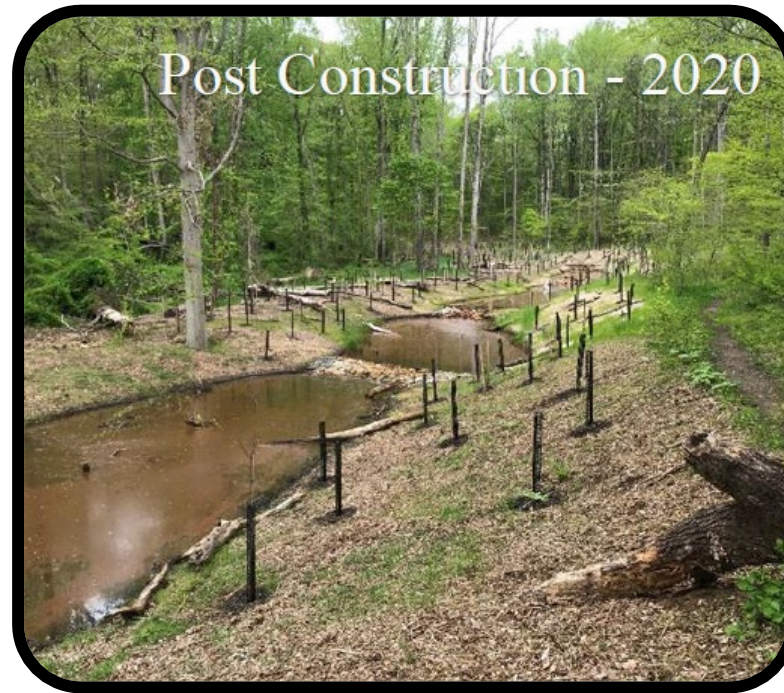
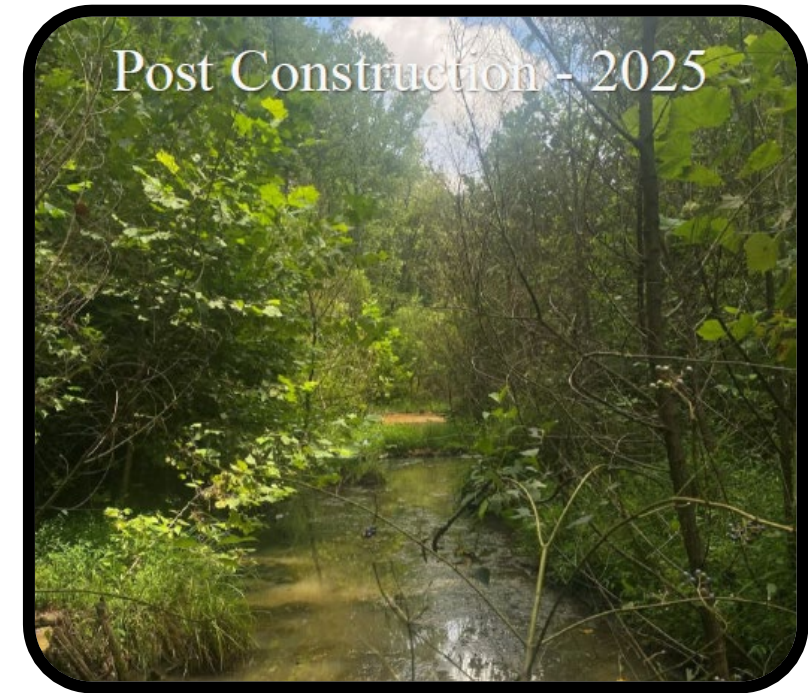
UT Flat Creek Stream Restoration

Photos depict the stream system before (left) and after (middle) construction, as well as 5 years after completion (right). This project restored 3,400 linear feet of stream and 0.5 acres of wetland in Annapolis, MD.

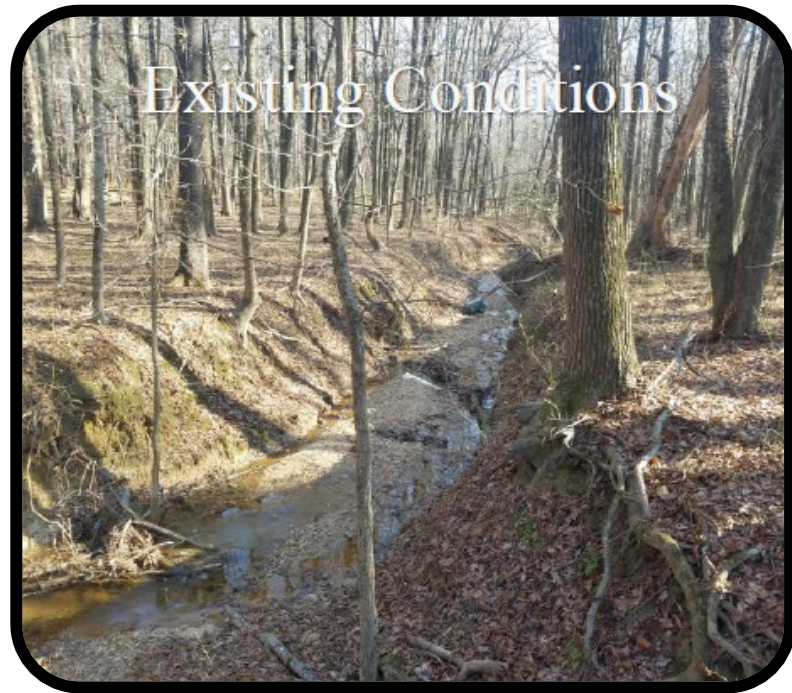
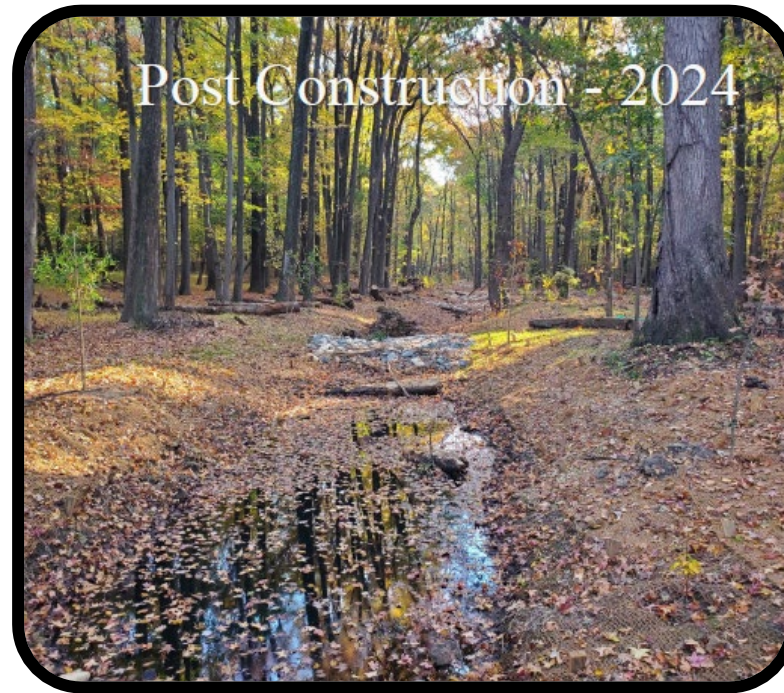
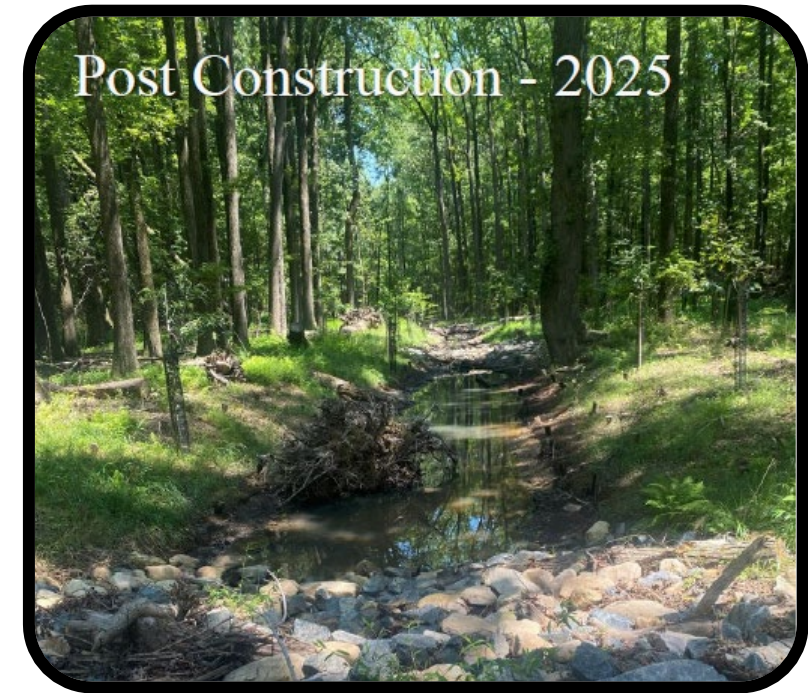
Fort Meade Stream Restoration

Photos depict the stream system before (left) and after (middle) construction, as well as 1 year after completion (right). This project restored 1,920 linear feet of stream in Laurel, MD.

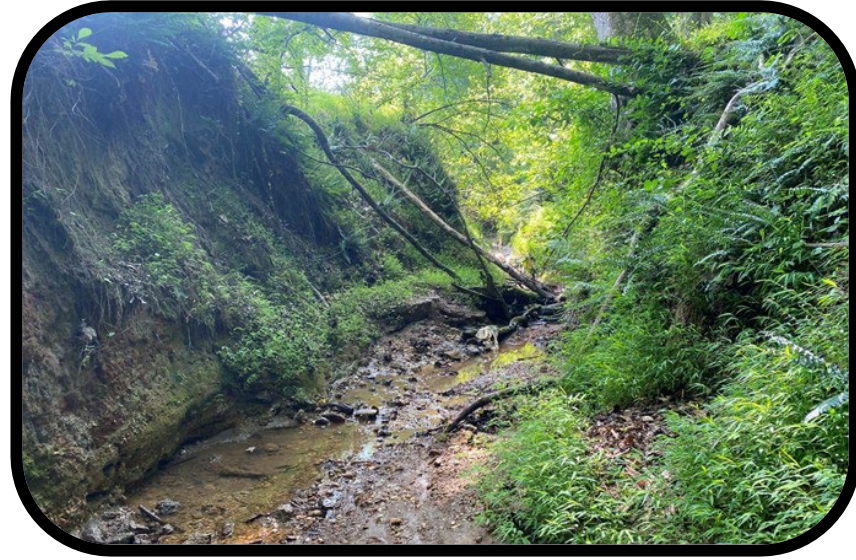
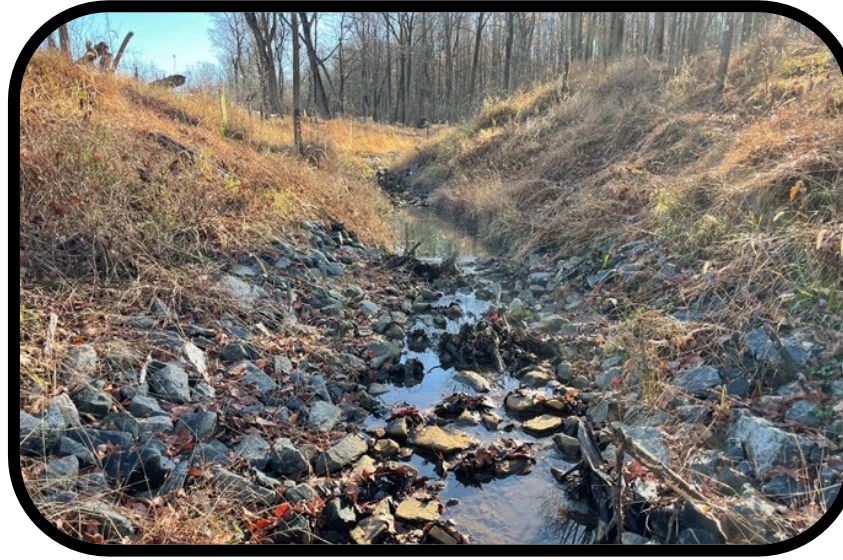
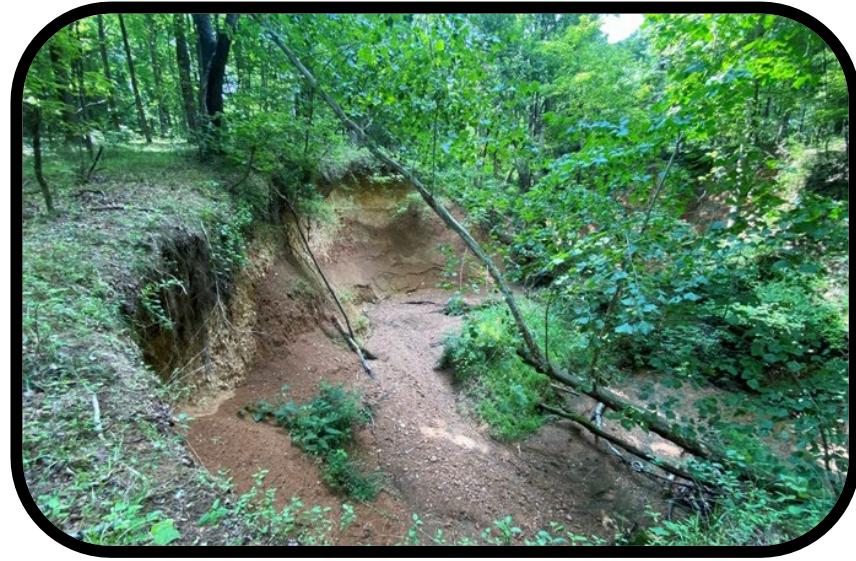
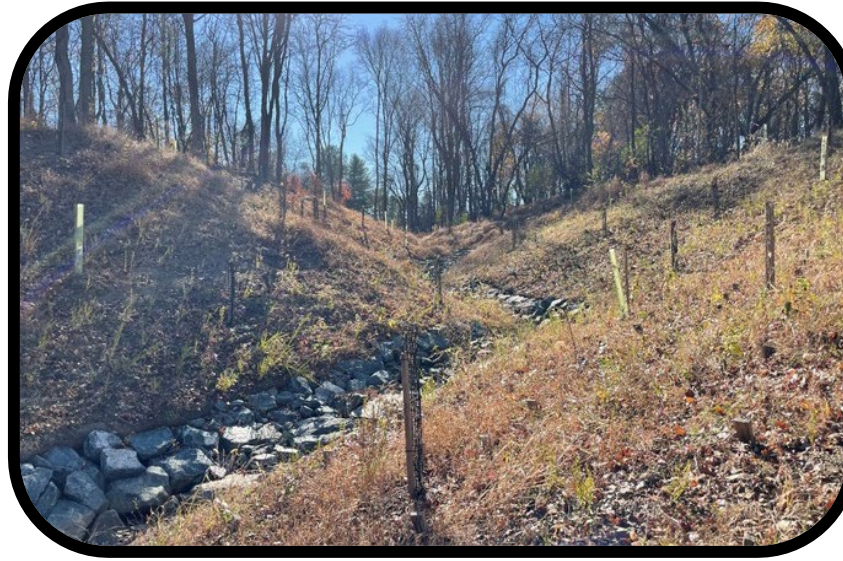
Liberty Sports Park Stream Restoration

Photos depict the stream system before (left) and after (right) construction. The project restored approximately 7,833 linear feet of heavily eroded headwater tributaries, achieving channel protection volume, increased ecological function, and corridor resiliency during storm events.
