Indigo Null* **HB703 Testimony**

A full professional code report documenting the violations and dangerous conditions in my apartment can be found attached at the end of this document on page 09

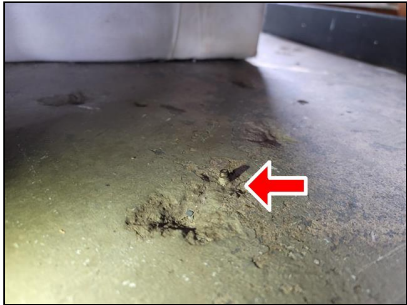
1.0 Item 1(Picture)

All floors were concrete and no flooring was installed. Many areas had metal bolts sticking out of floor which are a hazard.

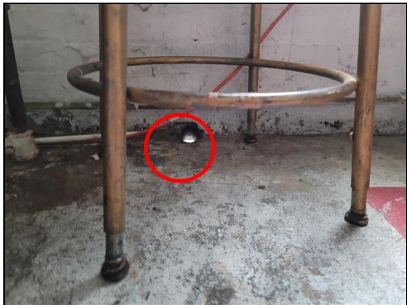
1.1 Item 1(Picture)

(1) Holes in the exterior walls were observed in many areas.

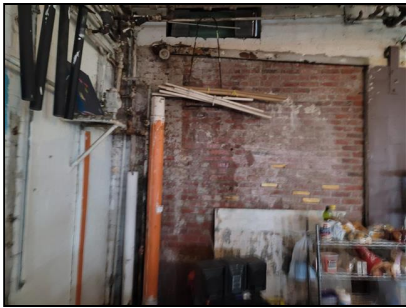
1.1 Item 2(Picture)

(2) Stains on the walls in the visible in many areas at the time of the inspection appeared to be the result of moisture intrusion. The moisture meter showed elevated moisture levels in the affected areas at the time of the inspection, indicating that the leakage has been recent. The Inspector recommends consultation with a qualified contractor to discuss options and costs for correction and repair.

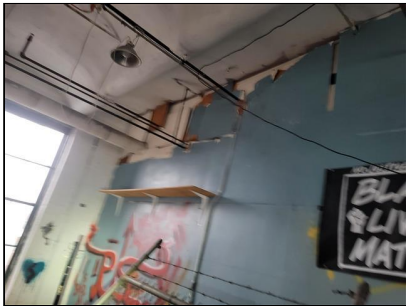
1.1 Item 7(Picture)

(4) Walls in the exhibited moderate damage or deterioration and were poorly installed.

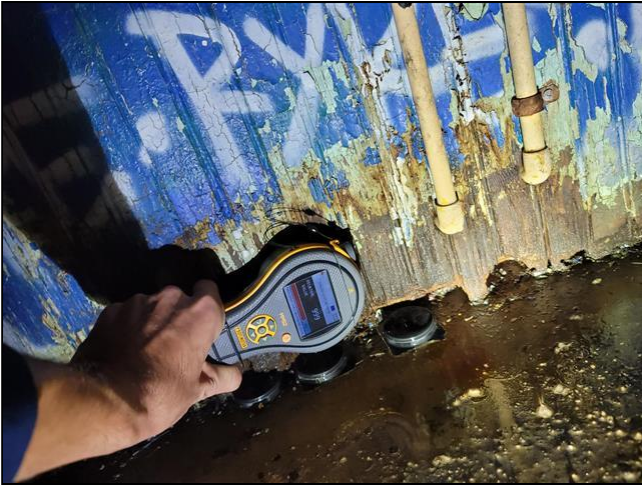
1.1 Item 9(Picture)

- 🔧 (5) Stains on the walls in the kitchen below sink and behind the shower visible at the time of the inspection appeared to be the result of moisture intrusion. The moisture meter showed elevated moisture levels in the affected areas at the time of the inspection, indicating that the leakage has been recent. The Inspector recommends consultation with a qualified contractor to discuss options and costs for correction and repair to prevent mold growth and unhealthy conditions.

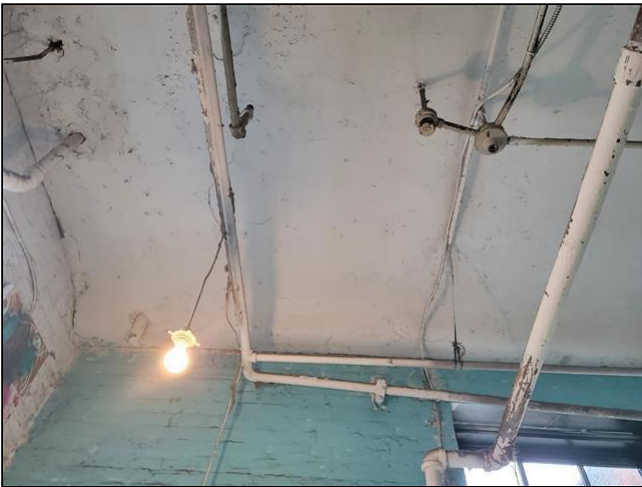
1.2 Item 1(Picture)

- 🔧 (1) Many interior light fixtures in the home were damaged or inoperable and extension cords with lighting was used instead. This condition is a potential fire or shock/electrocution hazard. The Inspector recommends repairs be performed by a qualified electrical contractor.

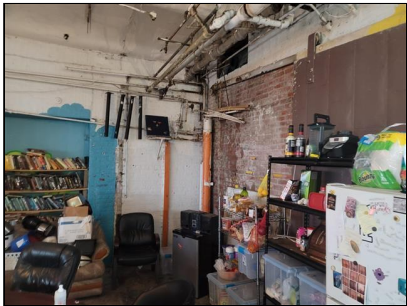
1.3 Item 8(Picture)

🔧 (2) Because this home was built before 1978, there is a good chance it has lead-based paint. In 1978, the federal government banned consumer uses of lead-containing paint as a potential health hazard, but some states banned it even earlier. Lead from paint, including lead-contaminated dust, is one of the most common causes of lead poisoning. Chipping, cracking, flaking and deteriorated paint was observed widespread throughout the building. All painted surfaces in the building should be repainted and repaired by a lead abatement contractor.

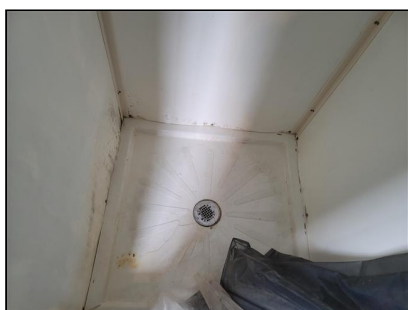
2.4 Item 5(Picture)

- 🔧 (4) In the bathroom, the shower enclosure was old and deteriorated.

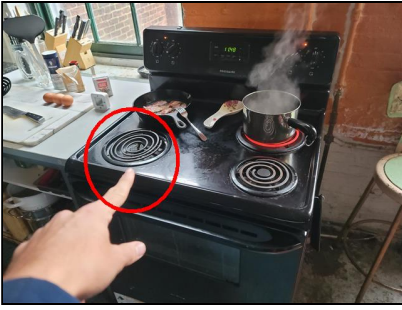
3.2 Item 1(Picture)

- 🔧 (2) The electric stove had one or more inoperable stove top burners. The Inspector recommends service by a qualified technician.

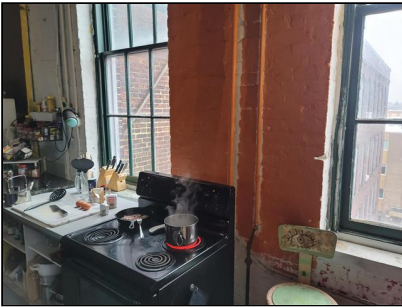
3.3 Item 1(Picture)

- 🔧 No range hood or exhaust system was installed at the time of the inspection. The Inspector recommends that an exhaust hood or air filtration system be installed to prevent possible moisture damage and grease accumulation on walls and ceiling adjacent to the range. All work should be performed by a qualified contractor.

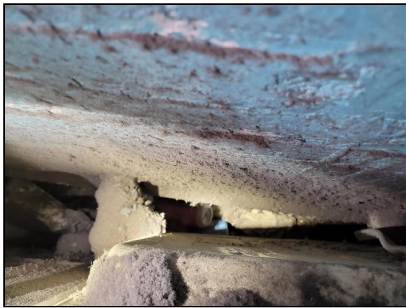
4.0 Item 1(Picture)

No vent connection was provided for the dryer. Lack of proper dryer venting to the exterior may result in excessively high humidity levels that can damage home materials or components and may encourage the growth of microbes such as mold. Lack of proper dryer venting can also result in the accumulation of lint in the home. Lint is combustible and its accumulation is a potential fire hazard and a possible health hazard from the inhalation of particulates. The Inspector recommends proper installation of an Underwriter's Laboratory (UL)-approved dryer vent for safety reasons. Dryer vents should be cleaned annually to ensure that safe conditions continue to exist. All work should be performed by a qualified contractor.

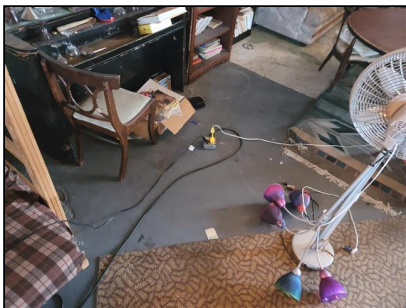
5.1 Item 1(Picture)

- Repair/Replace
- ⚡ (1) The number of electrical receptacles in the home was inadequate and extension cords were used throughout the unit. This condition is potential fire hazard and should be corrected.

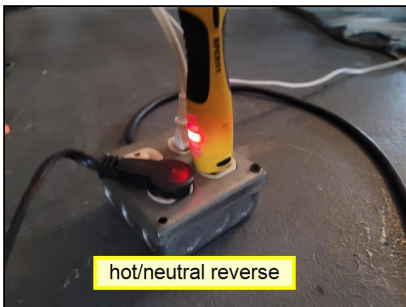
5.1 Item 6(Picture)

- ⚡ (2) Some electrical receptacles in this unit were improperly wired and should be corrected by a qualified electrical contractor to prevent a fire hazard.

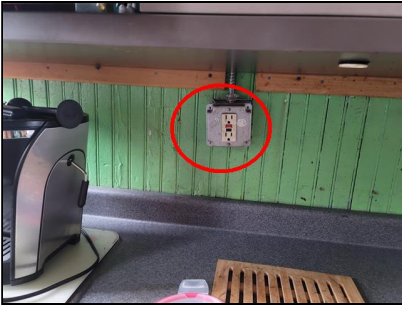
5.1 Item 8(Picture)

- 🔧 (3) Some electrical receptacles in the home were inoperable at the time of the inspection. The Inspector recommends service by a qualified electrical contractor.

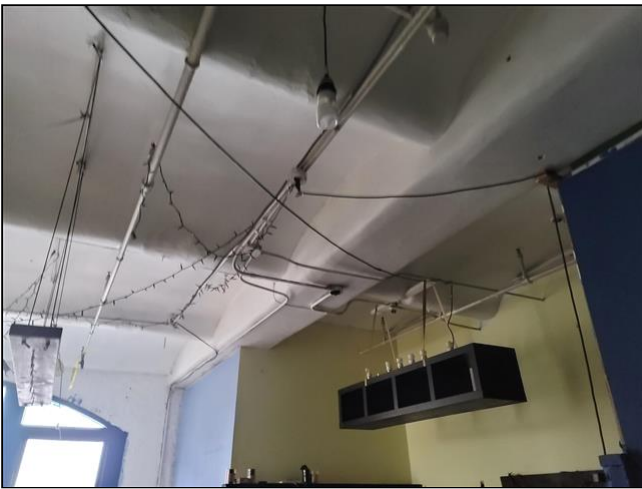
5.2 Item 1(Picture)

- 🔧 This unit did not have operable and enough light fixtures. Extension cords with lighting and string lights were used. This condition is a potential fire hazard.

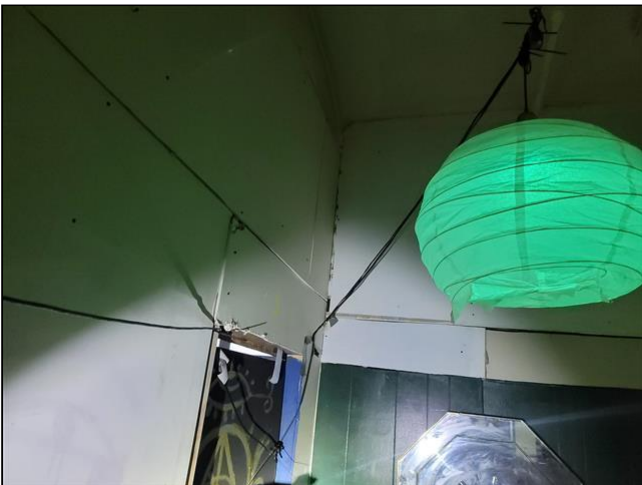
5.3 Item 1(Picture)

- 🔧 (1) One or more junction boxes were missing covers and energized electrical components were exposed to touch. This condition is an electrical shock/electrocution hazard.

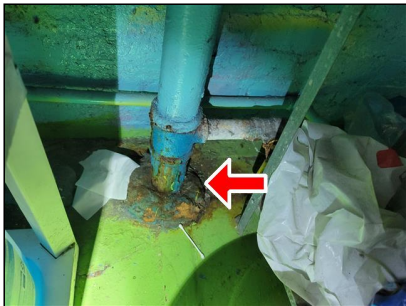
6.0 Item 1(Picture)

(1) Some of the visible water distribution pipes were galvanized steel. This pipes are old, and of a material no longer installed for this purpose due to bore shrinkage from accumulation of interior corrosion that over time reduces water flow. These pipes may need to be replaced soon.

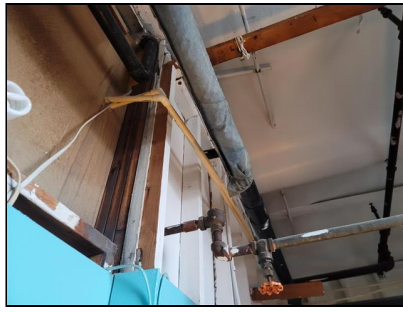
6.0 Item 4(Picture)

- (3) Chlorinated Poly Vinyl Chloride (CPVC) water distribution pipes were poorly supported in the unit. This condition puts excessive strain on fittings and may result in premature failure. Horizontally-oriented CPVC distribution pipes should be supported at least every 3 feet. The Inspector recommends installation of

additional supports by a qualified contractor. Some portions of the home distribution piping will not be accessible for installation of additional supports.

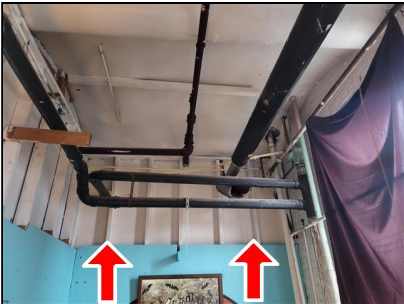
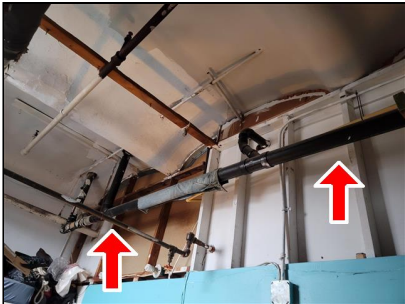
6.1 Item 6(Picture)

🔧 (3) Supports for the ABS or PVC drain/waste pipe visible in the rear bedroom were located too far apart. The maximum support spacing recommended by generally-accepted modern plumbing standards is 4 feet. The Inspector recommends correction by a qualified contractor.

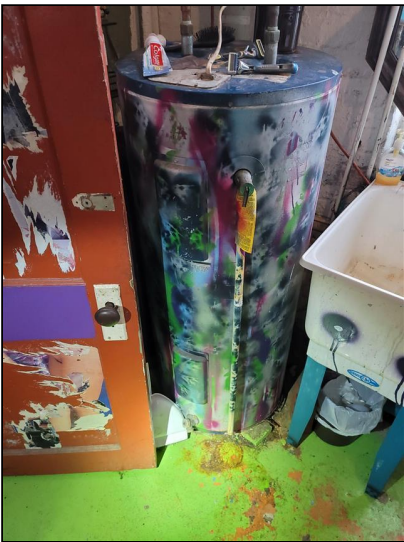
6.2 Item 1(Picture)

🔧 The pressure relief valve was leaking at the time of the inspection. Because the TPR valve is an important safety component it should be replaced by a qualified HVAC technician or plumbing contractor.

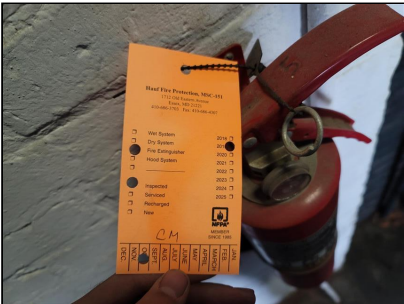
6.3 Item 1(Picture)

🔧 Some of the fire extinguishers in the common areas had expired inspections.

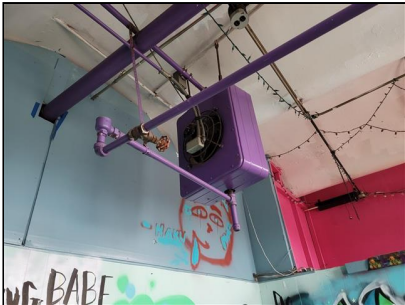
7.1 Item 1(Picture)

The apartment had no operable heat present in all the rooms. Heat was relied on old boiler distribution pipes to give off heat without radiators which was not suffice and was inoperable at the time of the inspection. Heat was not on and no controls were present. The Inspector recommends that heat be installed in each room with accessible thermostats to the occupants of the apartment by a qualified HVAC contractor or electrician. It was cold outside and in the units at the time of the inspection.

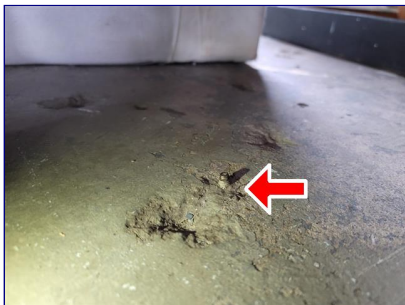
1.0 Item 1(Picture)

All floors were concrete and no flooring was installed. Many areas had metal bolts sticking out of floor which are a hazard.

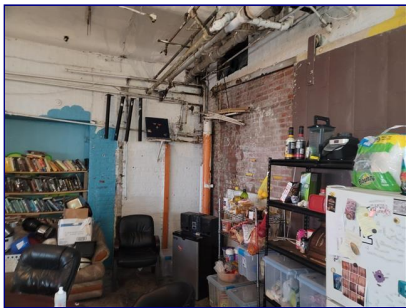
1.3 Item 8(Picture)

(2) Because this home was built before 1978, there is a good chance it has lead-based paint. In 1978, the federal government banned consumer uses of lead-containing paint as a potential health hazard, but some states banned it even earlier. Lead from paint, including lead-contaminated dust, is one of the most common causes of lead poisoning. Chipping, cracking, flaking and deteriorated paint was observed widespread throughout the building. All painted surfaces in the building should be repainted and repaired by a lead abatement contractor.

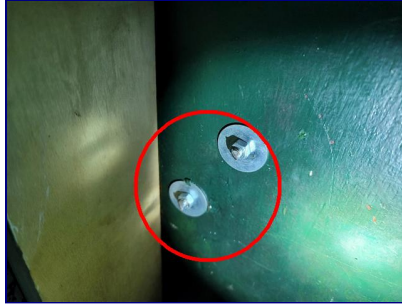
1.4 Item 3(Picture)

(2) The entry door did not have an operable locks and had sharp bolts sticking out. This condition is a fire hazard.

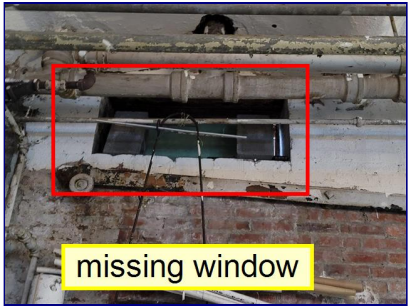
1.5 Item 2(Picture)

(4) A window in the common area was boarded up with loose wood and cinder blocks allowing moisture and air leakage into the building.

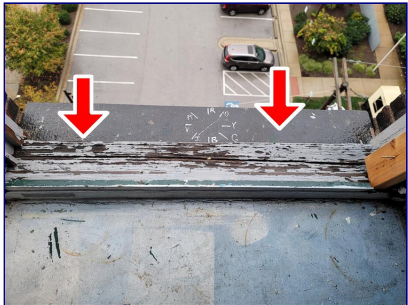
1.5 Item 3(Picture)

(5) Components of window sill exteriors were loose, damaged or deteriorated and needed maintenance to help prevent damage from moisture intrusion to the home materials, the exterior wall structure and to prevent development of microbial growth such as mold. All work should be performed by a qualified contractor.

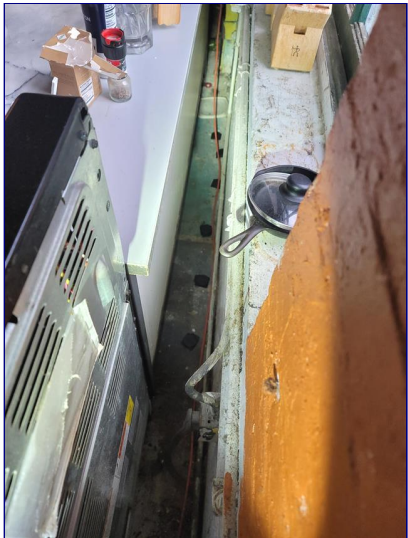
1.6 Item 1(Picture)

Signs of possible roach and pest infestation was observed and should be further evaluated and treated by a qualified pest control contractor.

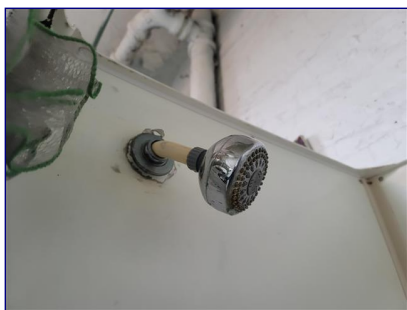
2.4 Item 1(Picture)

- 🔧 (1) In the bathroom, the showerhead connection leaked when the shower was operated. The inspector recommends service by a qualified plumbing contractor.

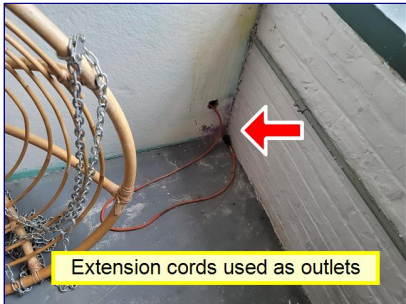
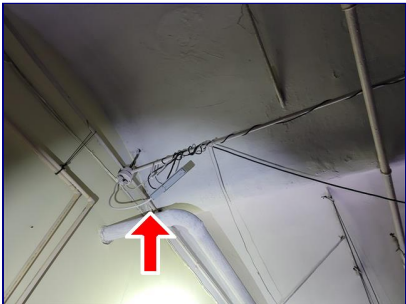
(1) The number of electrical receptacles in the home was inadequate and extension cords were used throughout the unit. This condition is potential fire hazard and should be corrected.

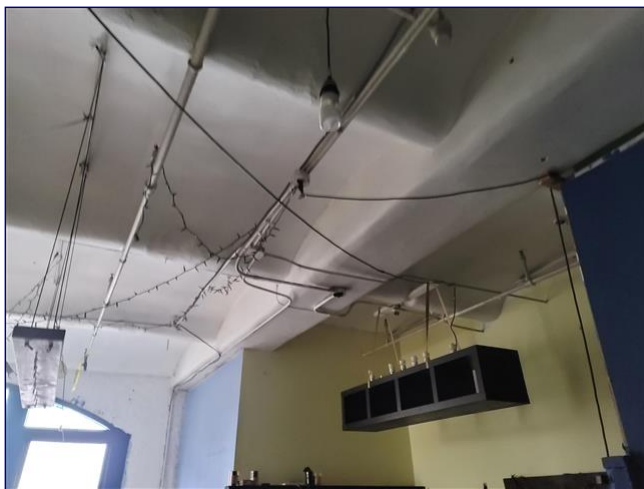
5.2 Item 1(Picture)

This unit did not have operable and enough light fixtures. Extension cords with lighting and string lights were used. This condition is a potential fire hazard.

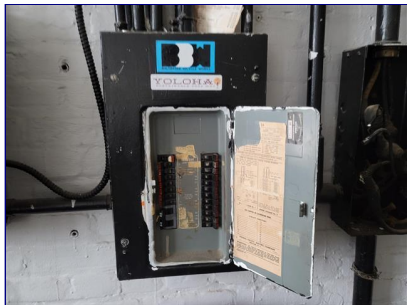
5.5 Item 1(Picture)

This sub-panel was made by Federal Pacific and was the Stab-lok model. Federal Pacific Stab-lok model sub-panels are reputed to have a high rate of circuit breaker failure which can result in a fire or shock/electrocution. One of the breakers was damaged and sparks when turned on. The Inspector recommends that you consult with a qualified electrical contractor concerning for replacing this sub-panel. Information about defective Federal Pacific Stab-lok panels is widely available on the internet.

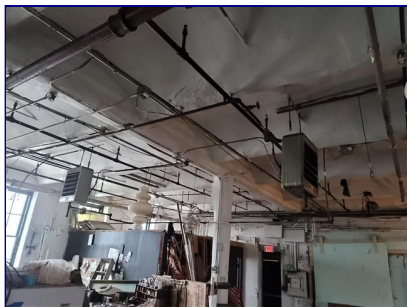
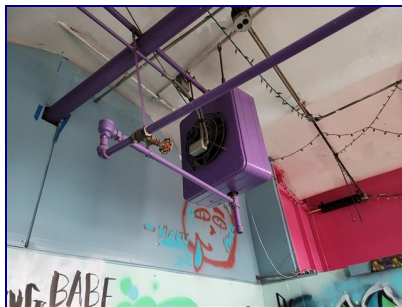
The apartment had no operable heat present in all the rooms. Heat was relied on old boiler distribution pipes to give off heat without radiators which was not suffice and was inoperable at the time of the inspection. Heat was not on and no controls were present. The Inspector recommends that heat be installed in each room with accessible thermostats to the occupants of the apartment by a qualified HVAC contractor or electrician. It was cold outside and in the units at the time of the inspection.
