WEST MONTGOMERY COUNTY CITIZENS ASSOCIATION

Testimony on: Bill Number HB 942 “Wetlands and Waterways Program - Authorizations for Stream Restoration Projects”

Stream “Restorations” Don’t Restore Streams

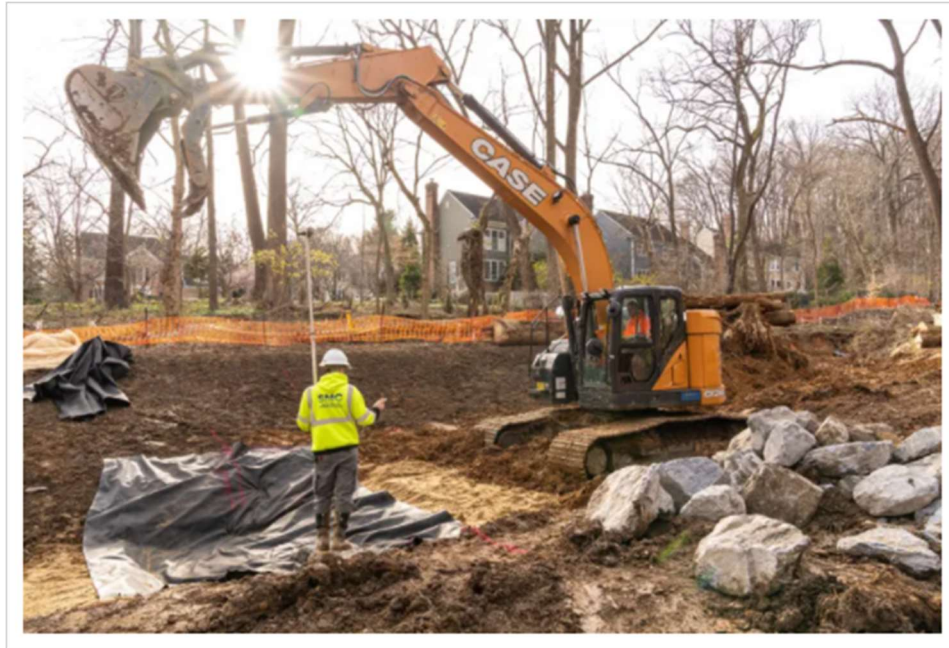
(Above: Nature Forward, Chevy Chase; <https://conservationblog.anshome.org/tag/stream-restoration/>)

This was once a fully wooded area. It shows the heavy construction equipment being used. Visible are the plastic sheets used and large boulders dumped in the stream channel.

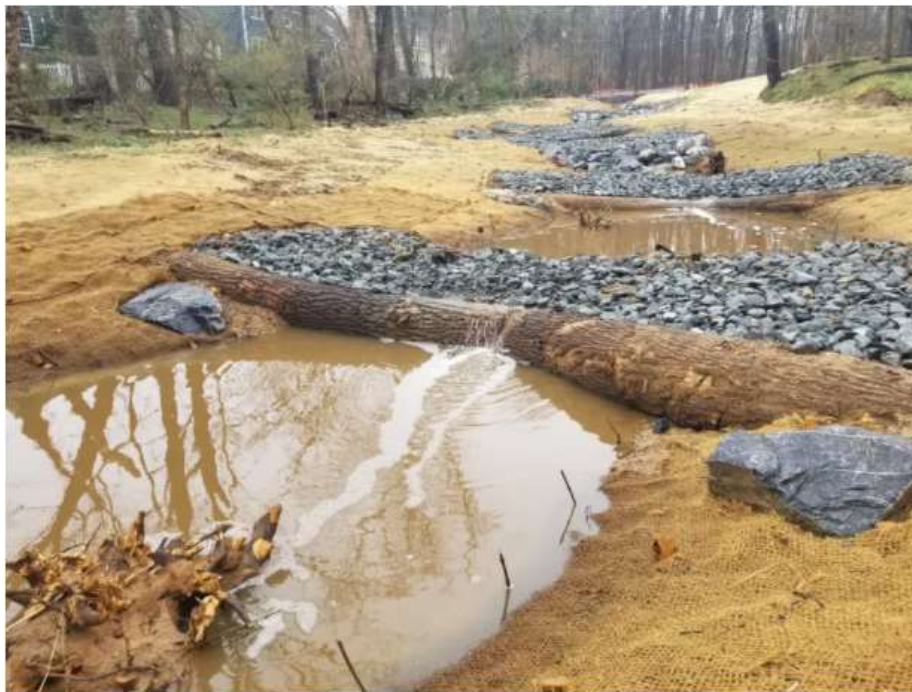
(Above: Nature Forward, Chevy Chase; <https://conservationblog.anshome.org/tag/stream-restoration/>)

The next photo at this same site shows a series of rock dams built with rock rubble that has been dumped into the stream channel. Now there is no way for aquatic creatures to move up and down this stream.

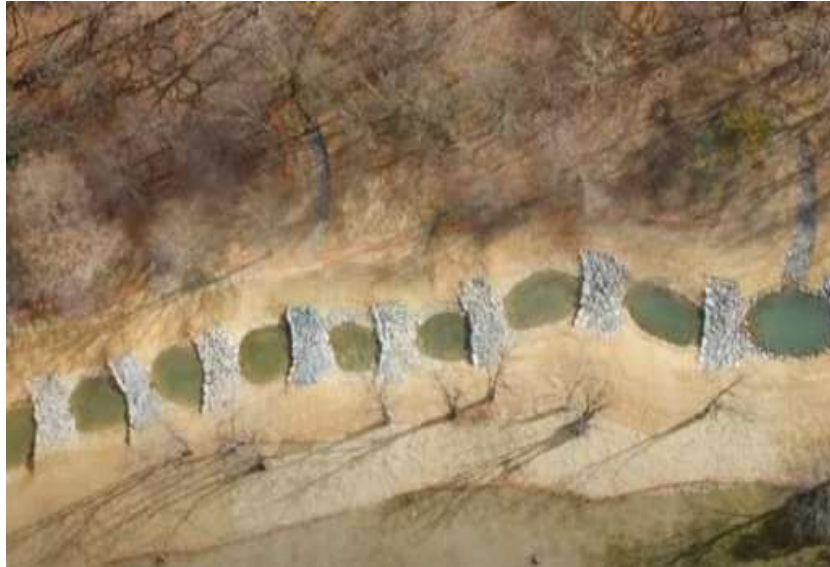
(Above: Asbury Methodist Village, Gaithersburg, <https://www.youtube.com/watch?v=hGZN-L0Qrj0>)

The aerial photo of a stream restoration at the Asbury Methodist Village in Gaithersburg shows how rock rip rap has been dumped at intervals into the stream to create a series of dams. These dams prevent the migration of fish and other aquatic organisms. You can get an idea of scale compared to the large trees at the bottom.

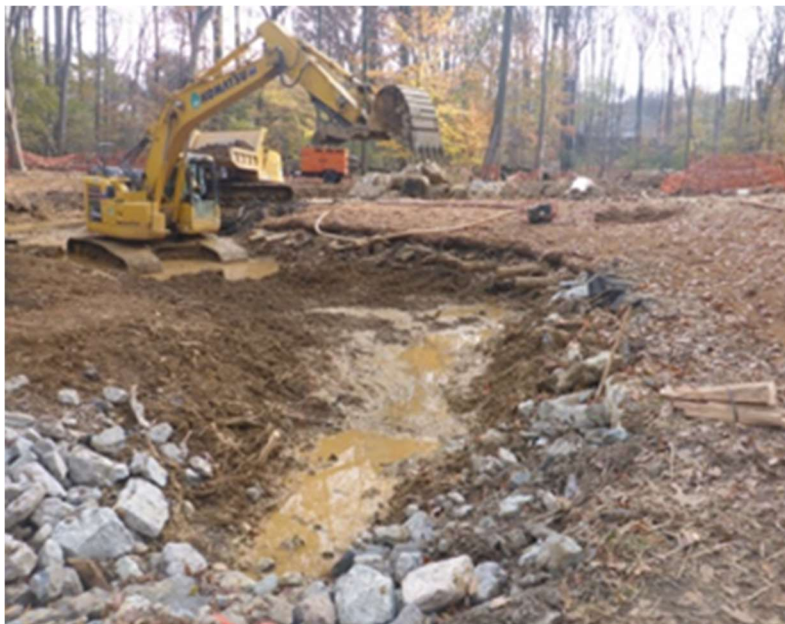
(Above: Stream "restoration" in Upper Watts Branch, Rockville; photo by City of Rockville)

The next photo is an example of the utter destruction caused by a stream restoration in the City of Rockville in the upper Watts Branch. This project was completed in 2018. The riparian, or stream-side, forest buffer has been completely destroyed and scraped down to bare soil. Before it was clearcut, the trees along this stream provided shade which lowered the water temperature required by some sensitive aquatic organisms.

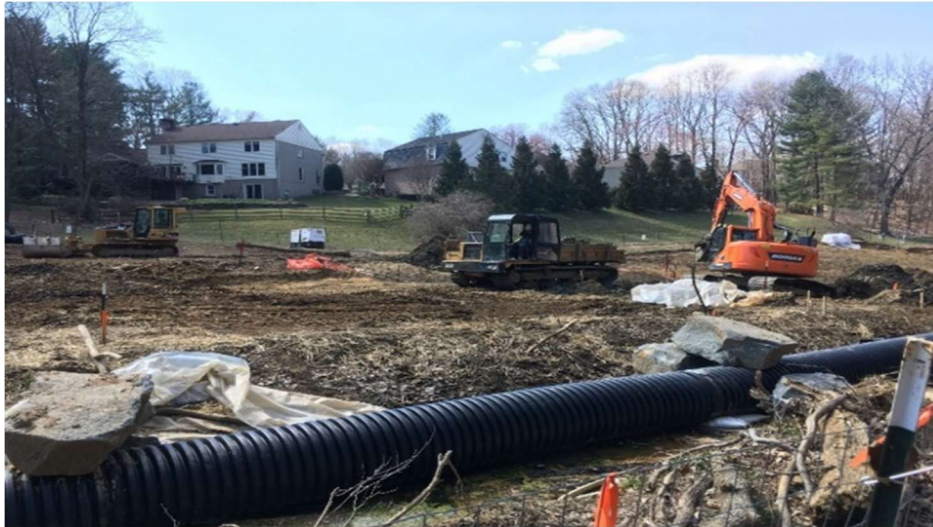
(Above: Falls Reach Stream Restoration Project; photo by K. Bawer, 3/19/2019)

What happens to the stream during these construction projects? Below is the Falls Reach project in Potomac, MD. The entire stream was forced to run through this black pipe during construction. How hot do you think that water gets? No longer can frogs, turtles, and other animals access the water. And it gets worse. According to a U.S. Department of Agriculture National Engineering Handbook called “Stream Restoration Design”, “Aquatic life would be either be prevented from passing the project or pulverized by the pumps.”¹ So not just fish but frogs, crayfish, northern water snakes, baby snapping turtles, spotted turtles, etc. are at risk.

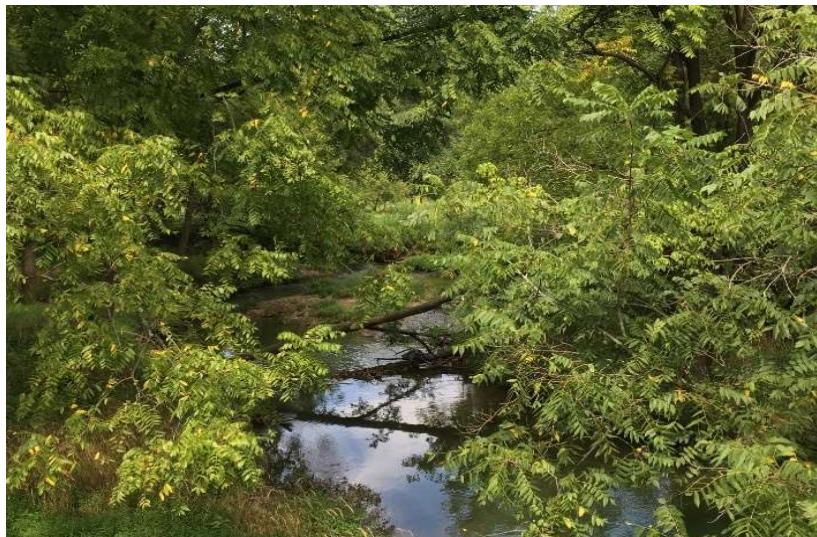
(Above: before construction, Whetstone Run in Blohm Park, Gaithersburg; by K. Bawer, 5/03/2021)

The pre-construction photo of Whetstone Run in Blohm Park, Gaithersburg shows a riparian, or stream-side, forest that was quite dense and lush.

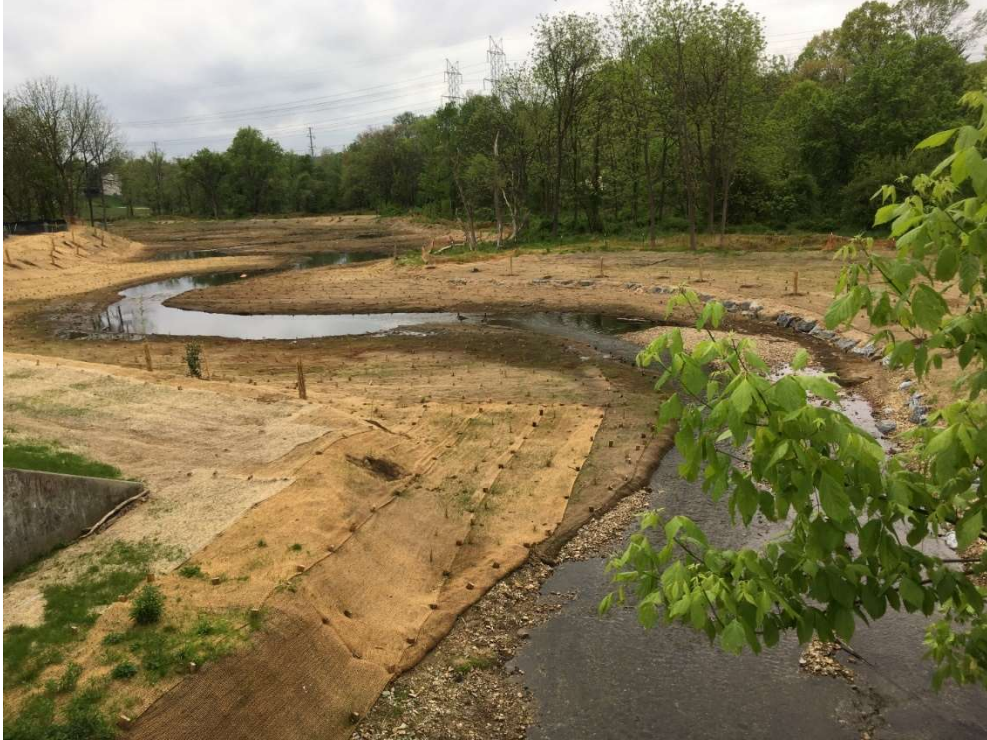
(Above: after construction: Whetstone Run in Blohm Park, Gaithersburg; by K. Bawer on 5/03/2021)

The post-construction photo below, taken at the exact same location, shows the total destruction of the stream-side forest. The original stream channel was filled and a whole new stream channel was dug. The original, natural stream never had this kind of artificial meander pattern, or sinuosity, that was created by the heavy machinery. Some of the paltry replanting is barely evident.

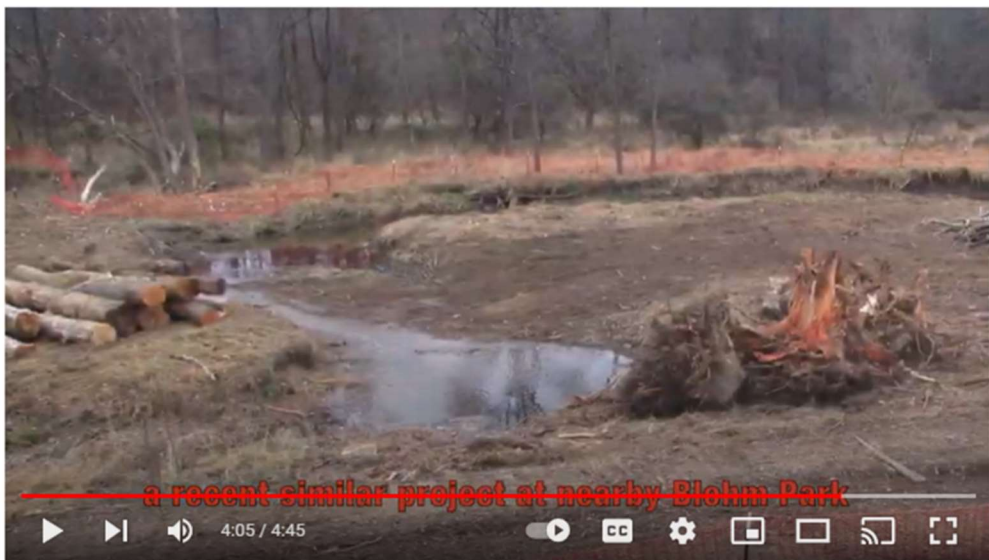
(Above: Whetstone Run , Gaithersburg from <https://www.youtube.com/watch?v=1XLXRNmN9L8&t=61s>)

This is another view of the Whetstone Run project just to show that there were, in fact, lots of mature trees cut down.

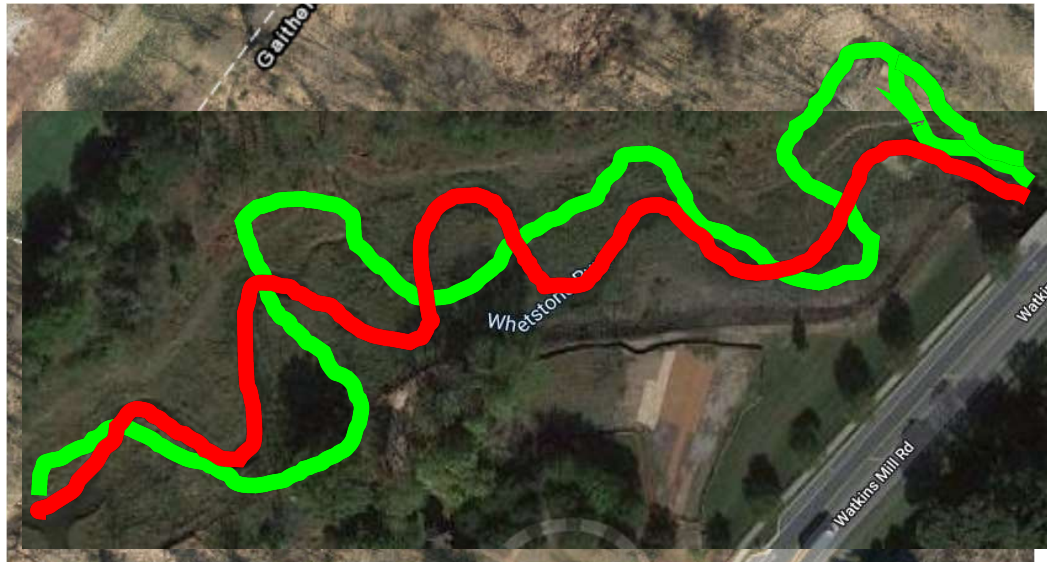
(Above: photo for “before” green trace from <https://earthexplorer.usgs.gov/>, photo for “after” red trace from Google Maps)

To show how the original, pre-construction stream was moved, a trace of the original stream channel location in green is overlaid with a trace of the new stream channel in red. The image is quite shocking.

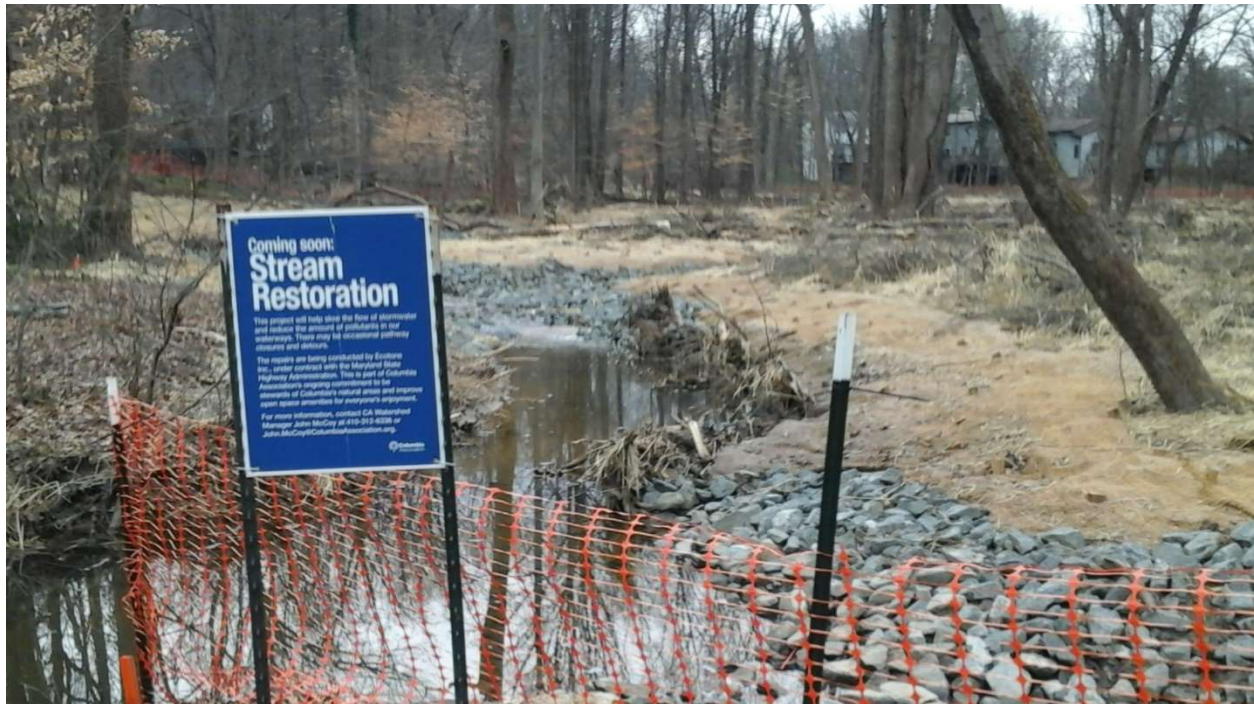
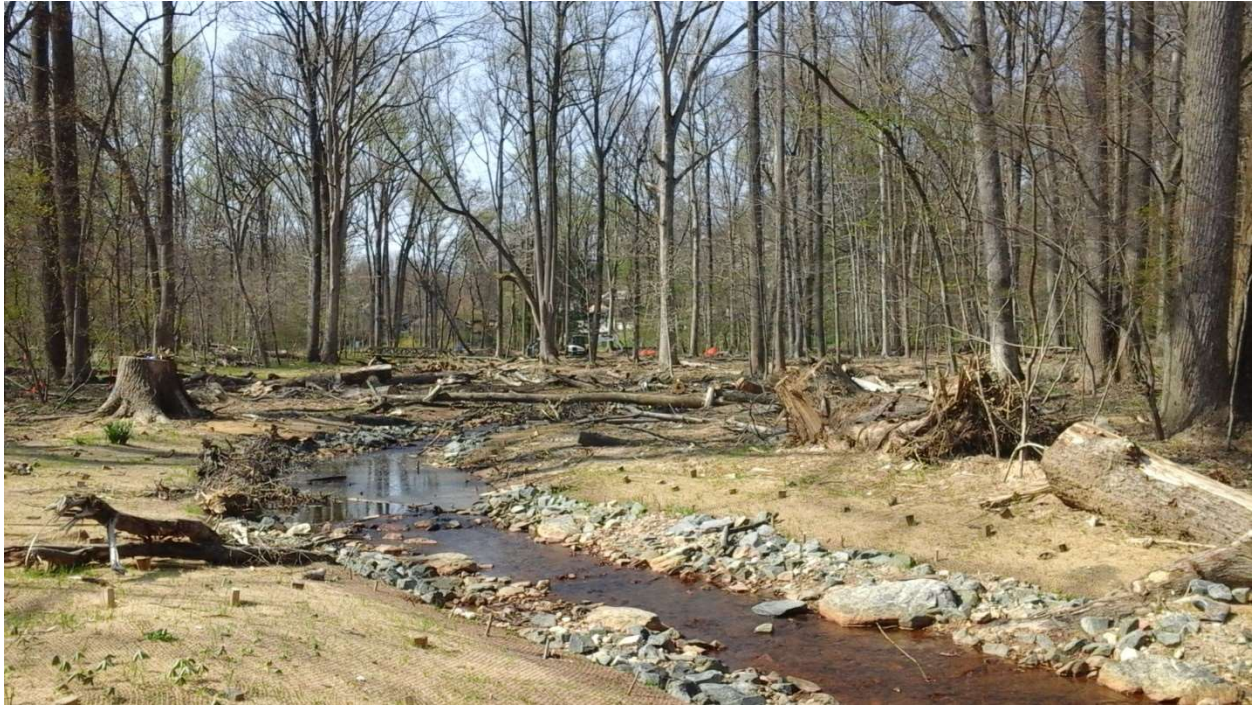
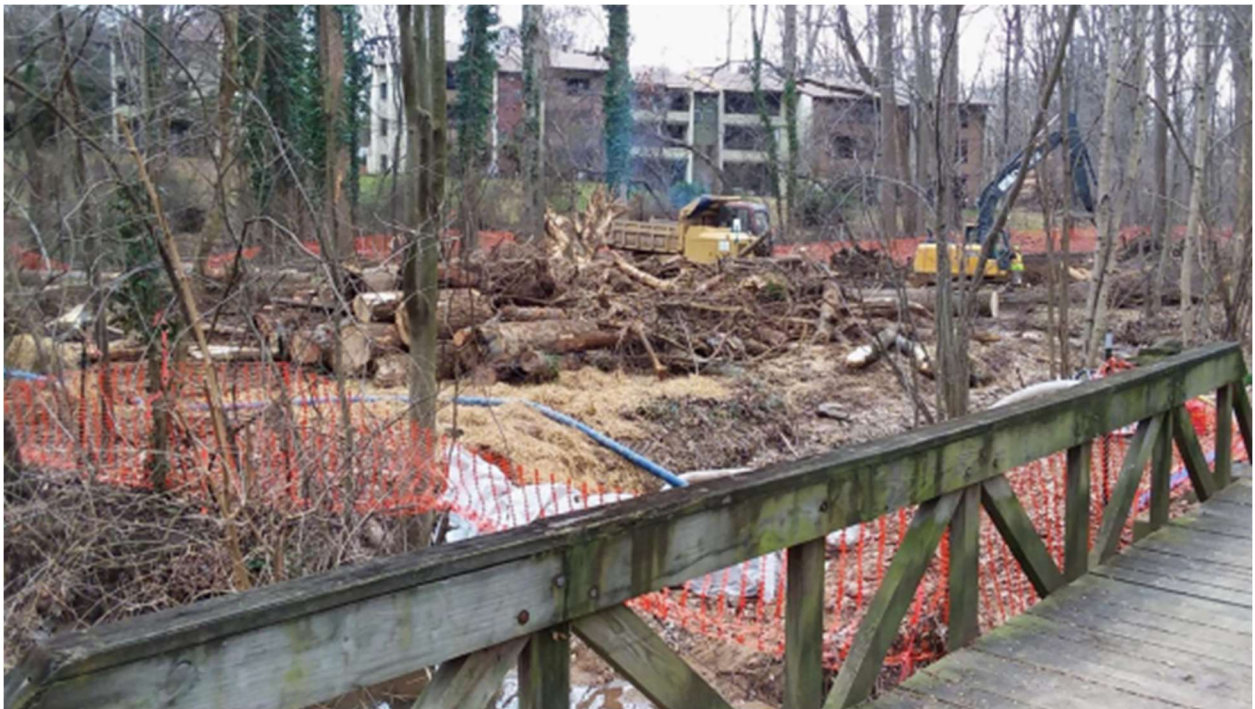
The next several photographs show different views of a destructive stream restoration in Columbia.

(Above: Columbia stream restoration in Longfellow neighborhood; by S. Boies, 1/8/2021)

(Above: Columbia stream restoration in Longfellow neighborhood; by S. Boies, 4/6/2021)

(Above: Columbia stream restoration; by S. Boies)

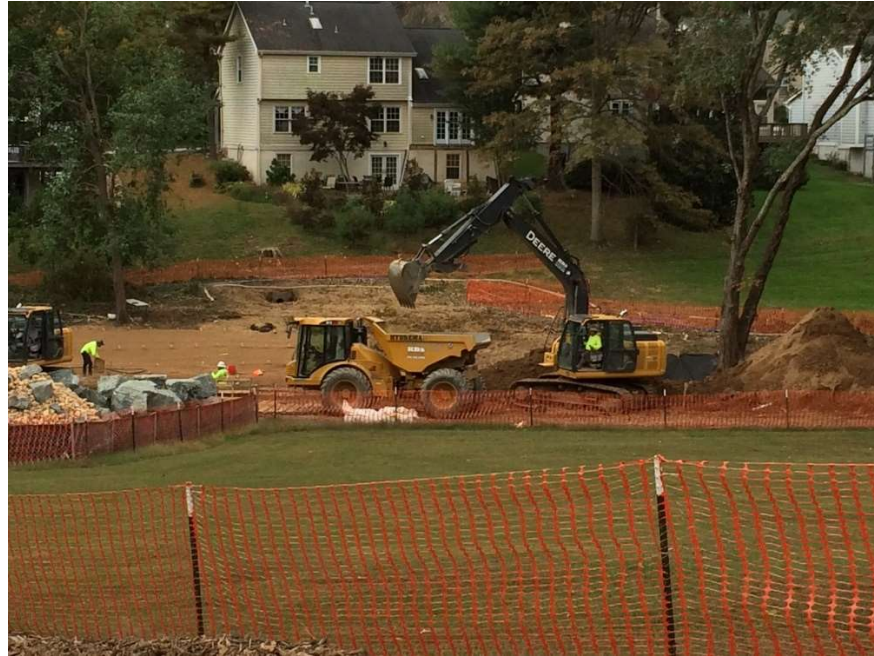
(Above: Solitaire Court stream restoration in Gaithersburg; photo by K. Bawer, 10/23/2021)

Next is the Solitaire Court stream restoration in Gaithersburg (the location of the video link on page 1). Before construction, none of the houses below were visible through the narrow strip of forest. At the pre-construction walk-through, the city program manager was asked what will happen to little animals like frogs, turtles and salamanders. That person responded with a straight face, “Oh, they’ll just move away and come back after the construction.”

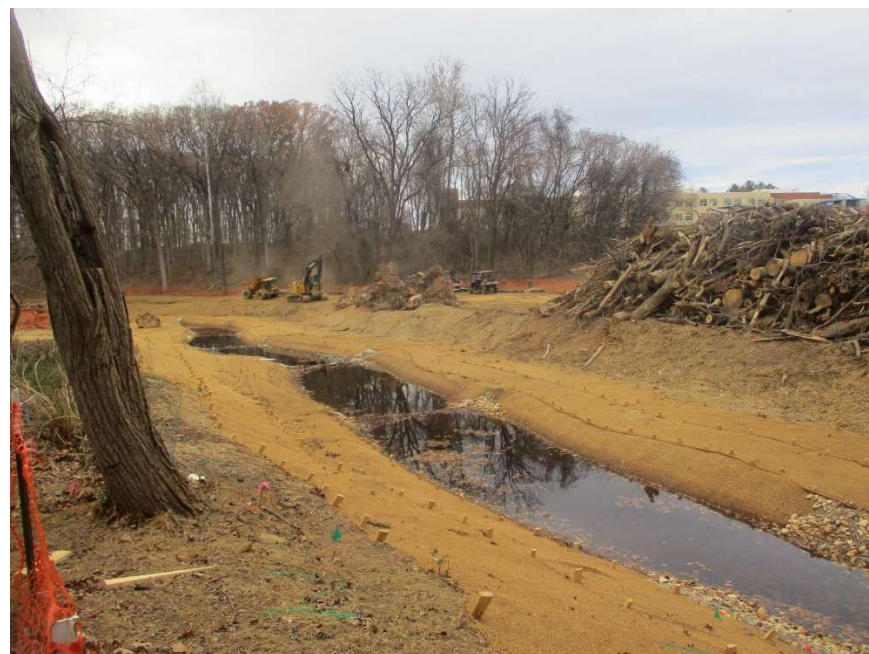
(Above: Solitaire Court stream restoration in Gaithersburg; photo by R. Portonova, 12/3/2021)

In another photograph, the former forest can be seen reduced to a giant pile of logs.

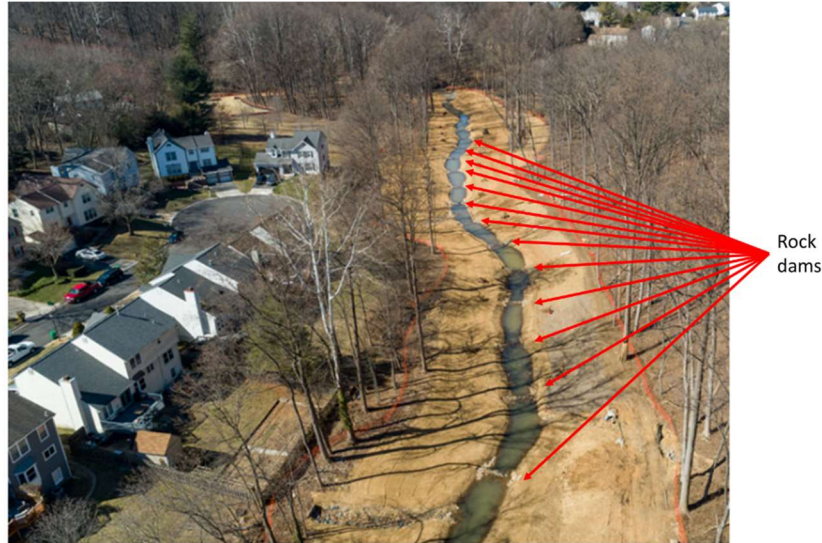
(Above: Solitaire Court project in Gaithersburg; <https://www.gaithersburgmd.gov/government/projects-in-the-city/solitaire-court-stream-restoration-project>)

In another view of the Solitaire Court project, the arrows point to some of the rock dams created by dumping rocks into the stream. These will totally block fish and other aquatic organisms. Plus, the stream will drastically heat up now that a large number of the shade trees were cut. Note that the critical root zones of the trees (the area around the base of a tree containing most of a tree's roots that are critical for its survival) near the orange construction fences (on both sides of the clear-cut area) were not protected, so many of these edge trees will die due to soil compaction.

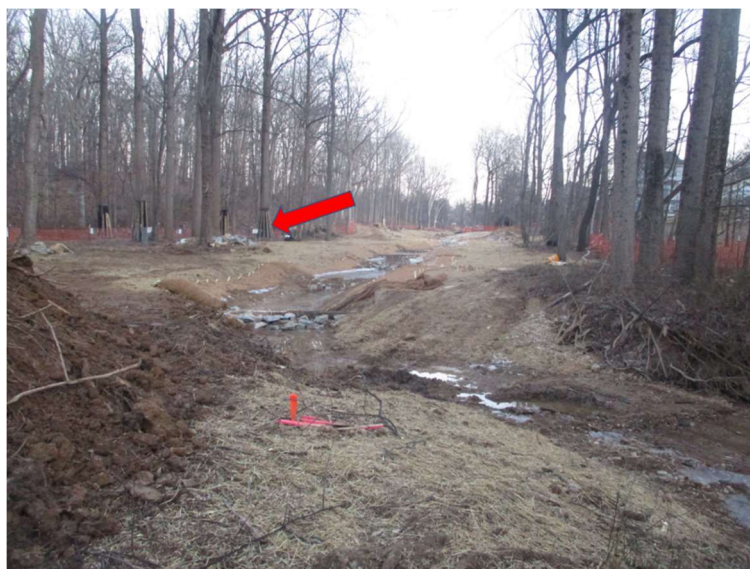
(Above: Solitaire Court stream restoration in Gaithersburg; photo by R. Portanova, 2/7/2022)

Below is another view of the Solitaire Court project from further downstream. Again, this was a fully wooded forest. All of the trees on the left with the vertical wood scape protectors (the red arrow points to one) will probably die because their critical root zones have been severely compacted. And the line of big trees on the right at the edge of the clear cut will also likely die due to soil compaction.

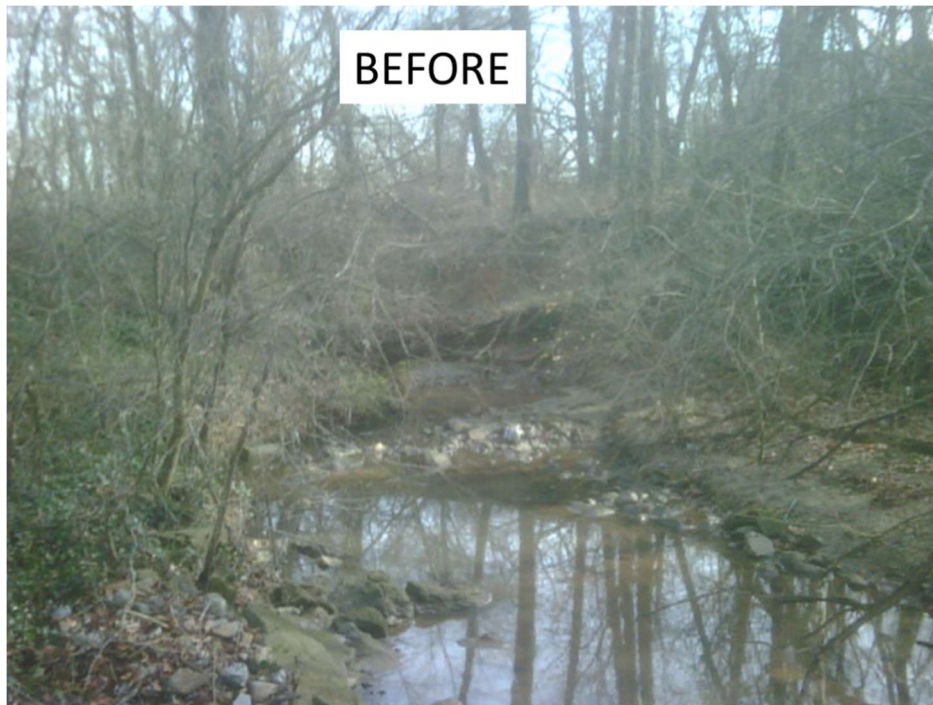
(Above: before construction, Takoma Branch, Takoma Park; photo by DPW, City of Takoma Park)

The following photos are “before” and “after” pictures of the Takoma Branch project in Takoma Park.

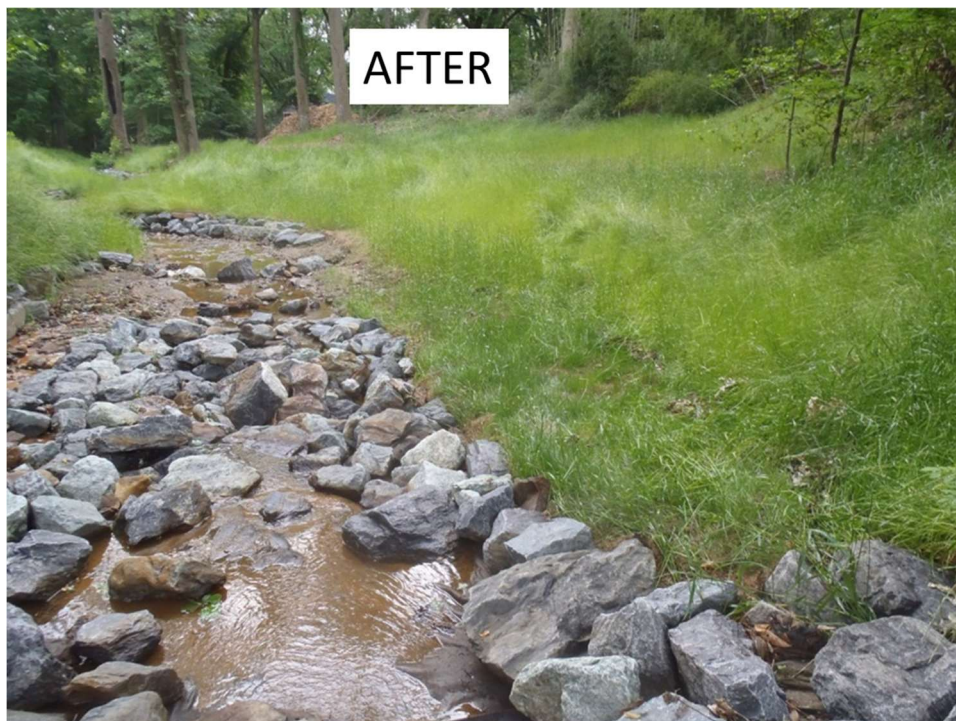
(Above: after construction, Takoma Branch, Takoma Park; photo by DPW, City of Takoma Park)

After construction, it can be seen that the natural character of the forest was wiped out including removal of woody debris such as the fallen trees that woodpeckers and other animals depend on.

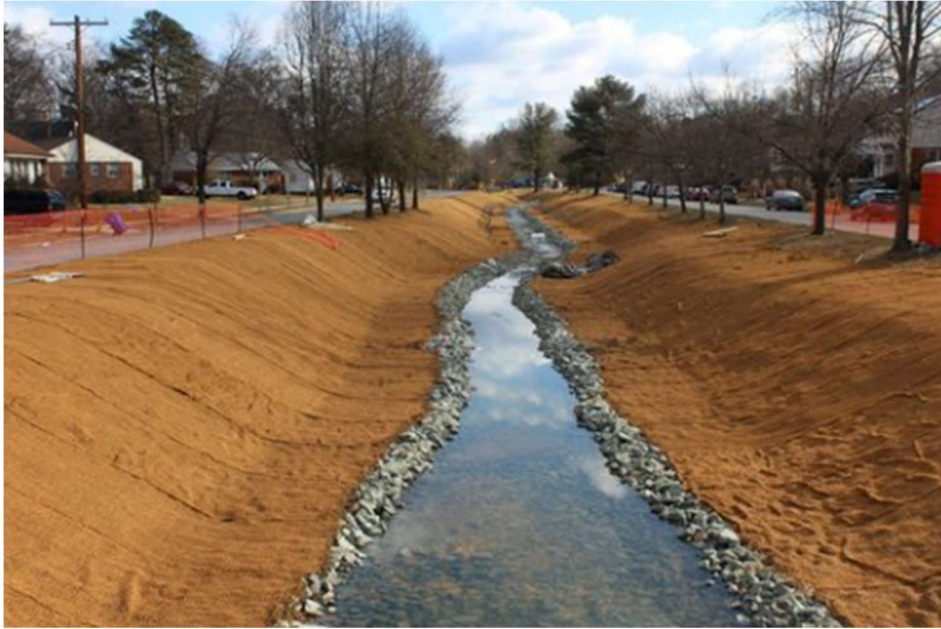
(Above: Briers Mill Run, Prince Georges County;
<https://www.facebook.com/PGCCWP/posts/1299726287063844>)

Below is the Briers Mill Run in Prince Georges County after restoration. Before this project, the area was a natural strip park with lots of trees and understory plants – a great place for kids to explore and animals to live. Not so much anymore. This is now merely an engineered drainage ditch.

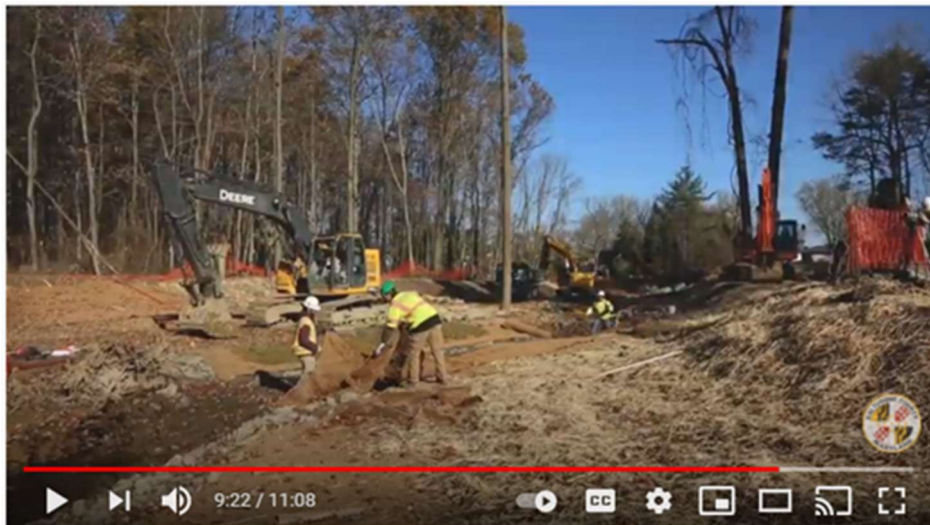
Scotts Level Branch Stream Restoration Project

Next is the Scotts Level Branch stream restoration in Baltimore County. The county web site says that they are concerned about providing essential habitat and vegetative buffers for streams. Why then are they destroying what they already have?

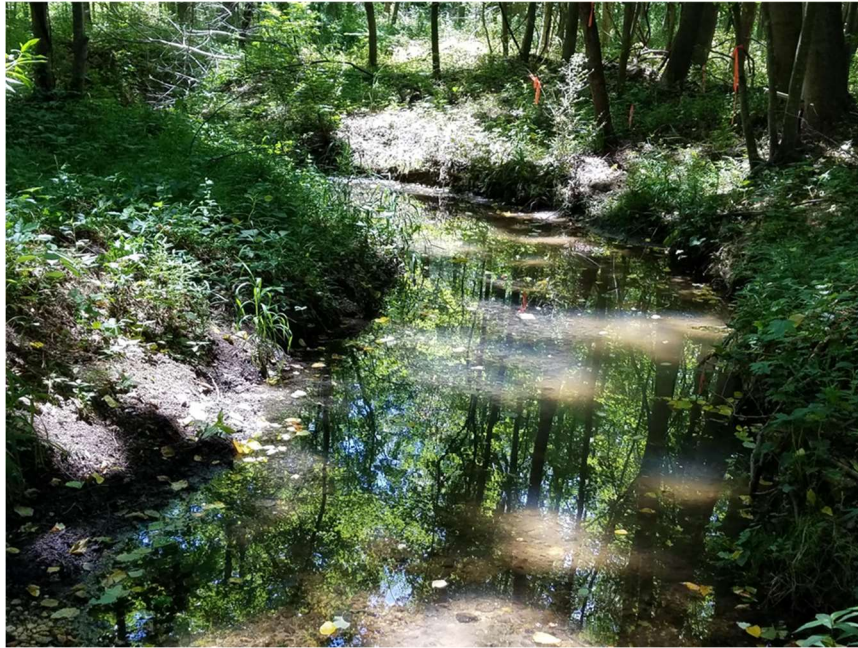
(Above, St. Charles Parkway stream restoration, Charles County; from <https://www.charlescountymd.gov/our-county/infrastructure-capital-services/npdes-project/st-charles-parkway#ad-image-0>)

The following photo shows the pre-restoration St. Charles Parkway stream in Charles County. This was a fine-looking stream valley until the riparian forest was clearcut.

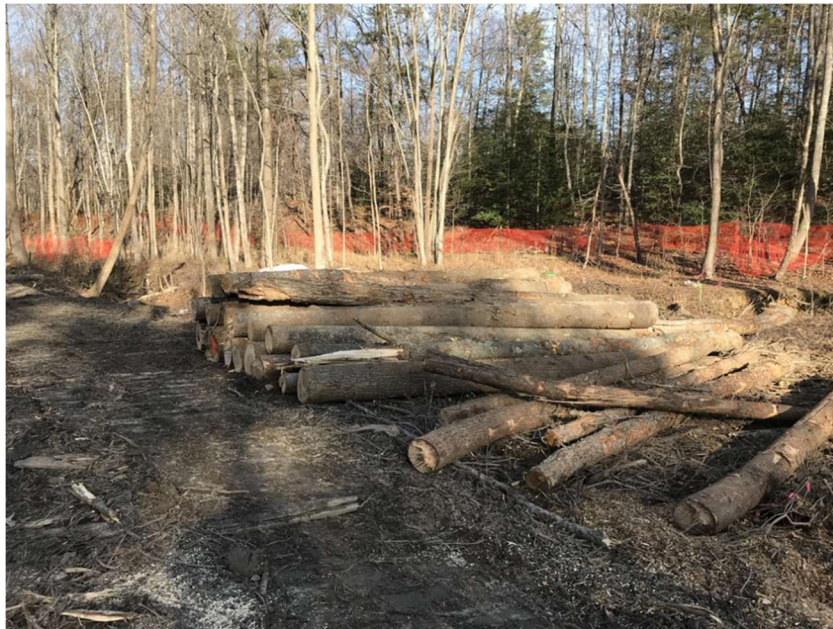
(Above, St. Charles Parkway stream restoration, Charles County, from <https://www.charlescountymd.gov/our-county/infrastructure-capital-services/npdes-project/st-charles-parkway#ad-image-0>)

What remained was a pile of logs, some of which are shown in the photo below.

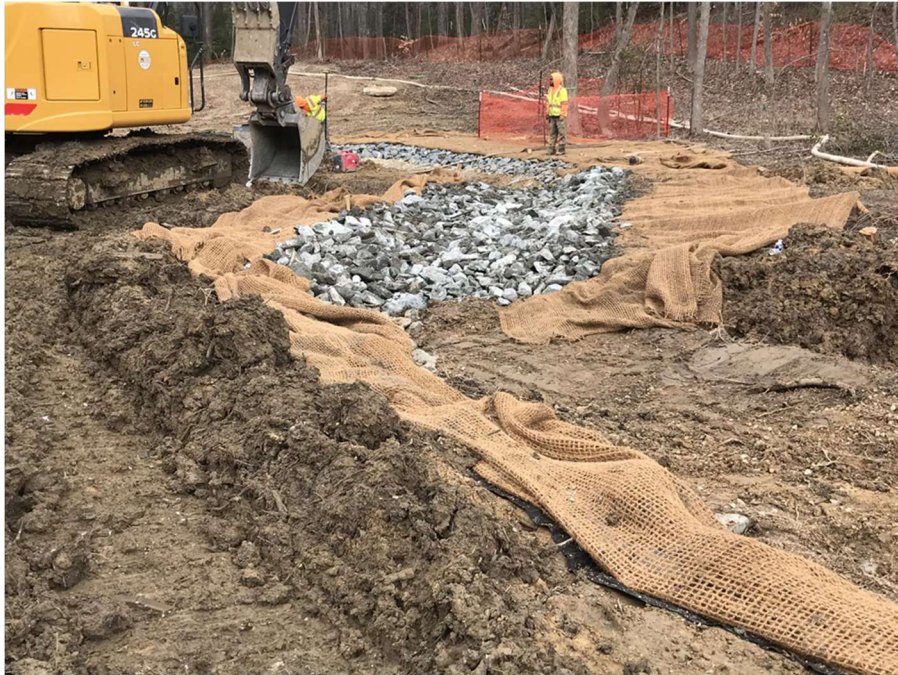
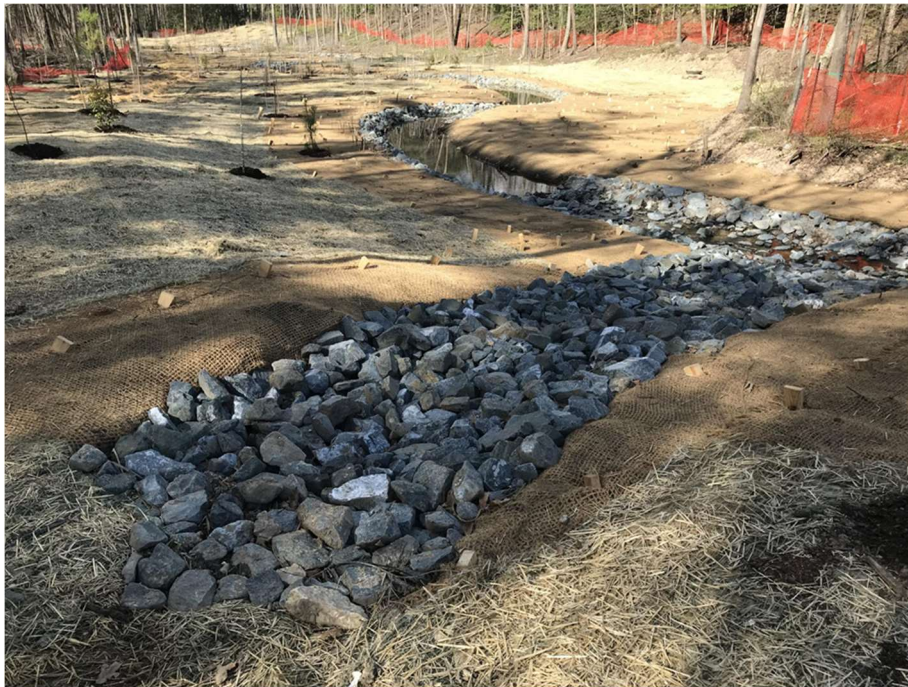
Two other views of the St. Charles Parkway stream restoration are shown below.

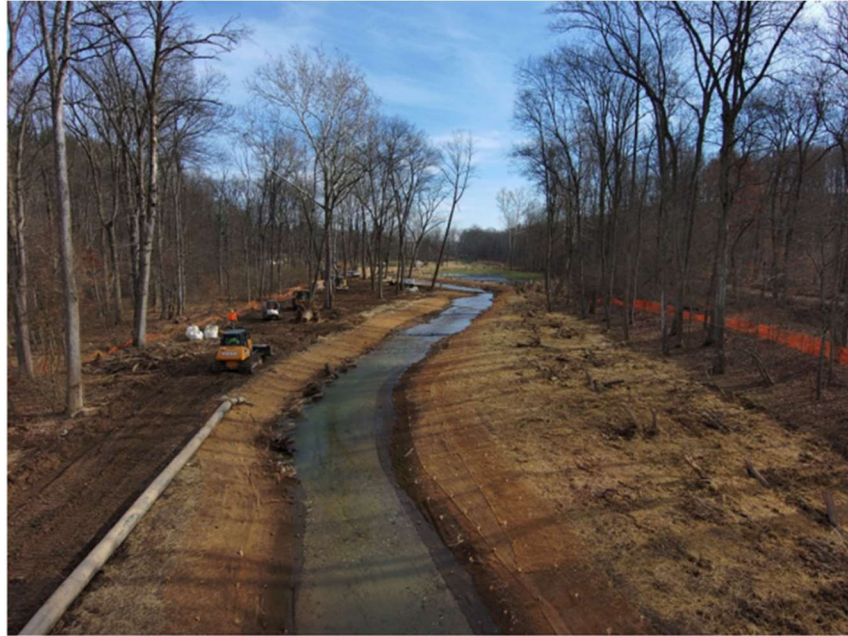
(Above: *Mayberry Stream Restoration in Carroll County*; from <https://www.carrollcountymd.gov/media/16472/mayberry-stream-restoration.pdf>)

The Mayberry Stream Restoration in Carroll County was completed in spring of 2022. Heavy construction equipment destroyed a wide swath right through the forest. Note how the trees on the edges have no protection. This photo shows a bulldozer running over trees' critical root zones and compacting the soil. Many trees along both sides of the project will probably die due to soil compaction.

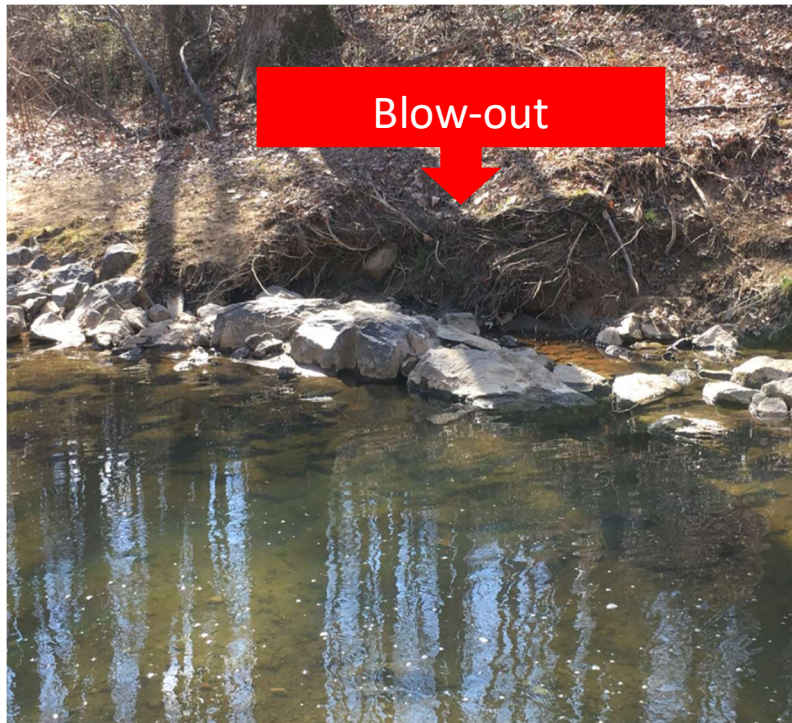
(Above: Cabin Branch Stream in Cabin John Regional Park, Montgomery County; by K. Bawer, 3/19/2021)

The next picture is a failed Cabin Branch stream restoration in Montgomery County showing how uncontrolled stormwater has eroded out the stream bank behind the rock armor-plating rendering it useless. This is an example of why stream restorations are only a temporary fix to stream bank erosion.

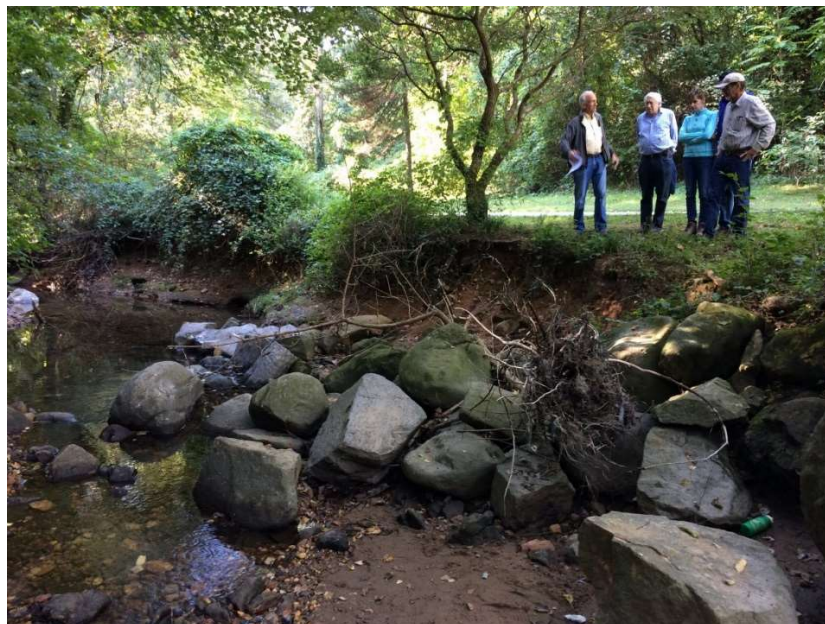
(Above: Long Branch, Takoma Park; photo by K. Bawer, 10/2/2021)

The photo below shows blown-out armor plating along Long Branch in Takoma Park. Notice the huge size of these boulders compared to the people.

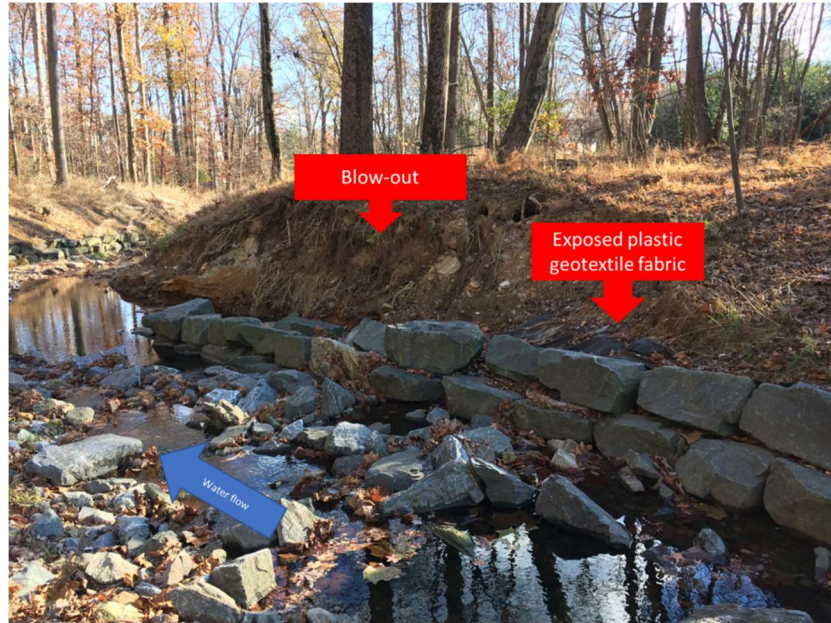
(Above: Snakeden Branch, Potomac; by K. Bawer, 11/23/2021)

The next photo is Snakeden Branch in Potomac. The blown-out area can be seen on the right bank. The water has gone over and behind the rock wall and has continued to erode the stream bank behind it. Also visible is exposed plastic geotextile fabric which will break down and add to the micro plastics problem.

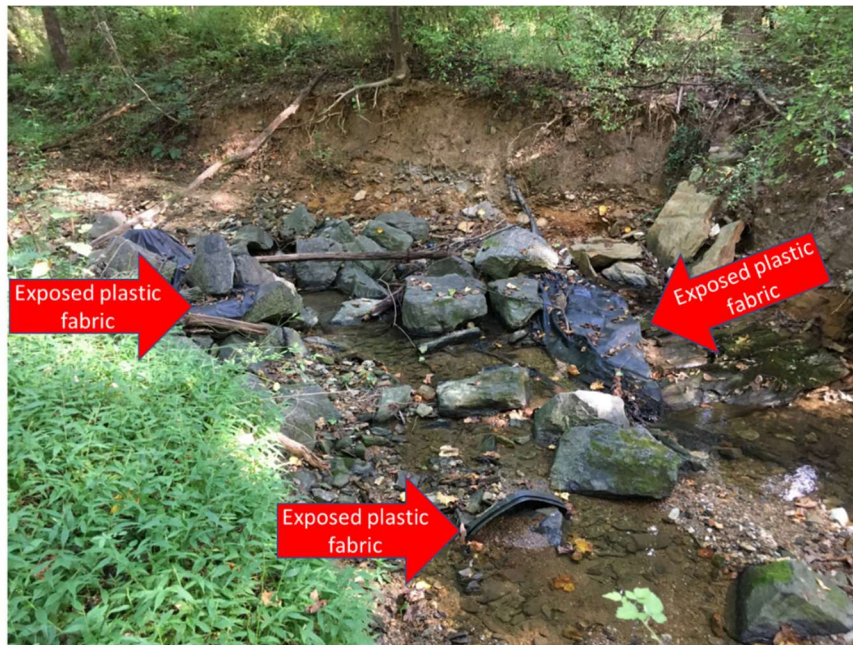
(Above: unnamed tributary to Great Seneca Creek, Gaithersburg; by K. Bawer, Fall, 2022)

Below is a photo of an unnamed tributary to Great Seneca Creek in Gaithersburg. Note the disrupted rock structure exposing plastic fabric. Stormwater has continued to erode the stream bank behind the rocks despite the stabilization attempt.

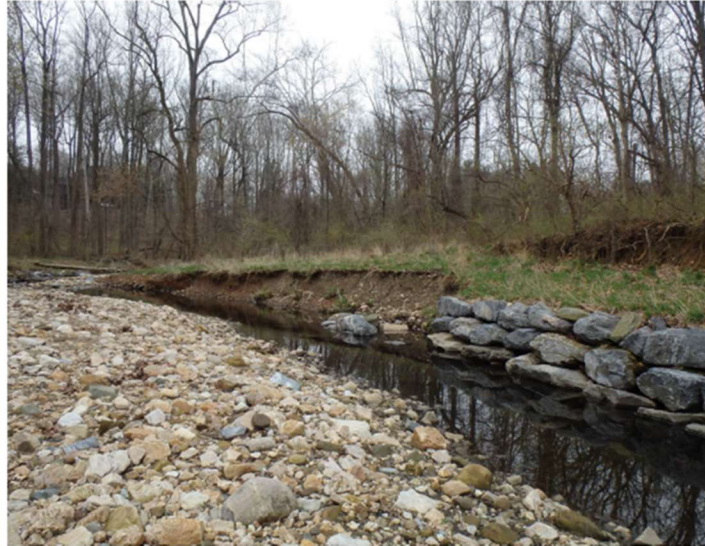
(Above: Lower Booze Creek, Potomac; photo from <https://www.montgomerycountymd.gov/water/Resources/Files/restoration/streams/Lower-Booze-Creek-Restoration-Repair-Fact-Sheet.pdf>)

The Lower Booze Creek stream restoration in Potomac originally cost \$700,000. After its completion, the Montgomery County Department of Environmental Protection web site states, “Storm damage occurred very soon after construction, initiating structural failures”. This photo shows some of the damage to the original stream restoration project at one location.

Lower Booze Creek - Erosion downstream of imbricated wall structure from original stream restoration.

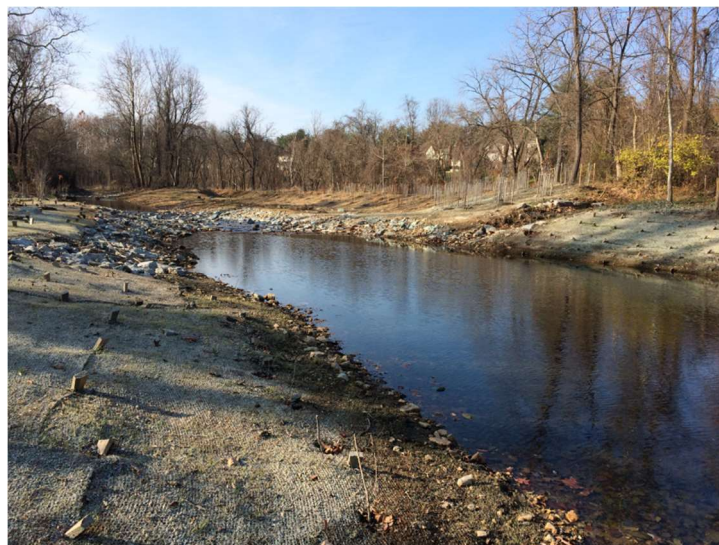
(Above: repair of the restoration in Lower Booze Creek, Potomac; photo by K. Bawer, 12/4/2021)

The repair work cost an additional \$3.6 million. Since stream restoration companies typically only guarantee their work for one year, when they are destroyed after that it is the taxpayers who pick up the bill. The photo below was after the repair work at one location which was formerly fully wooded.
