Collington Branch – The Need for Stream Restoration

Little Paint Branch Tributary Stream Restoration – The Need for Stream Restoration

Bacon Ridge Branch Stream Restoration – Pre-Restoration Conditions

Bacon Ridge Branch Stream Restoration

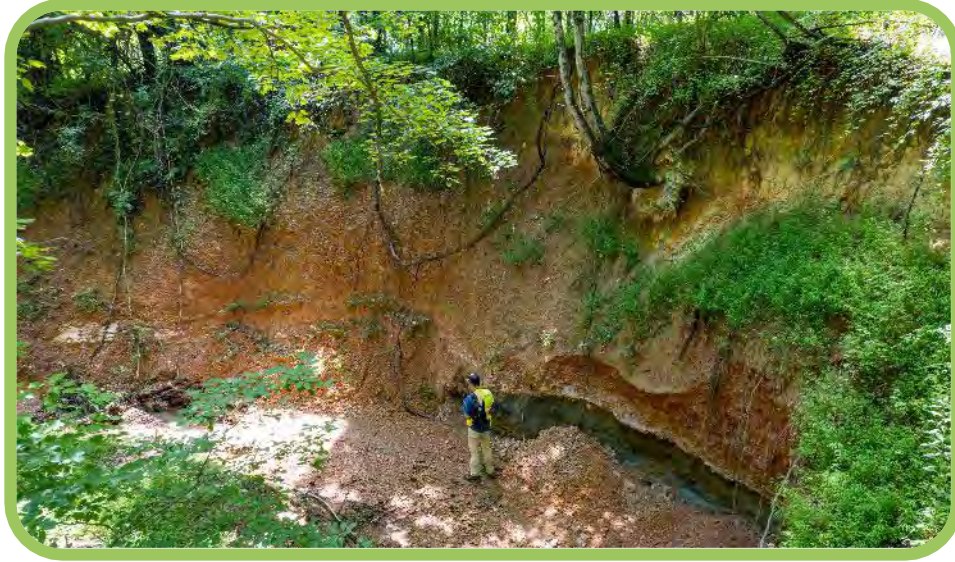
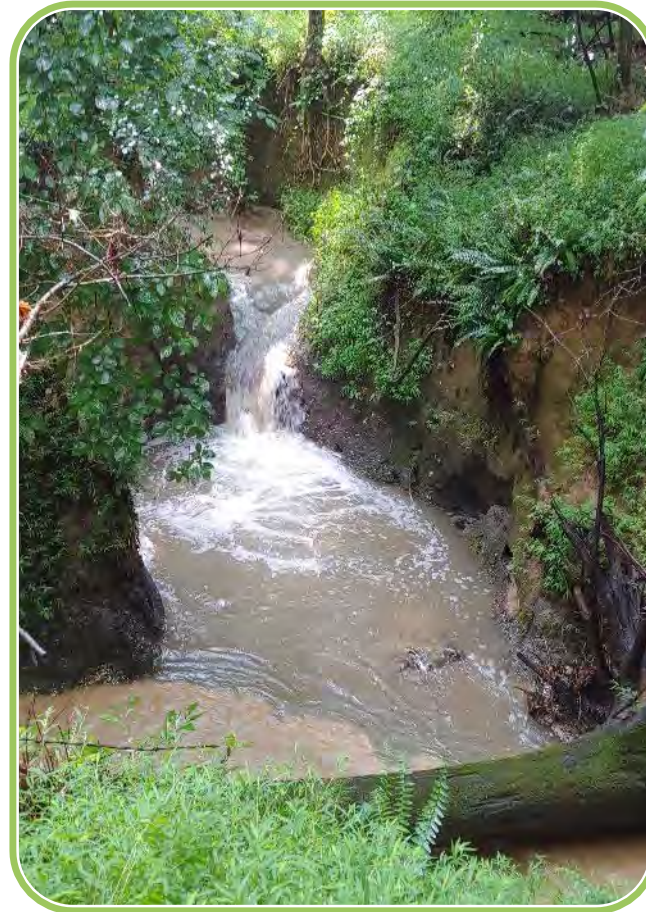
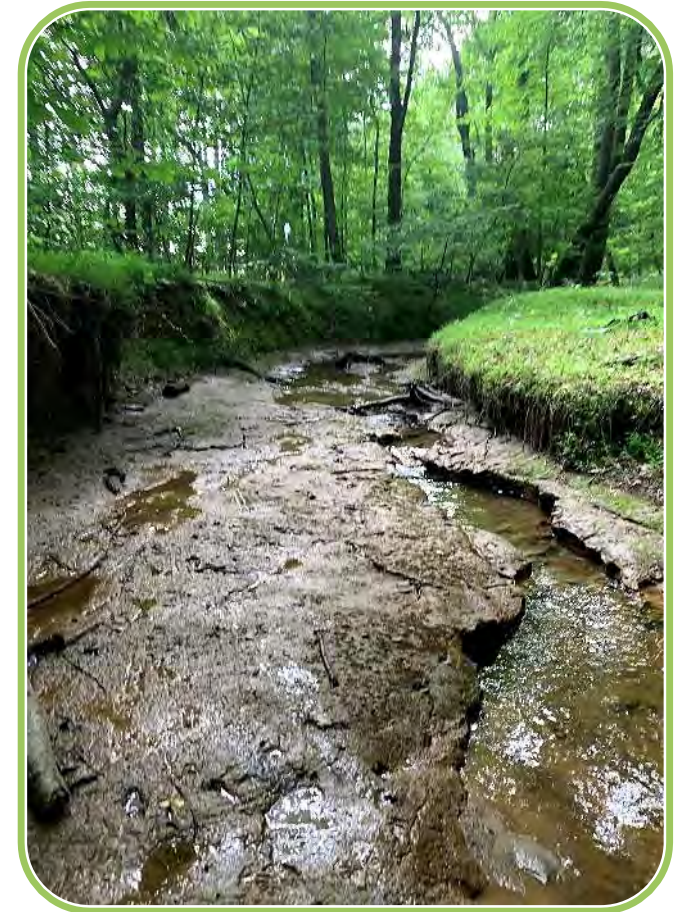
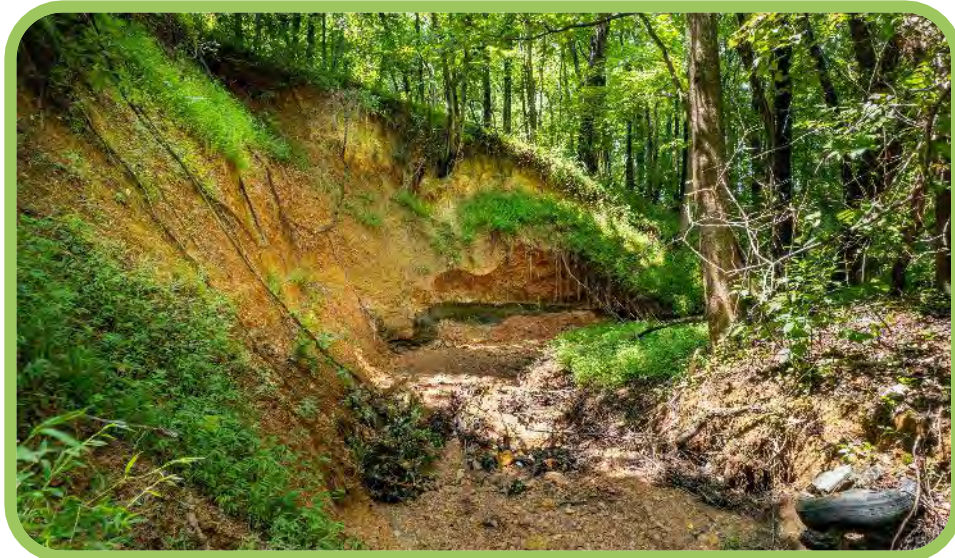
The photos show pre-restoration conditions, demonstrating the clear need for stream restoration. This project will include upland stormwater management components.

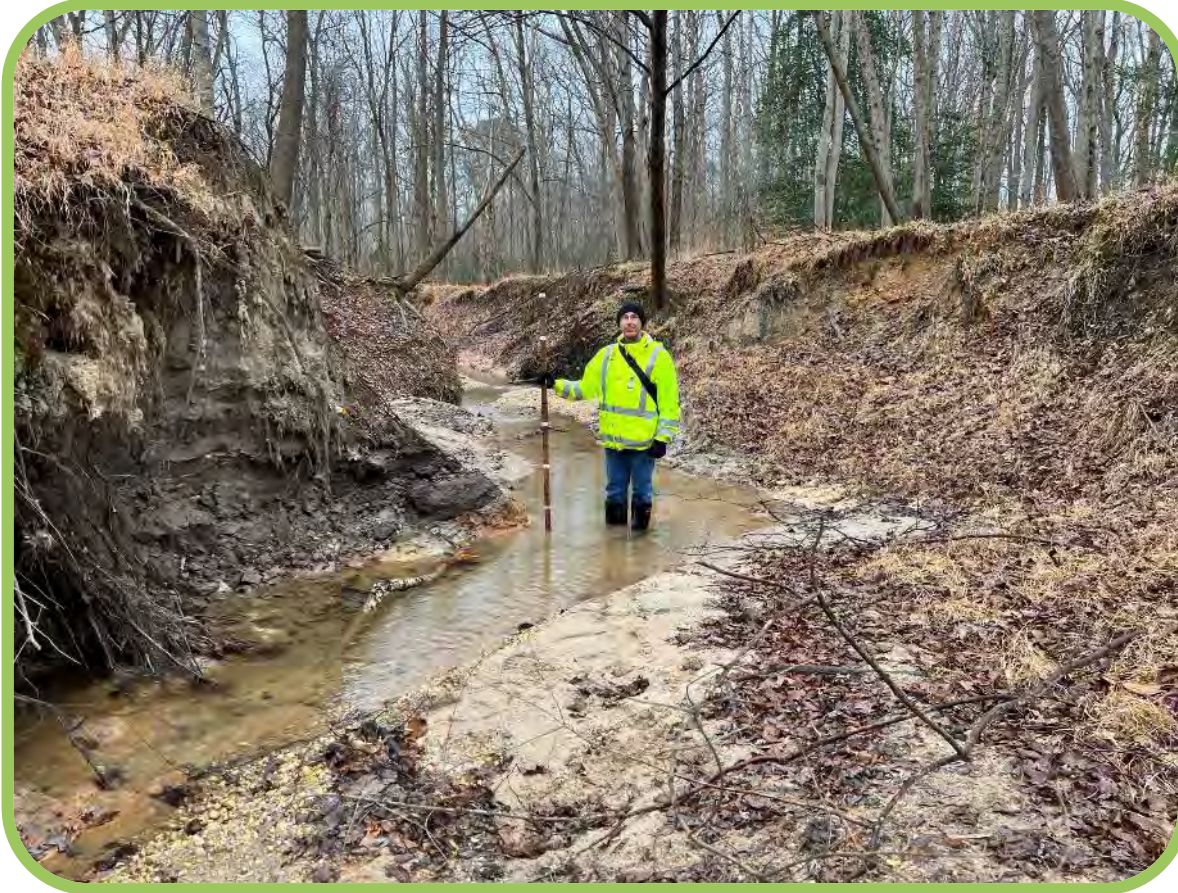
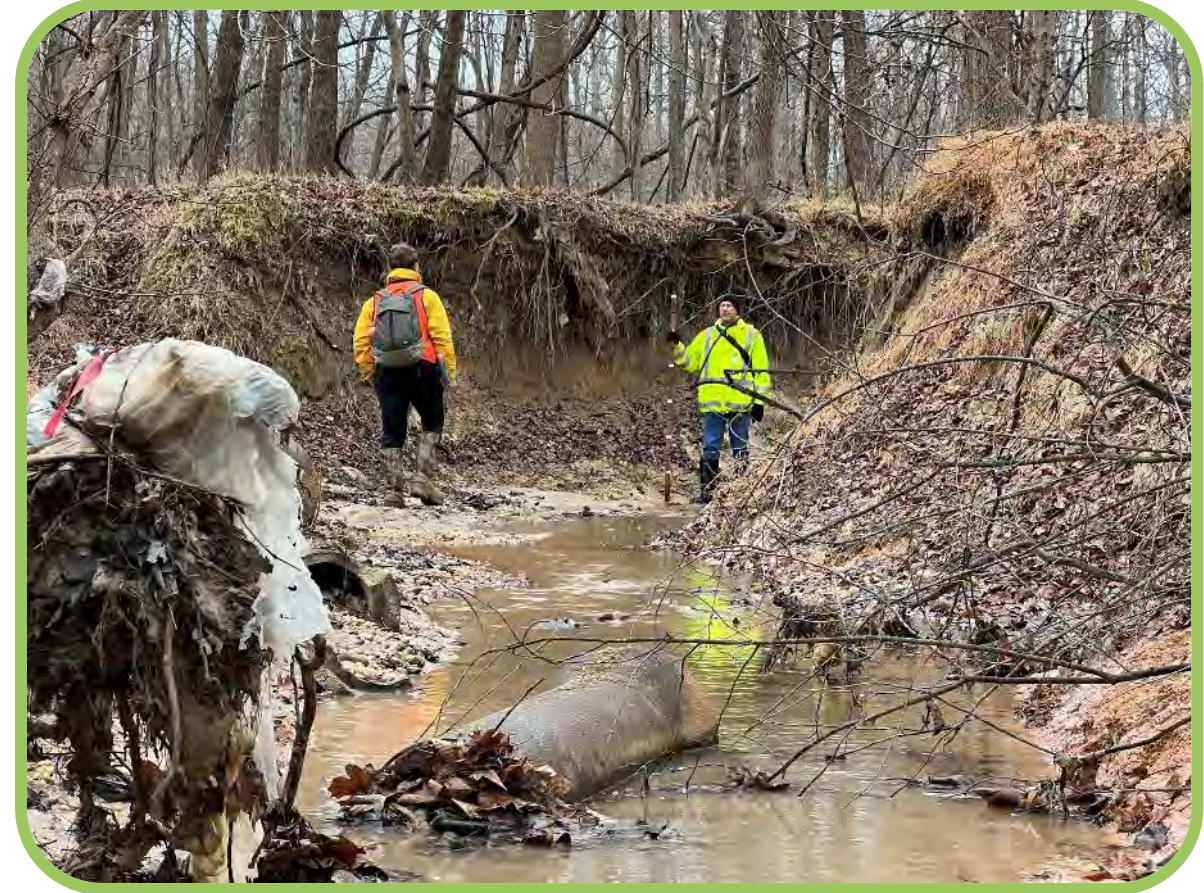
The photos show pre-restoration conditions, demonstrating the clear need for stream restoration including deeply incised stream banks. This project will include upland stormwater management components.

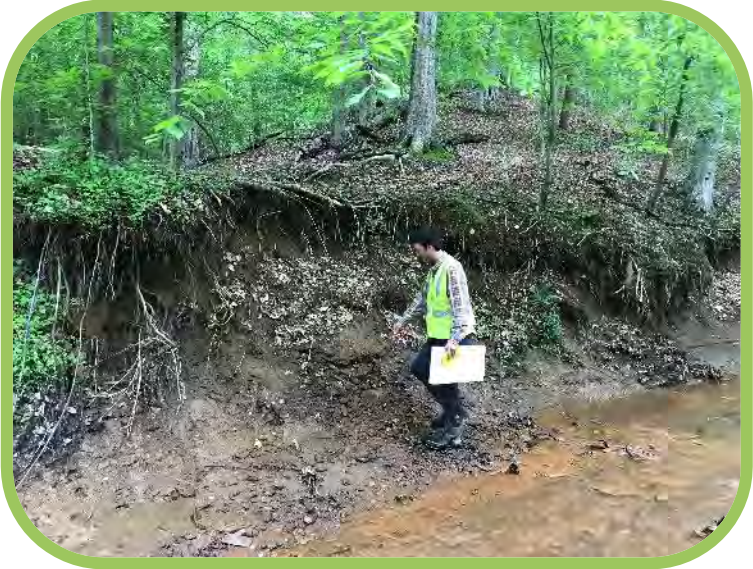
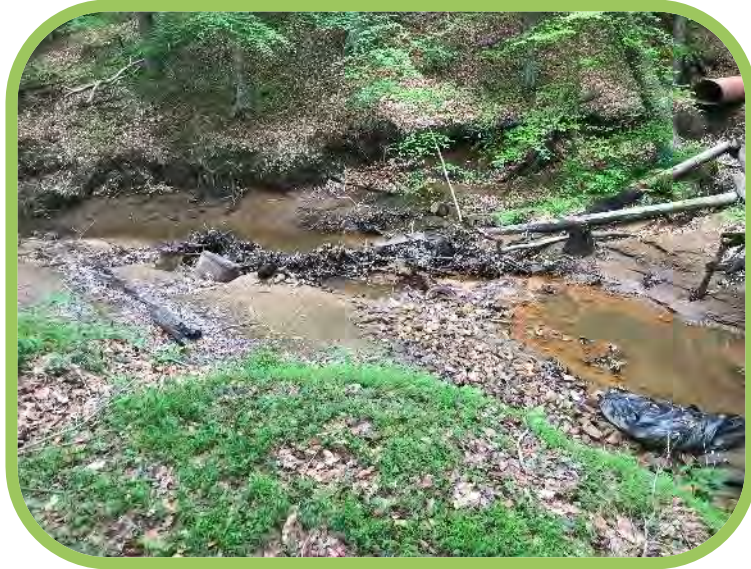
These photos demonstrate the severely degraded condition of these streams and the need for restoration.

Note the deep incision and vertical banks. Streams were actively eroding from both bed incision and bank widening, due to intensive historic land use.

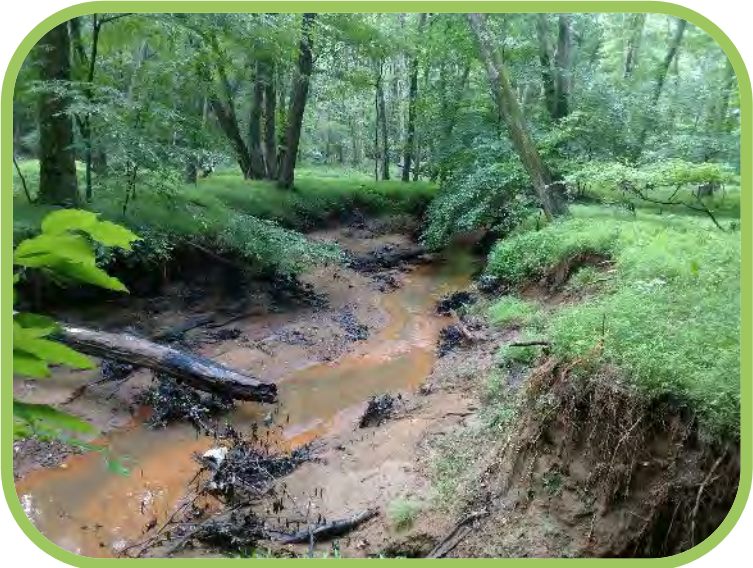
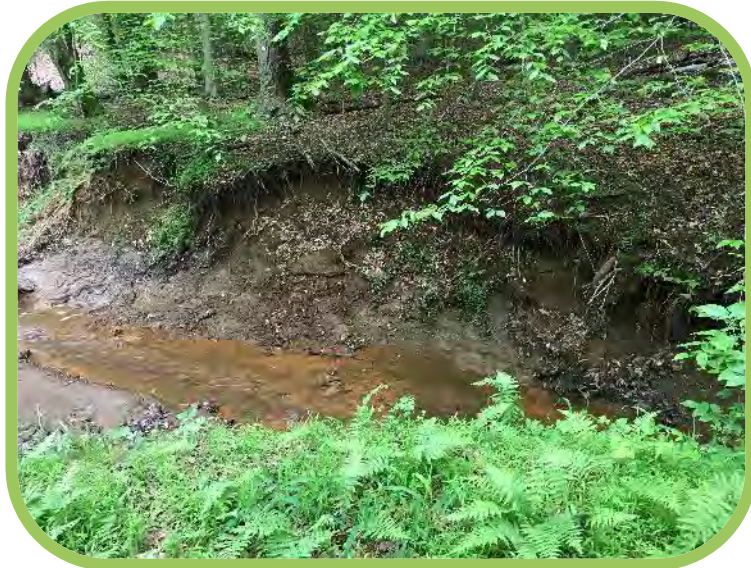
The large headcuts destroyed one critical pedestrian bridge used for access and severely threatened two others. The conditions also posed a safety hazard to the camp run on-site.

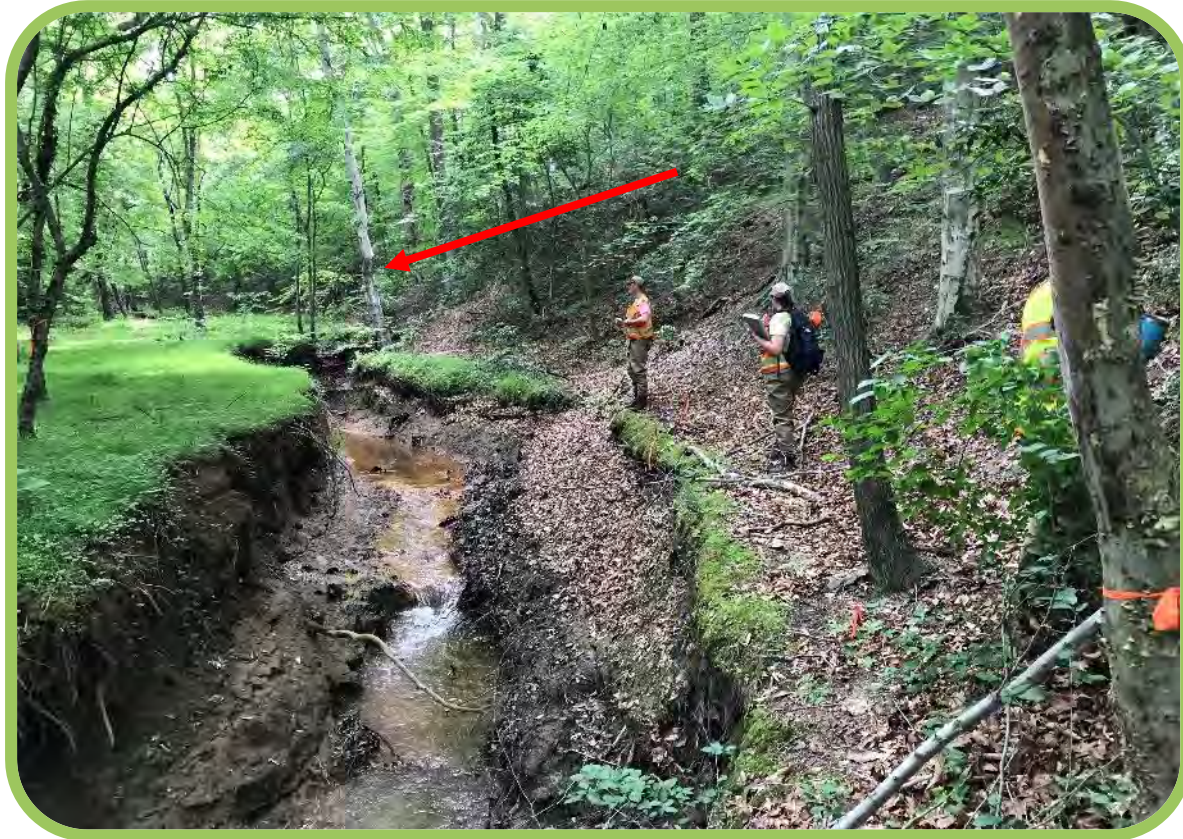
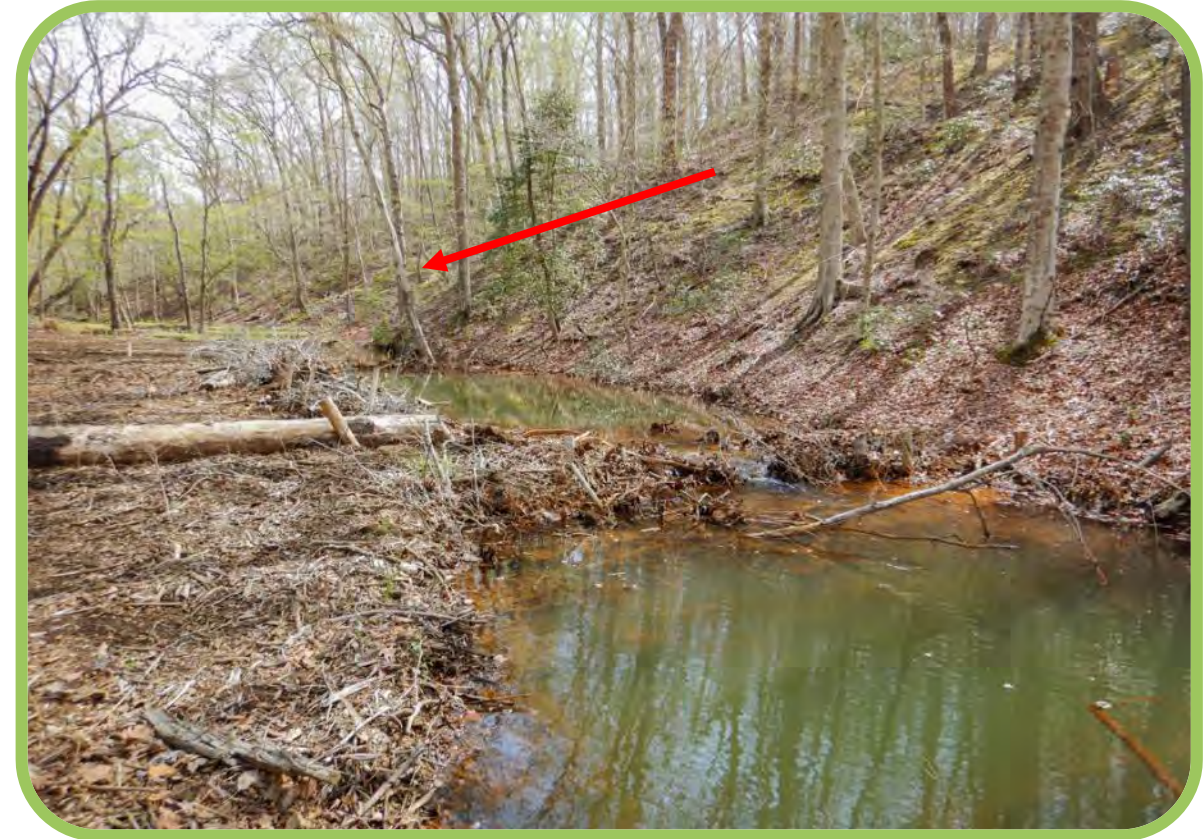
Photos depict the stream system before (left) and after (right) restoration. The restoration corrected deep incisions and reconnected the stream to its floodplain. This project uplifted water quality, restored a large forested floodplain (hydrology and vegetation), provided educational opportunities, and restored breeding habitat for yellow perch.

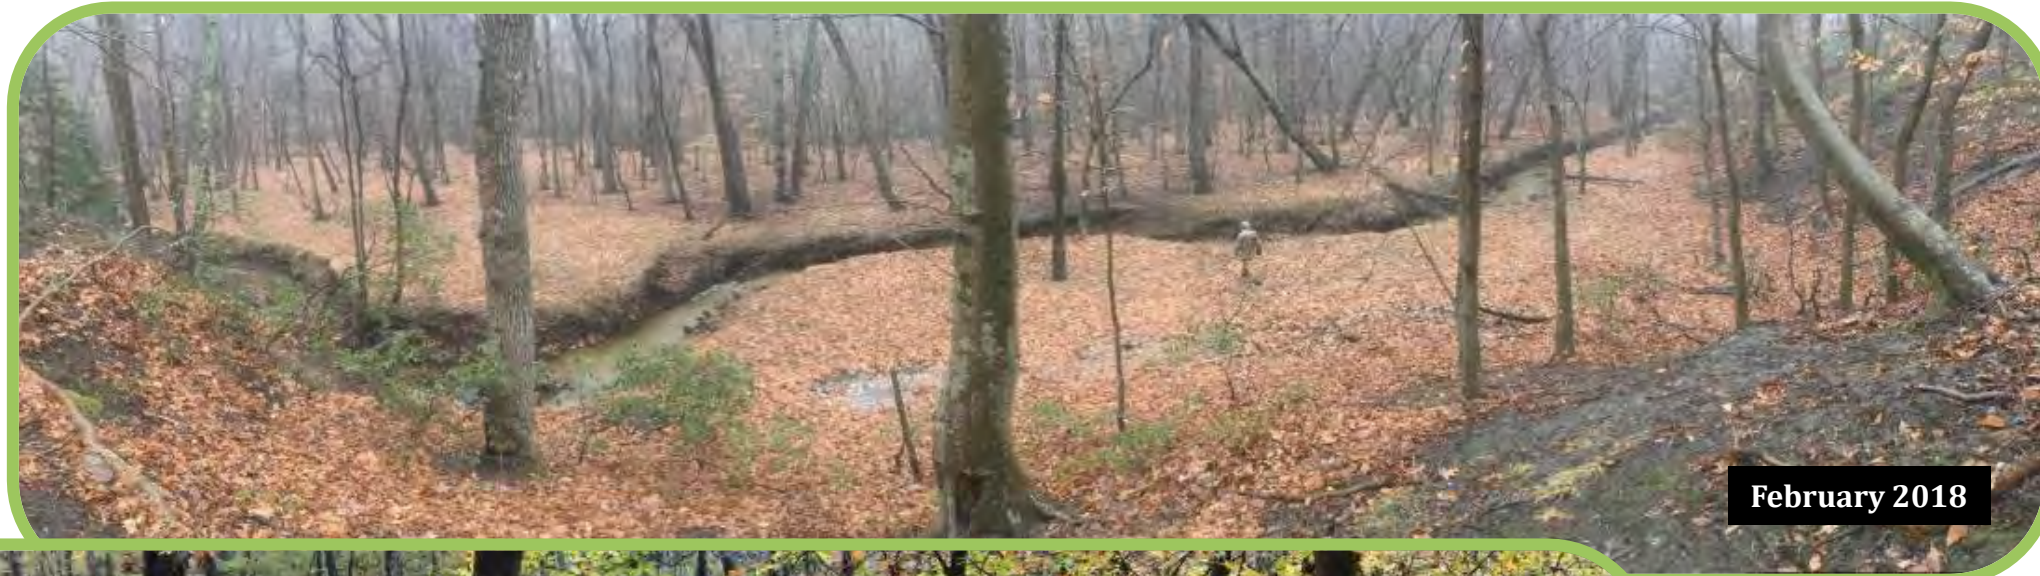
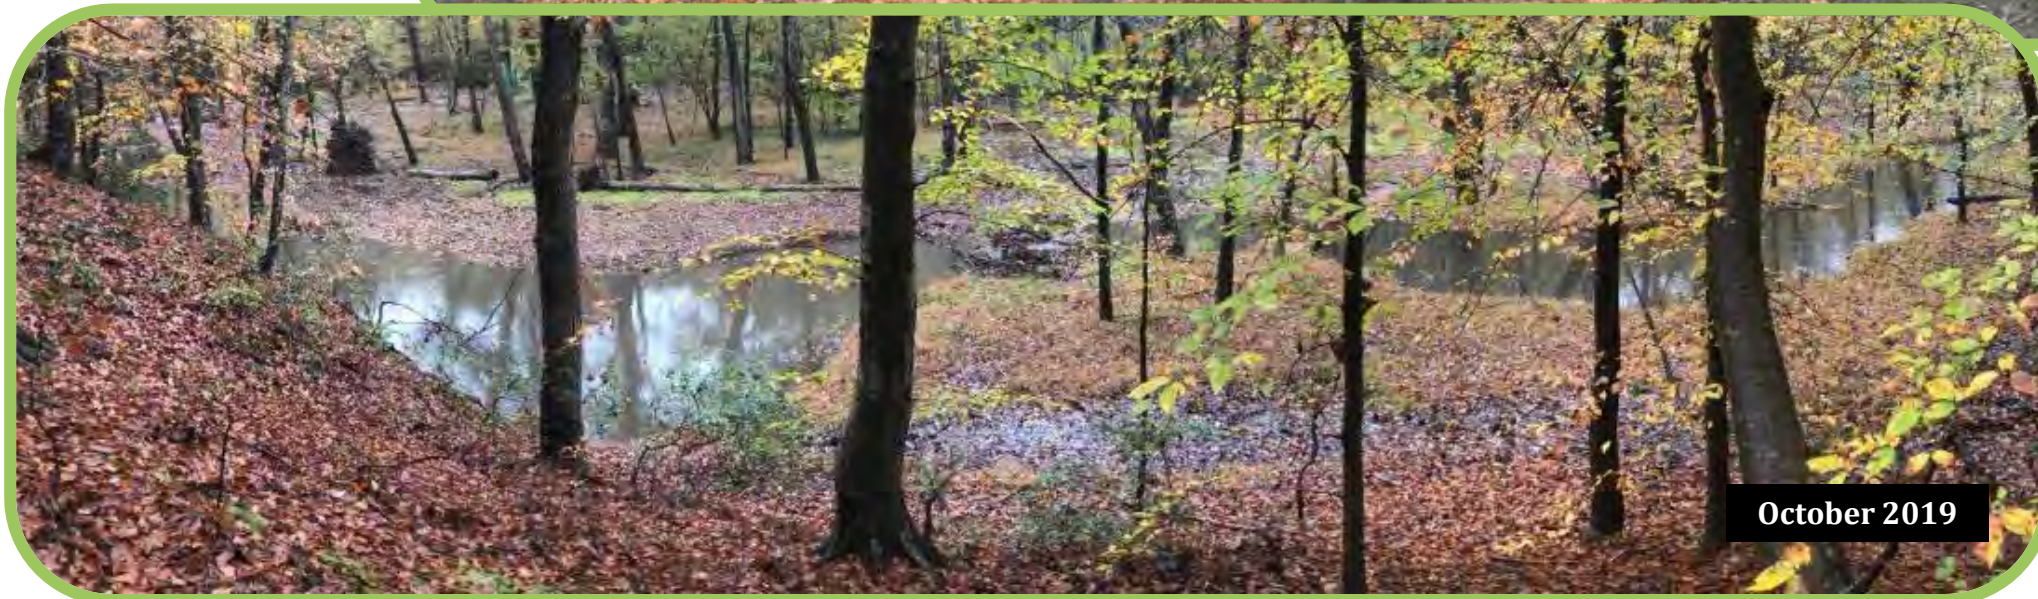
These photos show the stream corridor before (top) and after (bottom) restoration. The stream was realigned and reconnected with its floodplain.

Note the surgical construction technique that maximized tree conservation and forest restoration.

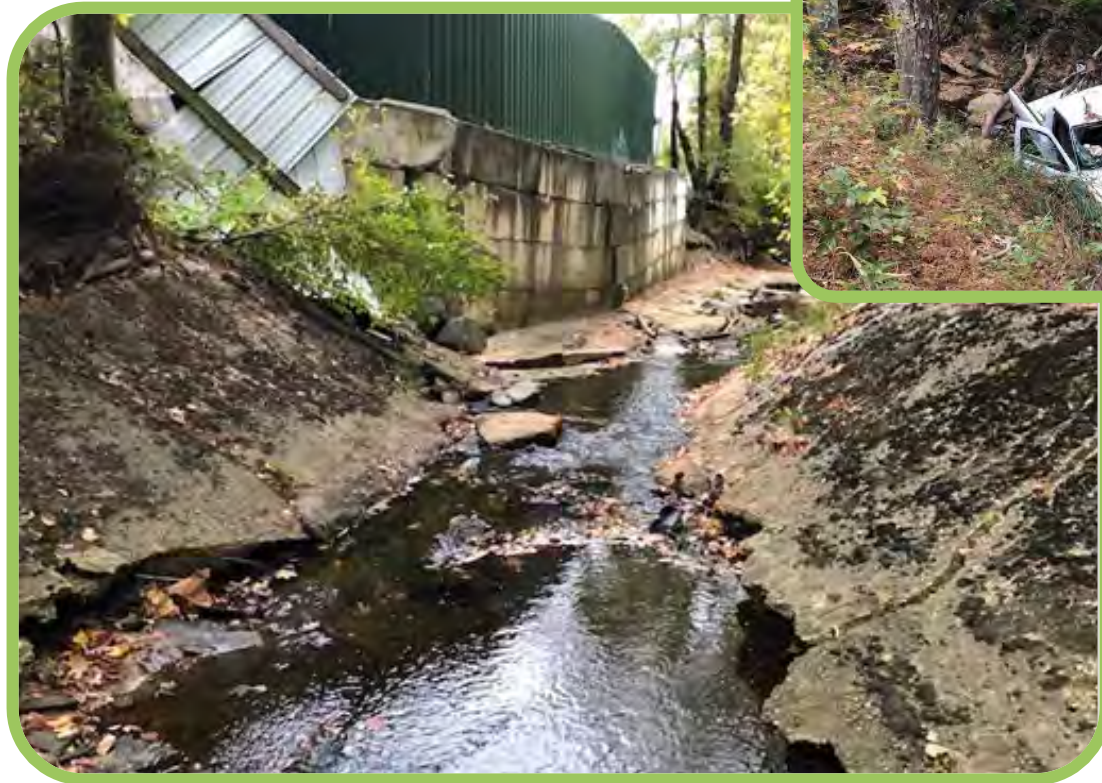
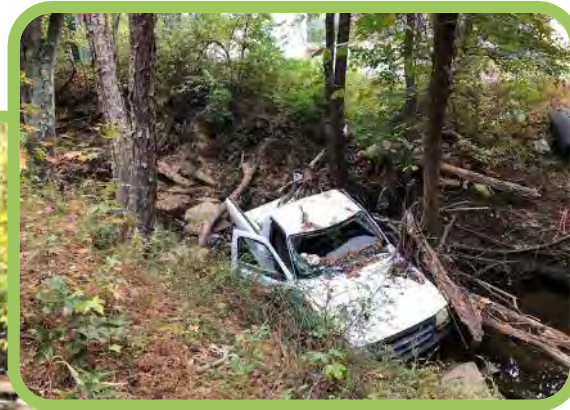
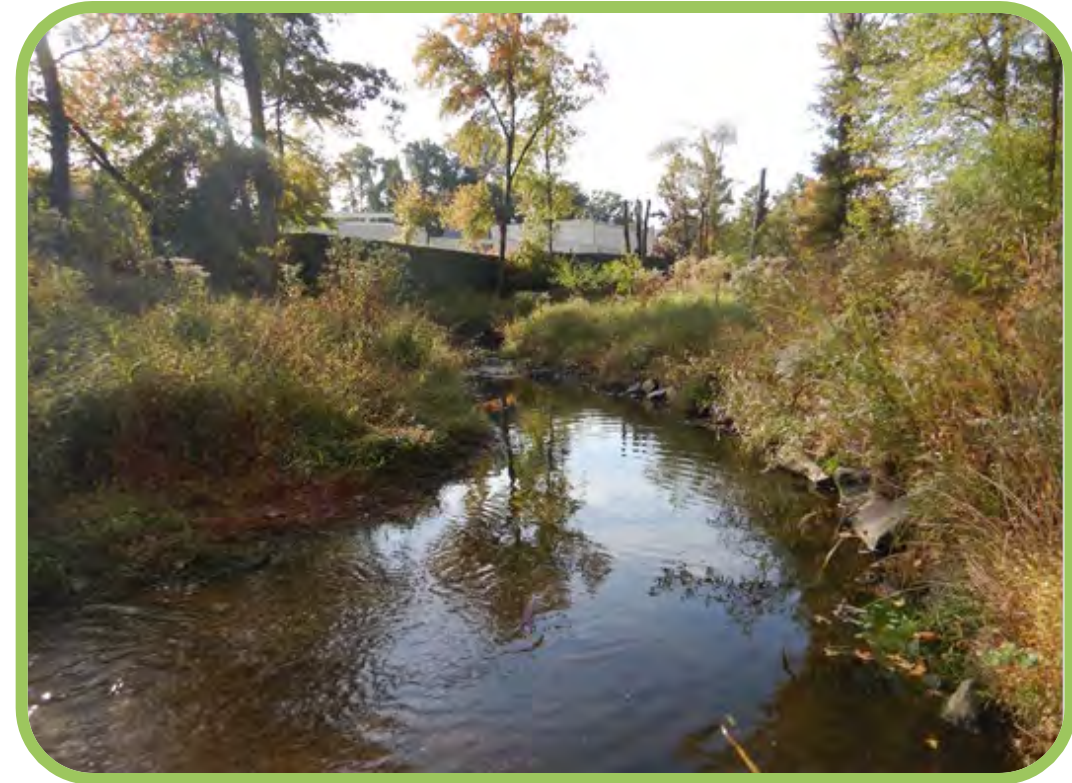
Photos show this stream reach before (left) and after (right) restoration. The truck shown was removed along with tons of other garbage and debris. The stream was stabilized, realigned, and restored habitat structure and function.

The project protected built infrastructure and reduced the flood surface elevation in the project corridor.

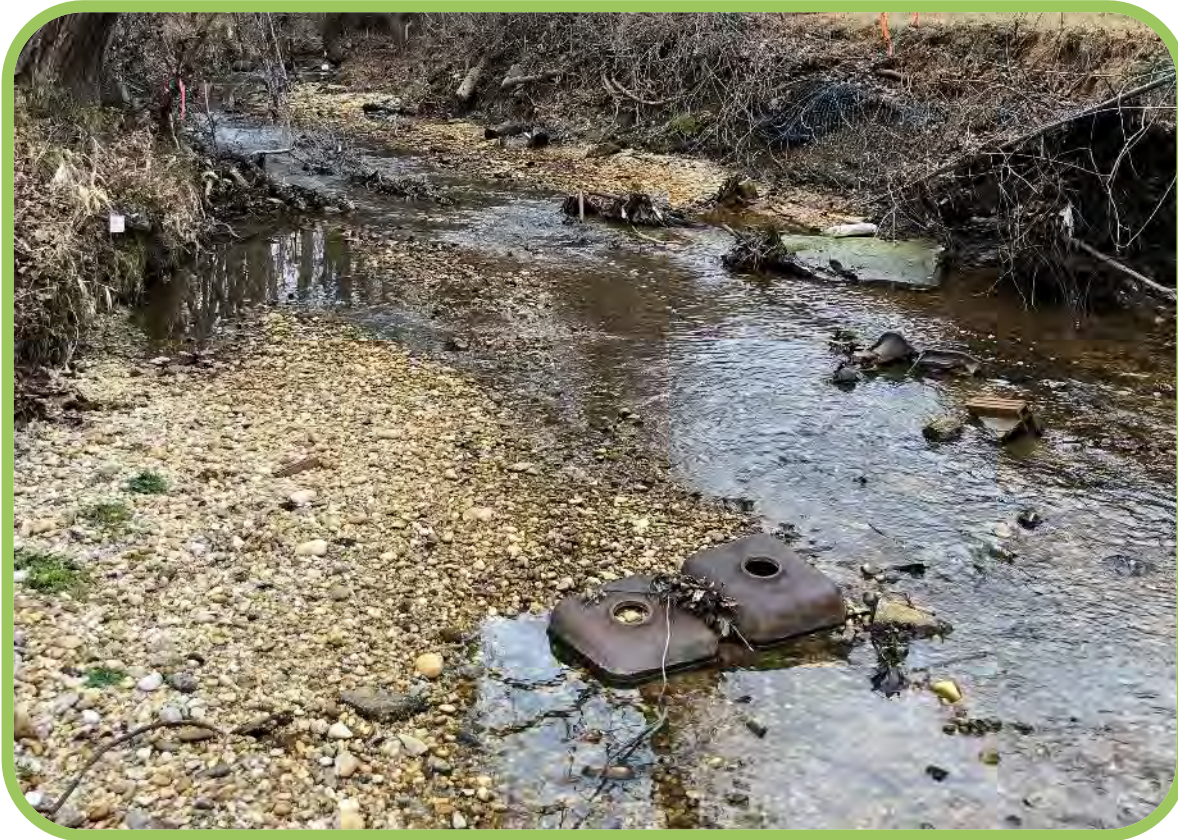
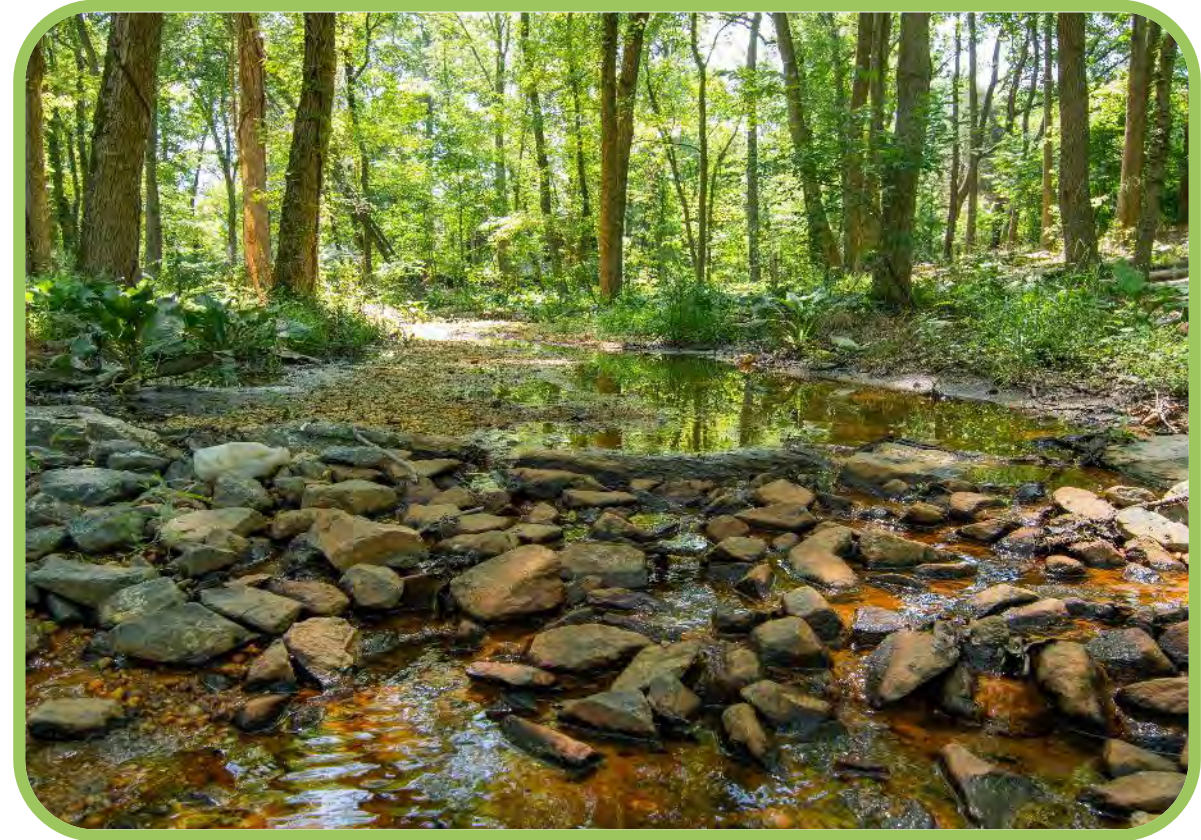
Photos depict the stream system before (left) and after (right) restoration. The restoration reduced planned impacts and installed a grade control to reduce erosion. The channel aggraded upstream as a result and is now functioning as a stable wetland complex.

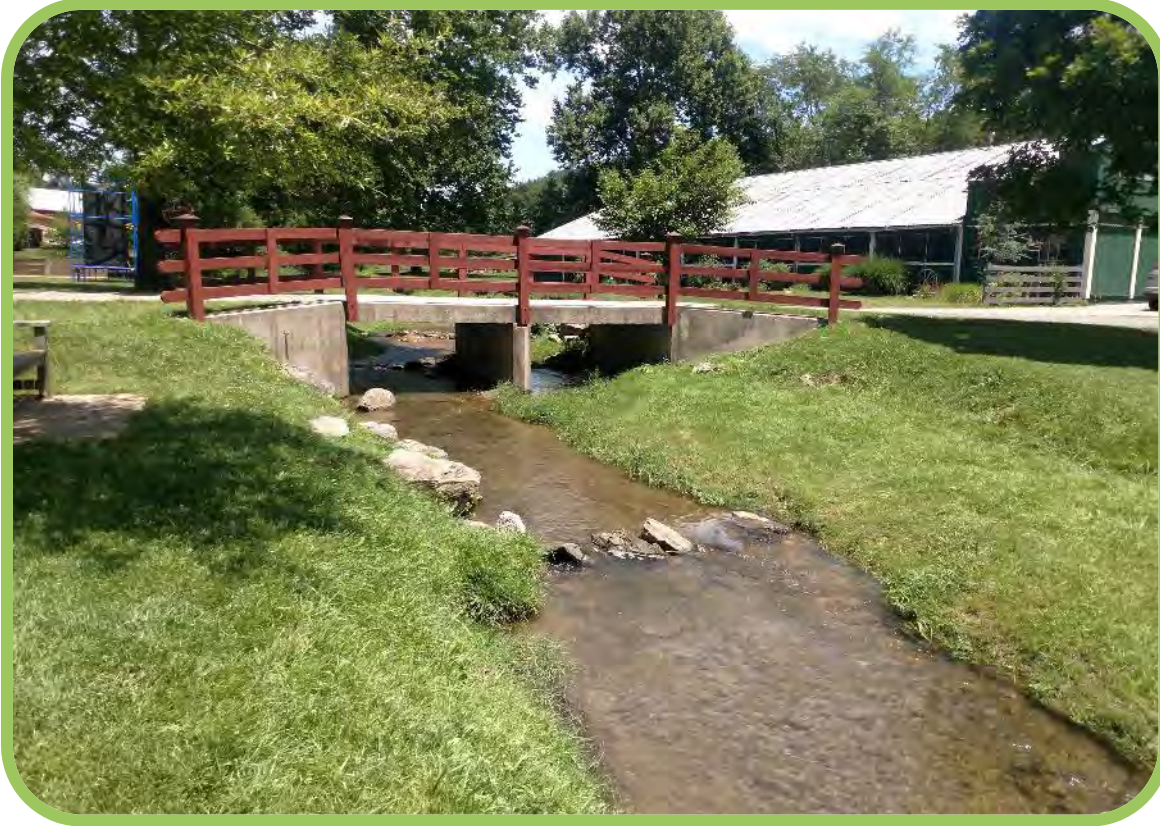
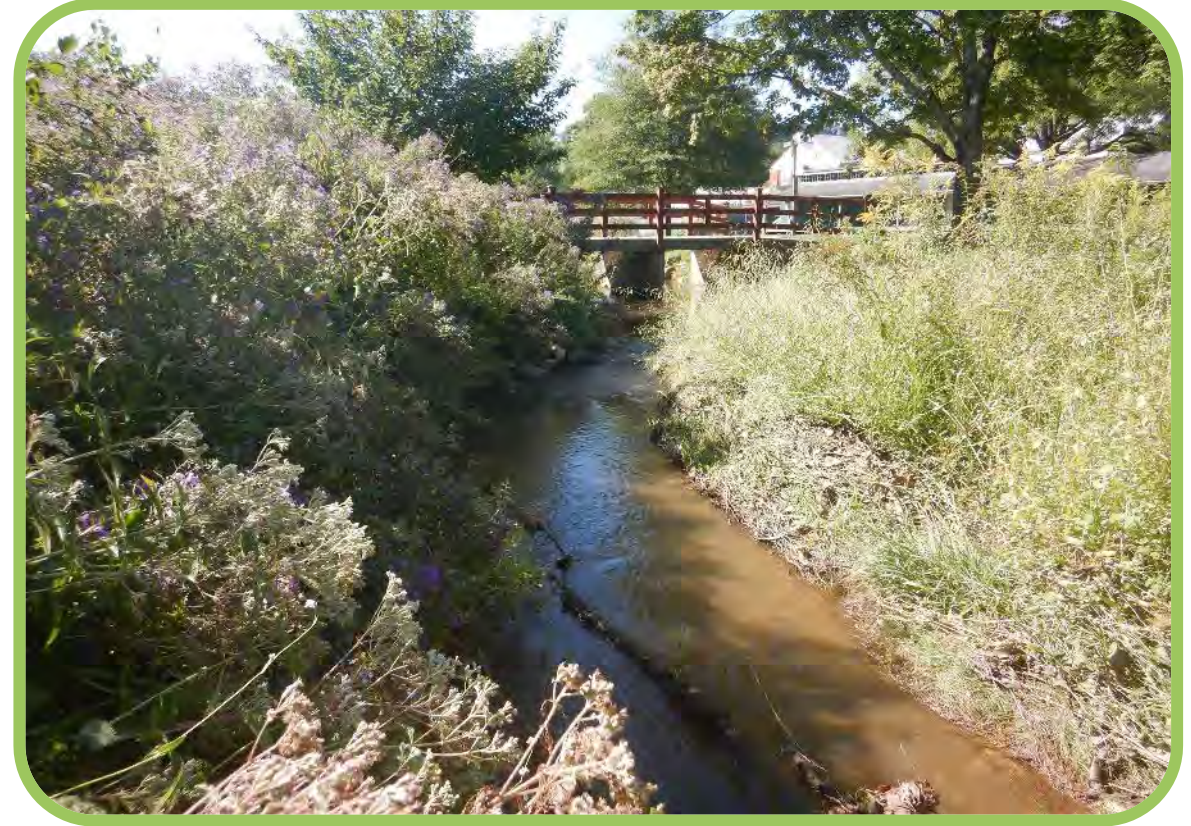
Photos depict the stream system before (left) and after (right) restoration. The restoration stabilized the stream, preventing further degradation that threatened on-site historic structures. The project provided flood attenuation, aquatic and terrestrial habitat improvements, and educational opportunities for this children's camp.

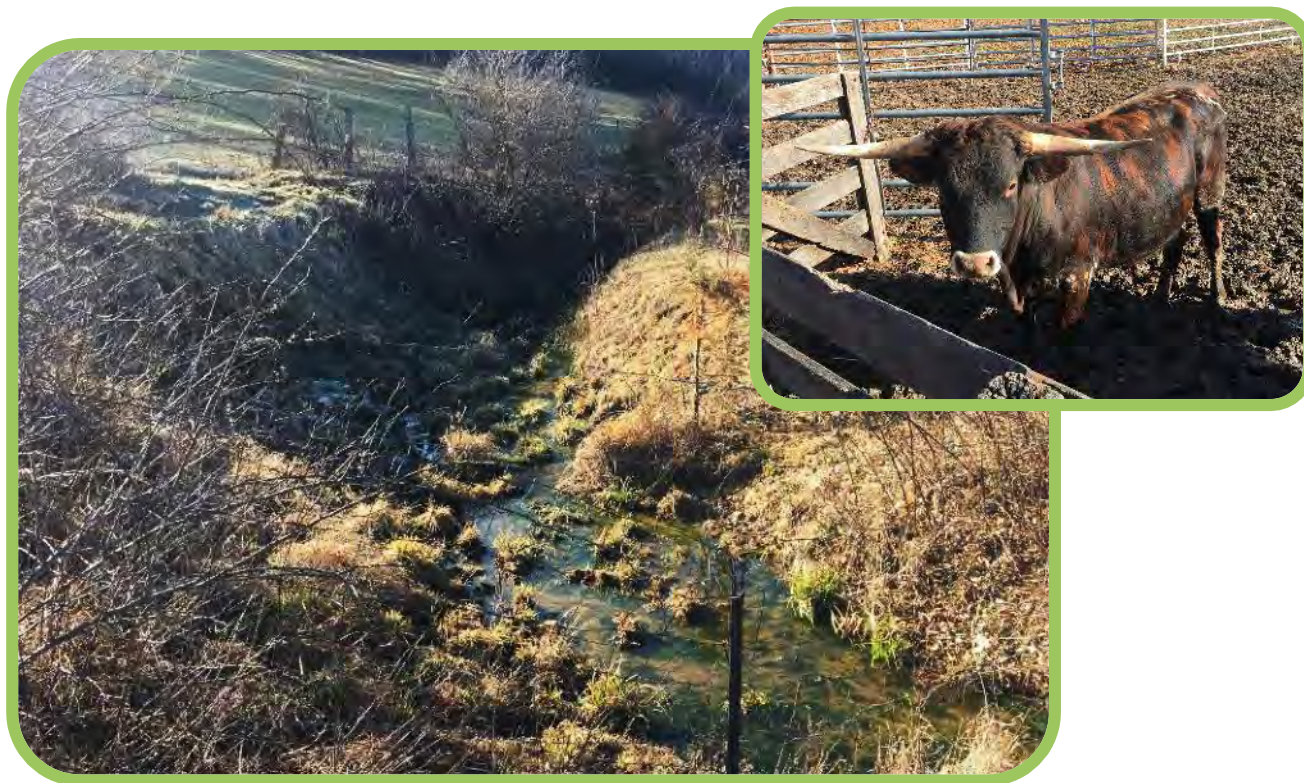
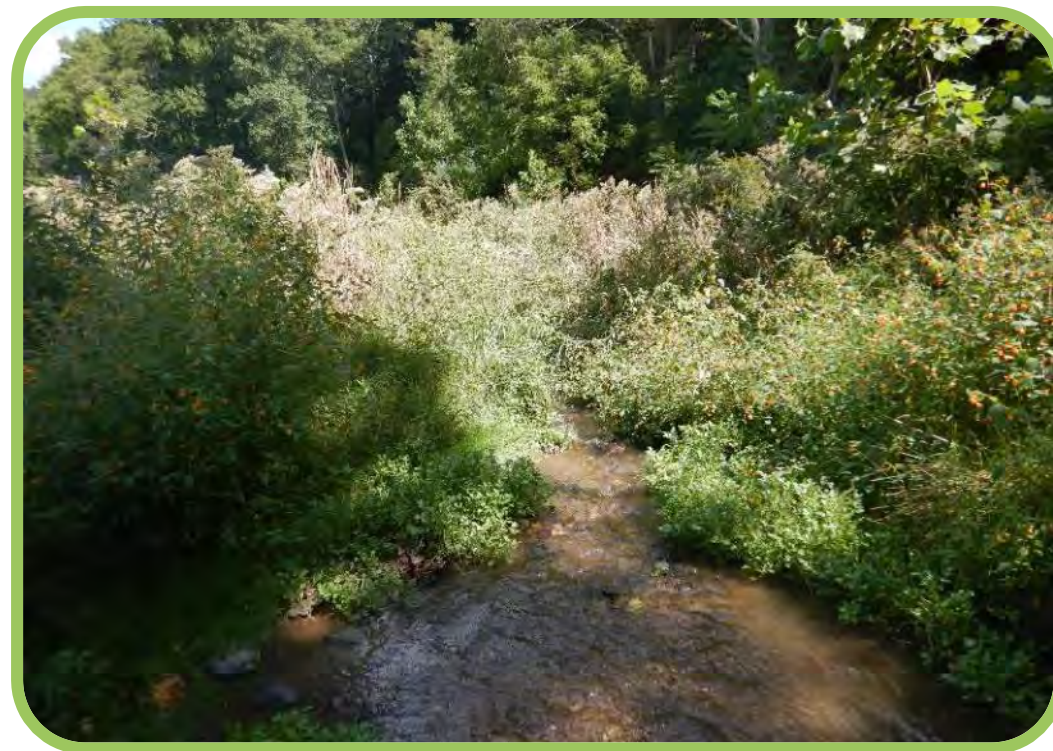
Photos depict the stream system before (left) and after (right) restoration. The restoration provided flood attenuation and habitat improvements for a population of a Federally listed (endangered) species of reptile and breeding populations of brook and brown trout. Longhorn cattle activity degraded the stream and wetland complex. Cattle fencing around the stream excluded livestock impacts from threatening the protected species and degrading the restored system. The project restored forested habitat and integrated it with the surrounding forest.
