## Testimony of Indigo Null

### SB0563 – Real Property – Actions to Repossess – Judgment for Tenants and Proof of Rental Licensure

Hearing before the Senate Judicial Proceedings Committee, Feb. 22, 2022

## Inspection Report

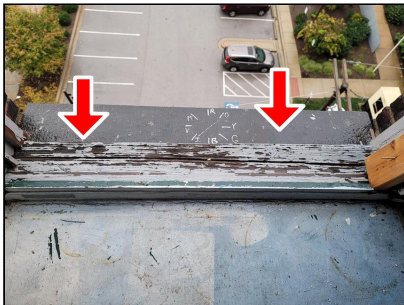
1.5 Item 3(Picture)

- (5) Components of window sill exteriors were loose, damaged or deteriorated and needed maintenance to help prevent damage from moisture intrusion to the home materials, the exterior wall structure and to prevent development of microbial growth such as mold. All work should be performed by a qualified contractor.

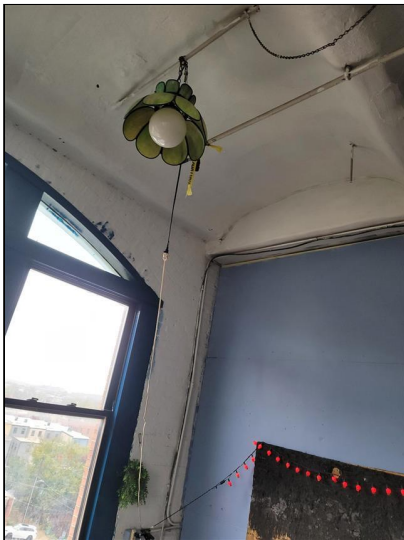
🔧 (3) Extension cords used as house wiring visible in the throughout the apartment at the time of the inspection is a potential fire hazard. The Inspector recommends removal of the extension cord and proper wiring be installed by a qualified electrical contractor.

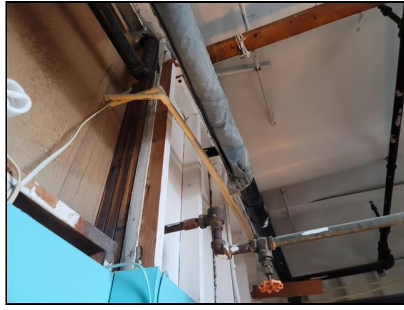
- (3) Chlorinated Poly Vinyl Chloride (CPVC) water distribution pipes were poorly supported in the unit. This condition puts excessive strain on fittings and may result in premature failure. Horizontally-oriented CPVC distribution pipes should be supported at least every 3 feet. The Inspector recommends installation of

additional supports by a qualified contractor. Some portions of the home distribution piping will not be accessible for installation of additional supports.<sup>34</sup>

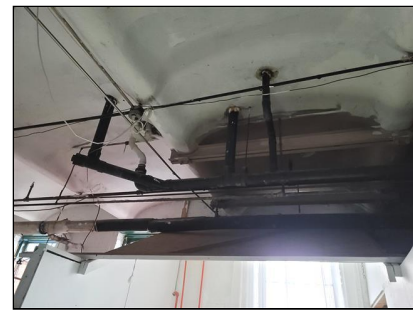
(2) Drain/waste pipes in the rear bedroom were damaged and had created unhealthy conditions at the time of the inspection. The Inspector recommends correction and disinfection by a qualified contractor.

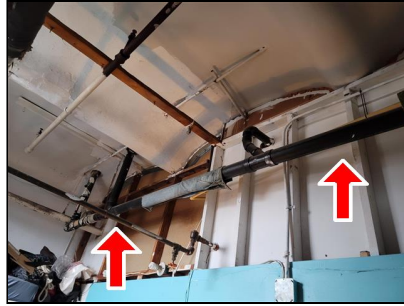
⚡ (3) Supports for the ABS or PVC drain/waste pipe visible in the rear bedroom were located too far apart. The maximum support spacing recommended by generally-accepted modern plumbing standards is 4 feet. The Inspector recommends correction by a qualified contractor.

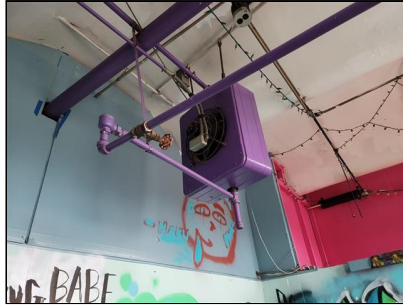
The apartment had no operable heat present in all the rooms. Heat was relied on old boiler distribution pipes to give off heat without radiators which was not suffice and was inoperable at the time of the inspection. Heat was not on and no controls were present. The Inspector recommends that heat be installed in each room with accessible thermostats to the occupants of the apartment by a qualified HVAC contractor or electrician. It was cold outside and in the units at the time of the inspection.

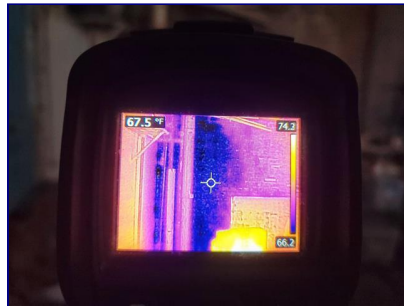
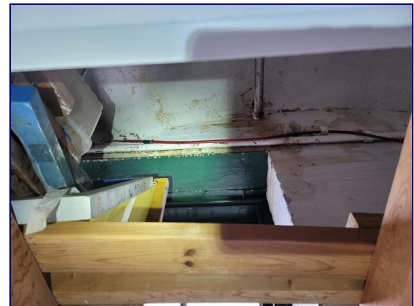
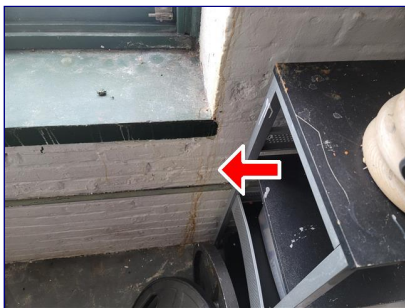
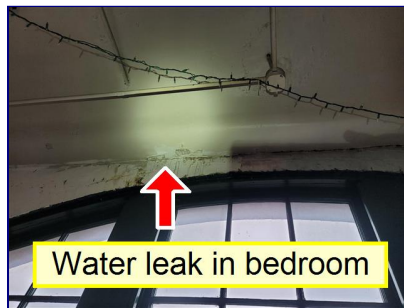
(2) Stains on the walls in the visible in many areas at the time of the inspection appeared to be the result of moisture intrusion. The moisture meter showed elevated moisture levels in the affected areas at the time of the inspection, indicating that the leakage has been recent. The Inspector recommends consultation with a qualified contractor to discuss options and costs for correction and repair.

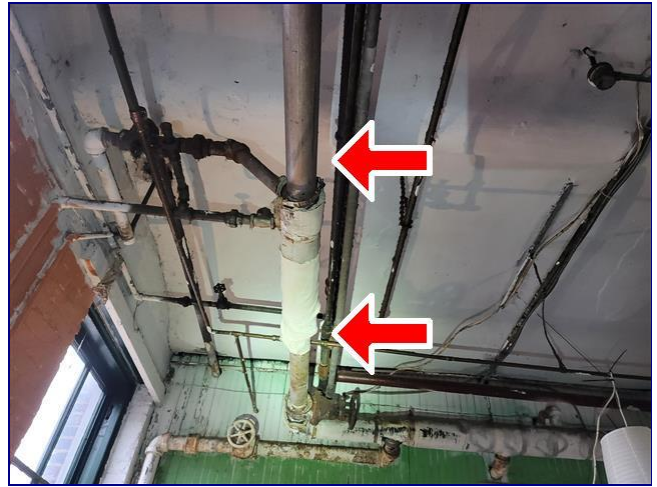
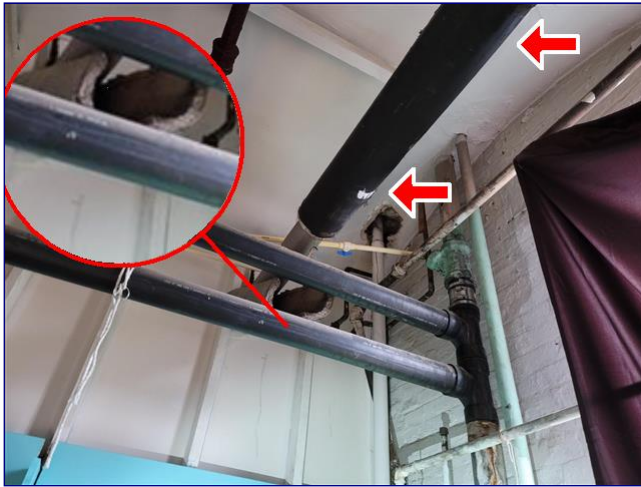
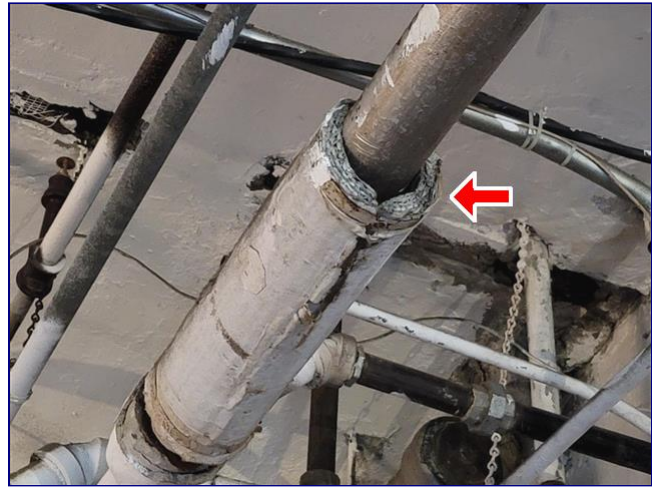
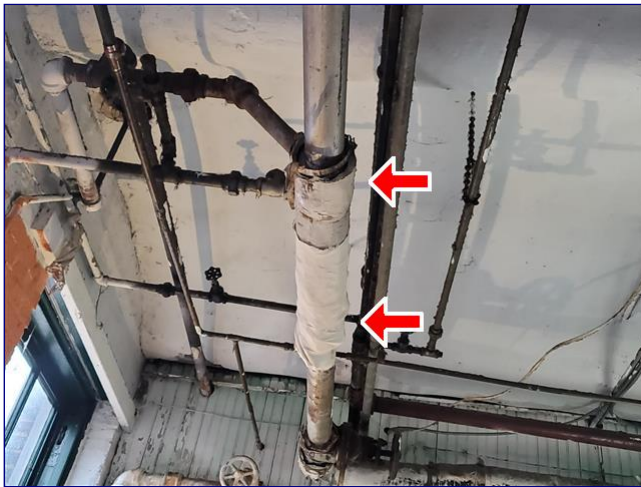
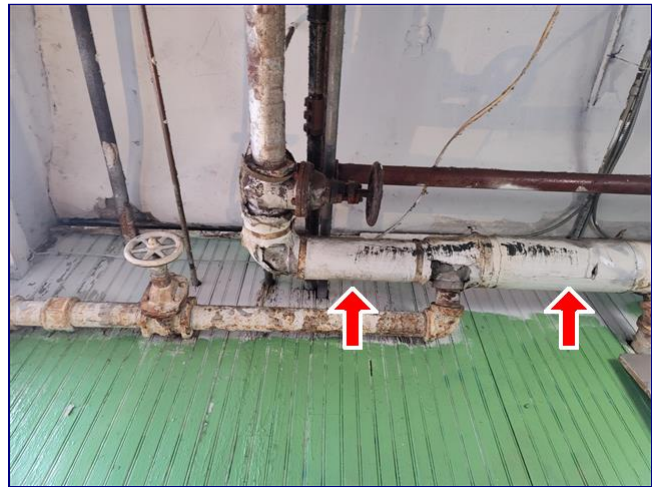
(1) Materials in the on the boiler distribution pipes throughout the home may contain asbestos. Asbestos has been classified as a known human carcinogen (a substance that causes cancer) by the U.S. Department of Health and Human Services, the EPA, and the International Agency for Research on Cancer. People who become ill from asbestos are usually those who are exposed to it on a regular basis, most often in a job where they work directly with the material or through substantial environmental contact. To cause health problems, asbestos must be in a form in which the fibers can be inhaled, such as when it is cut, torn, or sanded. The insulation on these pipes of concern had damage and deterioration that can be friable. The only way to know for certain whether asbestos is in a particular product or material is to have testing performed. A sample was taken and will be sent to a laboratory for testing.

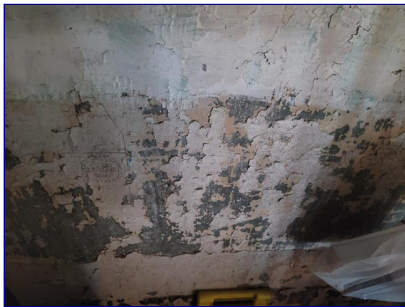
(2) Because this home was built before 1978, there is a good chance it has lead-based paint. In 1978, the federal government banned consumer uses of lead-containing paint as a potential health hazard, but some states banned it even earlier. Lead from paint, including lead-contaminated dust, is one of the most common causes of lead poisoning. Chipping, cracking, flaking and deteriorated paint was observed widespread throughout the building. All painted surfaces in the building should be repainted and repaired by a lead abatement contractor.

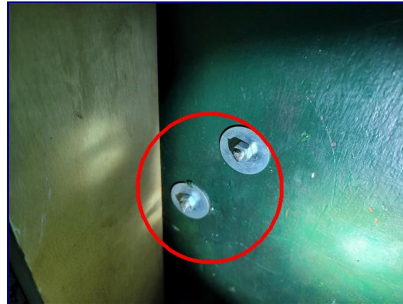
(2) The entry door did not have an operable locks and had sharp bolts sticking out. This condition is a fire hazard.

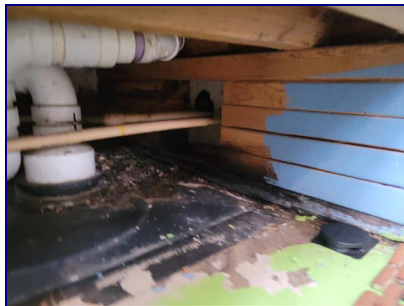
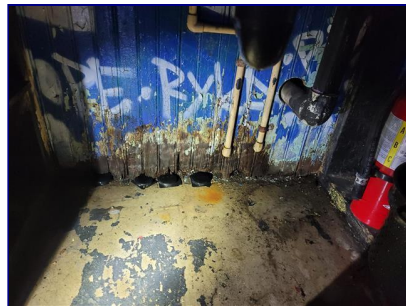
- ✎ (2) Water flow at the shower in the entry bathroom appeared to be inadequate. The Inspector<sup>45</sup> recommends that you have this condition evaluated by a qualified plumbing contractor to determine the potential need and costs for correction.
- ✎ (3) Fungi growth was observed below the shower pan due to water entering from behind the shower walls. The Inspector recommends installing a new shower enclosure to prevent water leakage and mold growth. The mold growth should be remediated by a qualified professional.

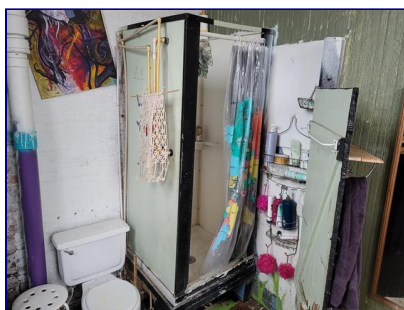
2.4 Item 6(Picture)

- ✎ (4) In the bathroom, the shower enclosure was old and deteriorated.

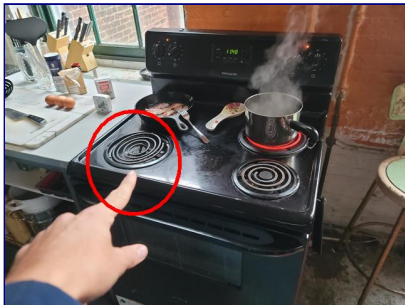
3.2 Item 1(Picture)

- 🔧 (1) The range was not fastened to the floor. A child standing on the open oven door could overturn the range. This condition is a life-safety issue. The Inspector recommends installation of an approved anti-tip device by a qualified contractor.
- 🔧 (2) The electric stove had one or more inoperable stove top burners. The Inspector recommends service by a qualified technician.

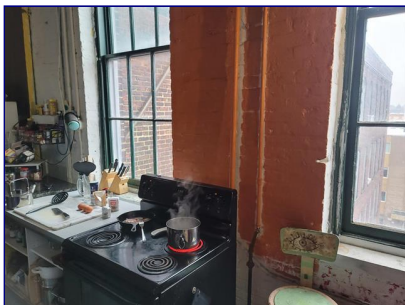
3.3 Item 1(Picture)

- 🔧 No range hood or exhaust system was installed at the time of the inspection. The Inspector recommends that an exhaust hood or air filtration system be installed to prevent possible moisture damage and grease accumulation on walls and ceiling adjacent to the range. All work should be performed by a qualified contractor.

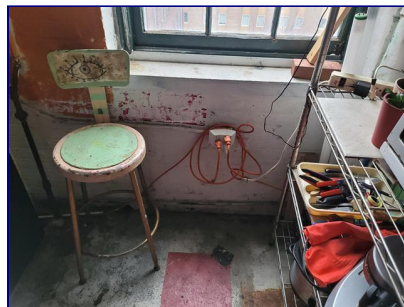
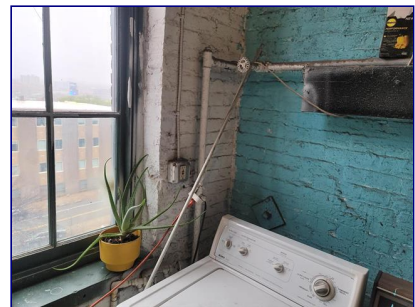
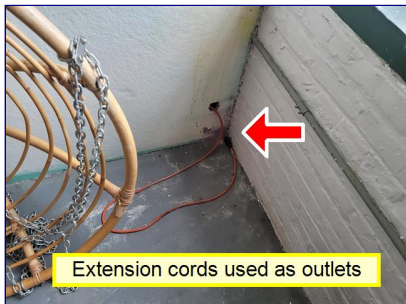
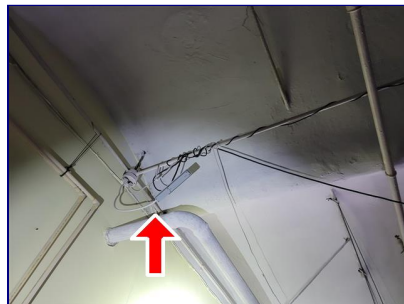
(1) The number of electrical receptacles in the home was inadequate and extension cords were used throughout the unit. This condition is potential fire hazard and should be corrected.

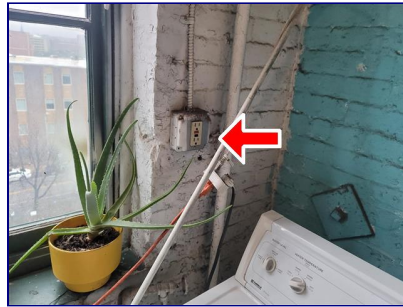
5.1 Item 9(Picture)

(3) Some electrical receptacles in the home were inoperable at the time of the inspection. The Inspector recommends service by a qualified electrical contractor.

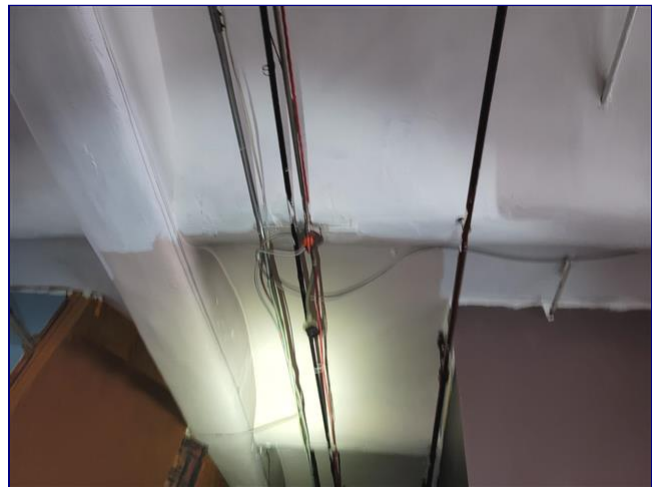
(3) Extension cords used as house wiring visible in the throughout the apartment at the time of the inspection is a potential fire hazard. The Inspector recommends removal of the extension cord and proper wiring be installed by a qualified electrical contractor.

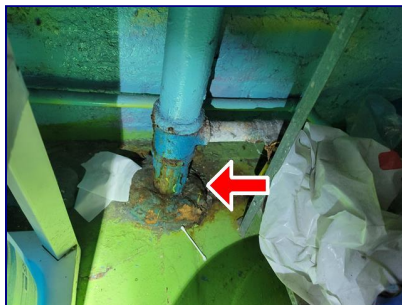
6.0 Item 2(Picture)

- (1) Some of the visible water distribution pipes were galvanized steel. These pipes are old, and of a material no longer installed for this purpose due to bore shrinkage from accumulation of interior corrosion that over time reduces water flow. These pipes may need to be replaced soon.

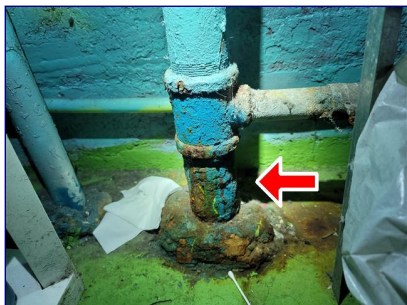
6.0 Item 3(Picture)

- (2) Actively leaking, heavily-corroded water distribution pipes visible in the bathroom should be repaired by a qualified plumbing contractor to avoid damage to home materials or the development of conditions which encourage the growth of microbes such as mold.

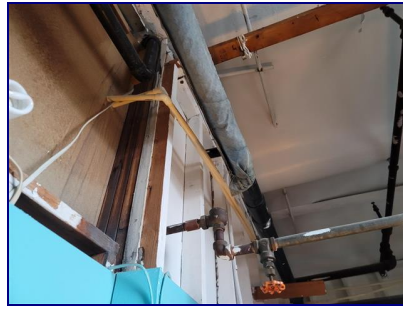
- (3) Chlorinated Poly Vinyl Chloride (CPVC) water distribution pipes were poorly supported in the unit. This condition puts excessive strain on fittings and may result in premature failure. Horizontally-oriented CPVC distribution pipes should be supported at least every 3 feet. The Inspector recommends installation of additional supports by a qualified contractor. Some portions of the home distribution piping will not be accessible for installation of additional supports.

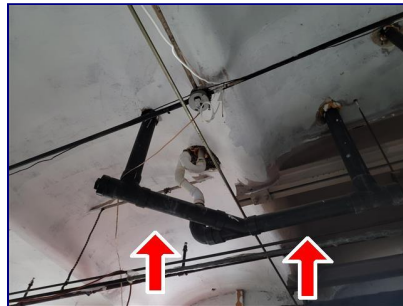
(1) Many traps were of a type called an "S-trap". S-traps are no longer allowed to be installed in new construction for safety reasons. A siphon can develop which empties the trap of water; a condition with the potential to allow toxic sewer gas to enter the living space. Although this type of trap may have been commonly considered safe at the time the home was originally constructed, as general knowledge of safe building practices has improved with the passage of time, building standards have changed to reflect current understanding. The Inspector recommends replacement of all such traps in the home by a qualified plumbing contractor.

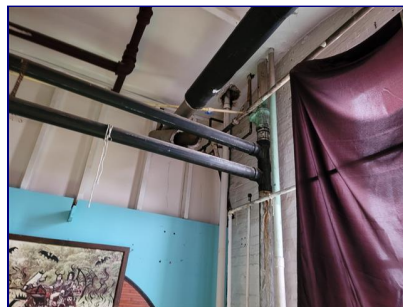
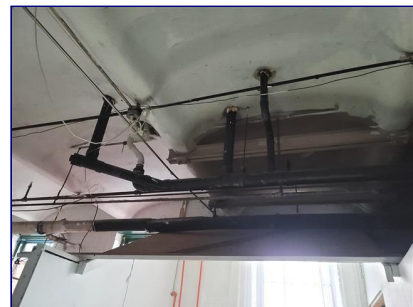
(2) Drain/waste pipes in the rear bedroom were damaged and had created unhealthy conditions at the time of the inspection. The Inspector recommends correction and disinfection by a qualified contractor.

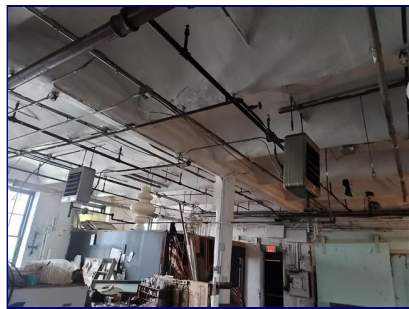
The apartment had no operable heat present in all the rooms. Heat was relied on old boiler distribution pipes to give off heat without radiators which was not suffice and was inoperable at the time of the inspection. Heat was not on and no controls were present. The Inspector recommends that heat be installed in each room with accessible thermostats to the occupants of the apartment by a qualified HVAC contractor or electrician. It was cold outside and in the units at the time of the inspection.
