Testimony of Indigo Null

SB100 – Actions to Repossess – Proof of Rental Licensure Hearing before

Inspection Report

Anna Velicky

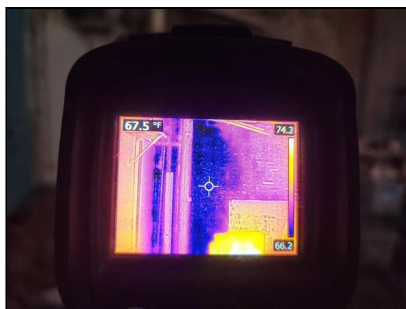
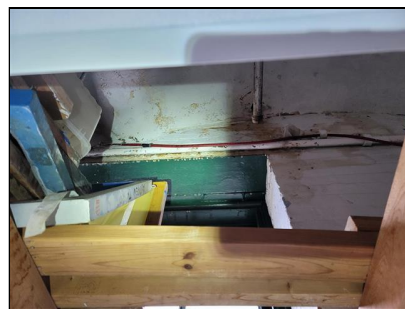
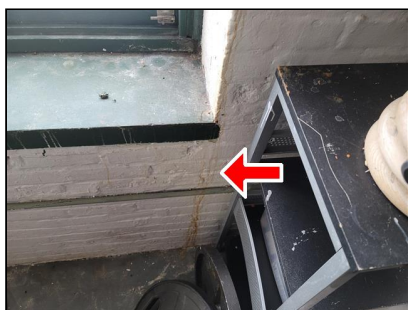
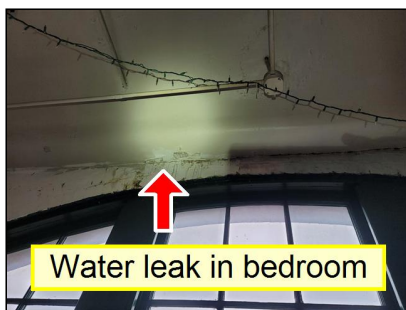
- 17
🔧 (2) Stains on the walls in the visible in many areas at the time of the inspection appeared to be the result of moisture intrusion. The moisture meter showed elevated moisture levels in the affected areas at the time of the inspection, indicating that the leakage has been recent. The Inspector recommends consultation with a qualified contractor to discuss options and costs for correction and repair.

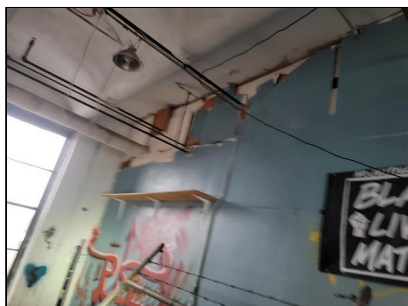
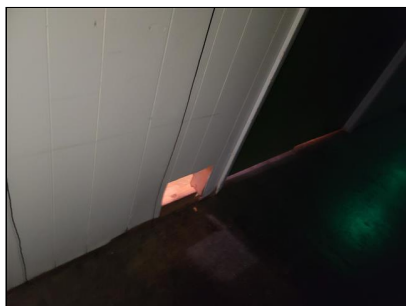
- 🔧 (3) No insulation was installed in the exterior walls or ceilings. This condition will result in higher heating and cooling costs and lower comfort levels than would be the case if the walls were insulated.
- 🔧 (4) Walls in the exhibited moderate damage or deterioration and were poorly installed.

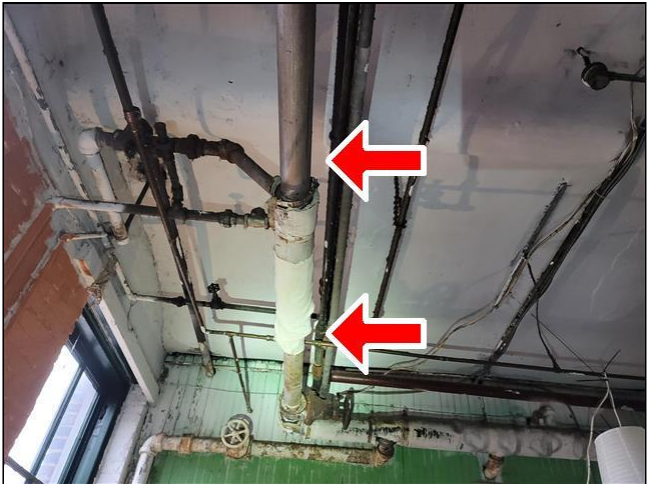
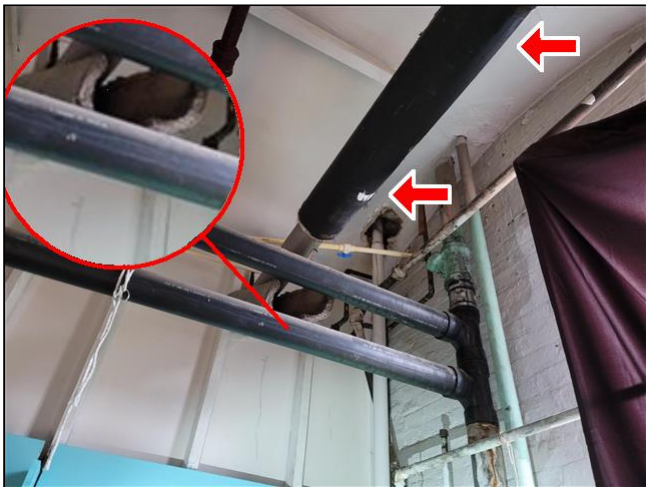
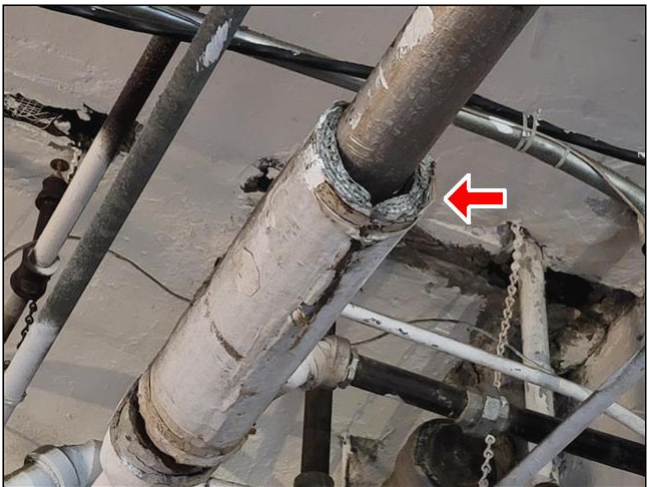
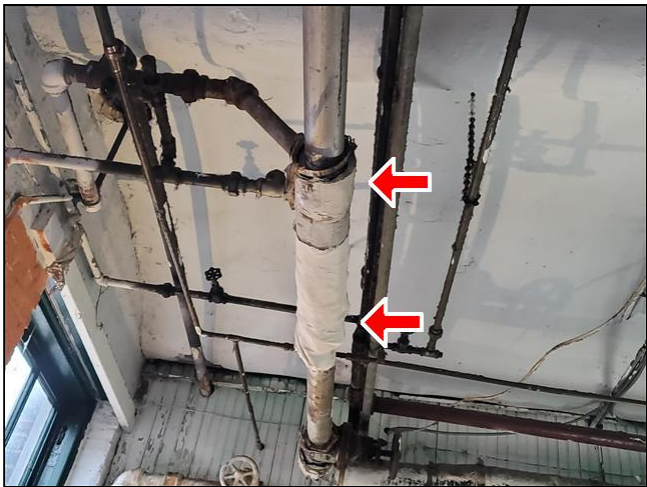
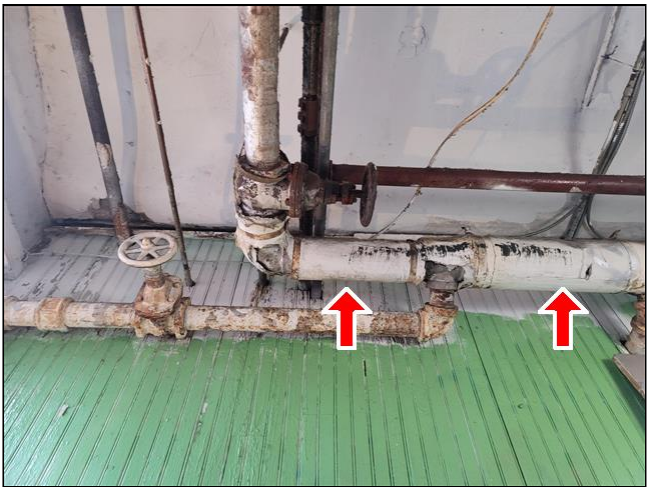
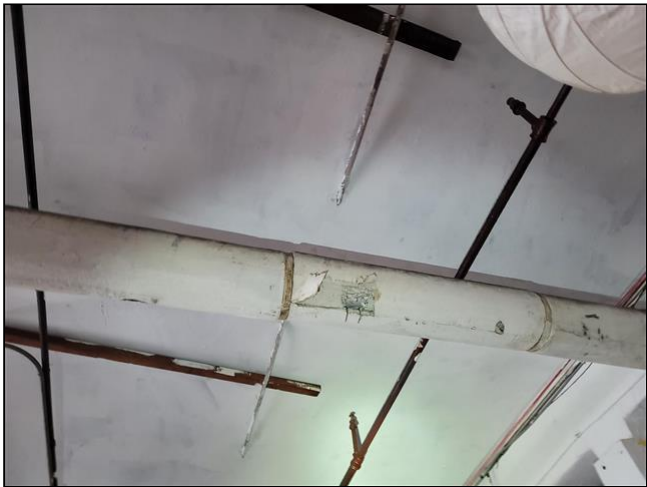
¹⁹
(1) Materials in the on the boiler distribution pipes throughout the home may contain asbestos. Asbestos has been classified as a known human carcinogen (a substance that causes cancer) by the U.S. Department of Health and Human Services, the EPA, and the International Agency for Research on Cancer. People who become ill from asbestos are usually those who are exposed to it on a regular basis, most often in a job where they work directly with the material or through substantial environmental contact. To cause health problems, asbestos must be in a form in which the fibers can be inhaled, such as when it is cut, torn, or sanded. The insulation on these pipes of concern had damage and deterioration that can be friable. The only way to know for certain whether asbestos is in a particular product or material is to have testing performed. A sample was taken and will be sent to a laboratory for testing.

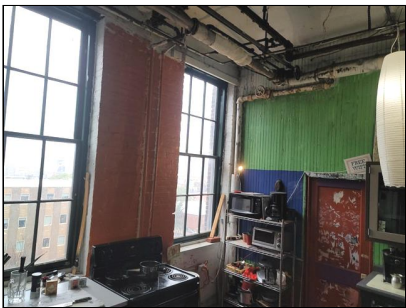
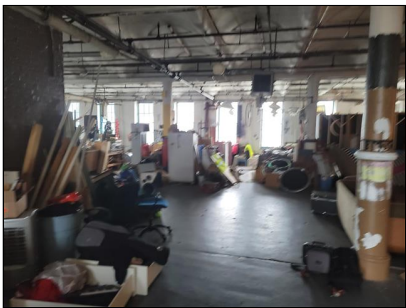
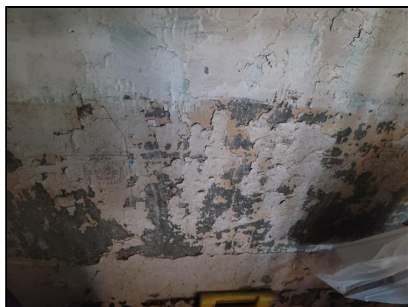
🔧 (2) Because this home was built before 1978, there is a good chance it has lead-based paint. In 1978, the federal government banned consumer uses of lead-containing paint as a potential health hazard, but some states banned it even earlier. Lead from paint, including lead-contaminated dust, is one of the most common causes of lead poisoning. Chipping, cracking, flaking and deteriorated paint was observed widespread throughout the building. All painted surfaces in the building should be repainted and repaired by a lead abatement contractor.

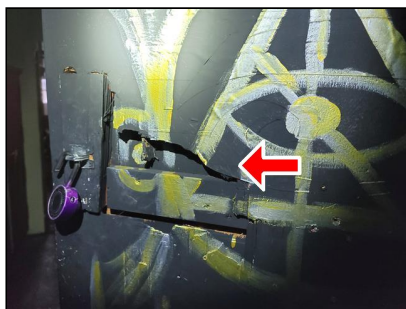
1.4 Item 2(Picture)

- 🔧 (1) Interior doors in the home were moderately damaged or deteriorated. This condition is a fire safety issue.

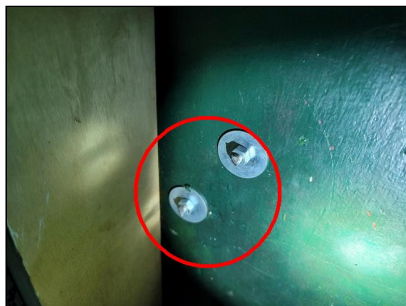
1.4 Item 4(Picture)

- 🔧 (2) The entry door did not have an operable locks and had sharp bolts sticking out. This condition is a fire hazard.

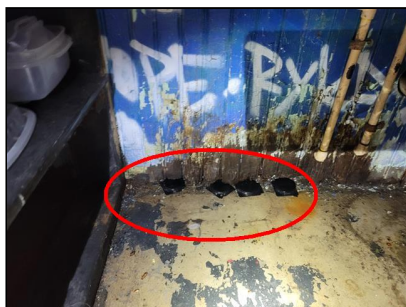
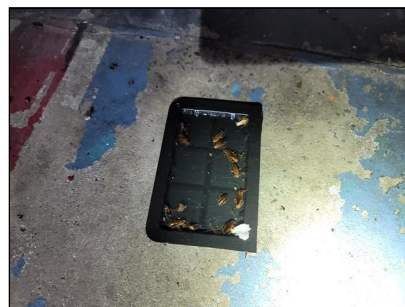
- ⚡ Signs of possible roach and pest infestation was observed and should be further evaluated and treated by a qualified pest control contractor.

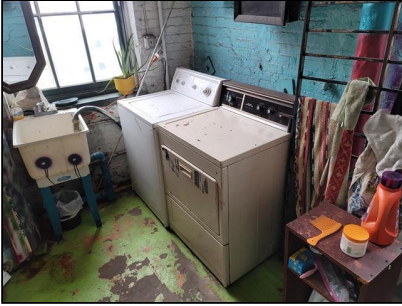
1.7 Item 1(Picture)

🔧 Laundry appliances were not functioning properly and should be repaired by a qualified technician.

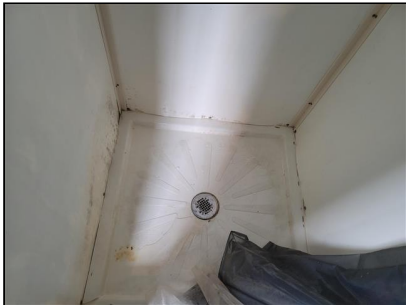
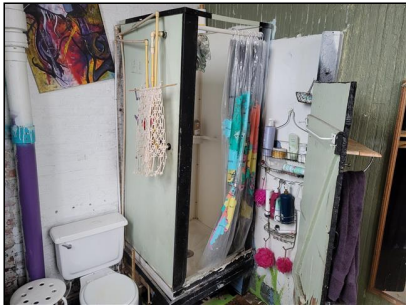
- (4) In the bathroom, the shower enclosure was old and deteriorated.

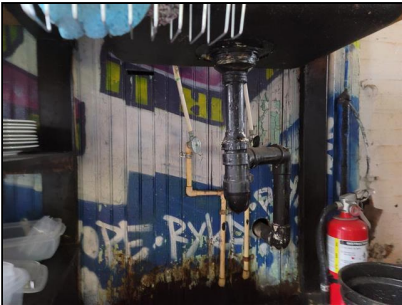
3.1 Item 1(Picture)

- ⚡ (1) Leaking connections at the trap assembly beneath the kitchen sink should be repaired to avoid future/ additional damage to the cabinet floor and possibly the wall/floor structures below. The Inspector recommends repair by a qualified plumbing contractor.

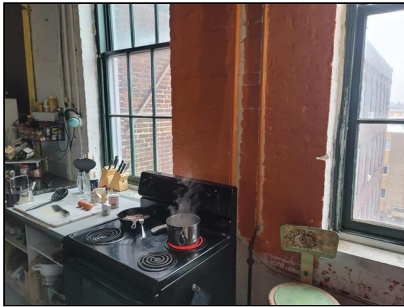
3.3 Item 1(Picture)

- 🔧 No range hood or exhaust system was installed at the time of the inspection. The Inspector recommends that an exhaust hood or air filtration system be installed to prevent possible moisture damage and grease accumulation on walls and ceiling adjacent to the range. All work should be performed by a qualified contractor.

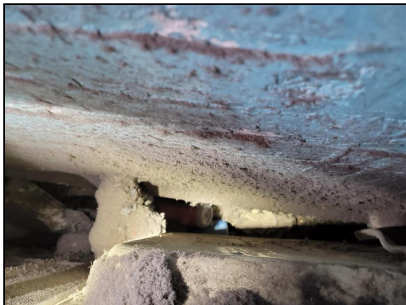
4.0 Item 1(Picture)

No vent connection was provided for the dryer. Lack of proper dryer venting to the exterior may result in excessively high humidity levels that can damage home materials or components and may encourage the growth of microbes such as mold. Lack of proper dryer venting can also result in the accumulation of lint in the home. Lint is combustible and its accumulation is a potential fire hazard and a possible health hazard from the inhalation of particulates. The Inspector recommends proper installation of an Underwriter's Laboratory (UL)-approved dryer vent for safety reasons. Dryer vents should be cleaned annually to ensure that safe conditions continue to exist. All work should be performed by a qualified contractor.

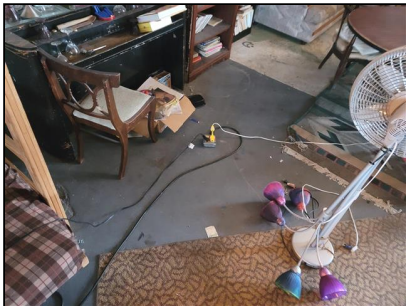
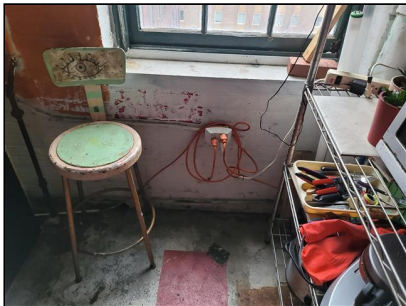
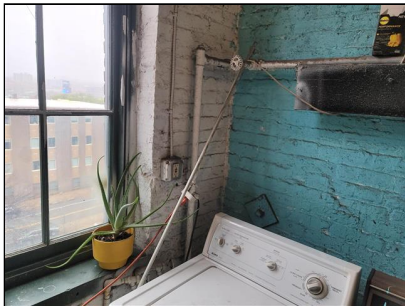
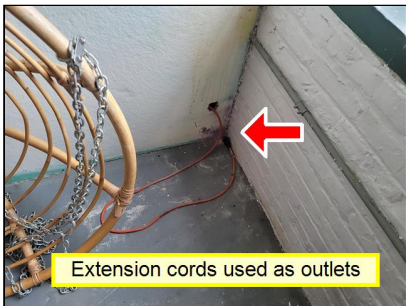
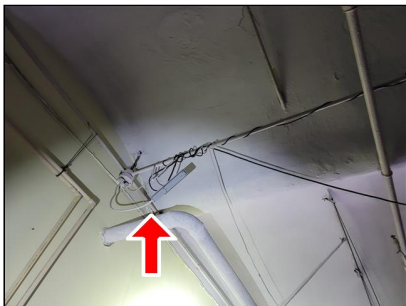
(1) The number of electrical receptacles in the home was inadequate and extension cords were used throughout the unit. This condition is potential fire hazard and should be corrected.

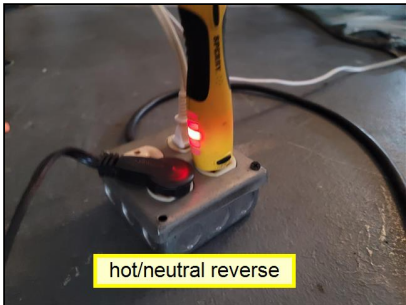
5.1 Item 6(Picture)

(2) Some electrical receptacles in this unit were improperly wired and should be corrected by a qualified electrical contractor to prevent a fire hazard.

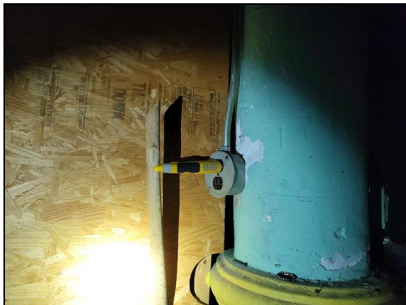
5.1 Item 7(Picture)

- 🔧 (3) Some electrical receptacles in the home were inoperable at the time of the inspection. The Inspector³⁰ recommends service by a qualified electrical contractor.

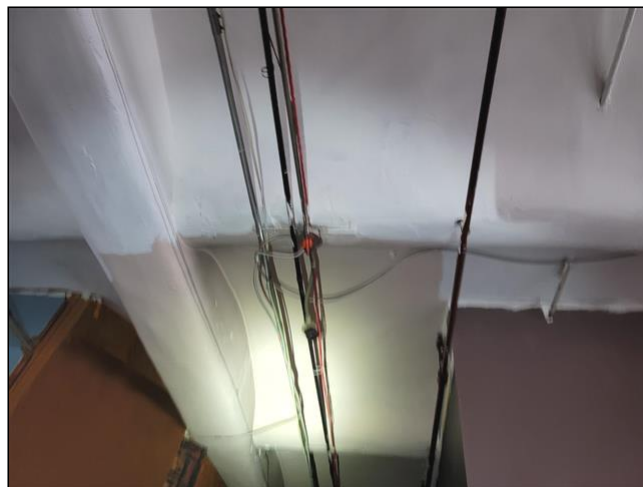
5.3 Item 4(Picture)

- 🔧 (3) Extension cords used as house wiring visible in the throughout the apartment at the time of the inspection is a potential fire hazard. The Inspector recommends removal of the extension cord and proper wiring be installed by a qualified electrical contractor.

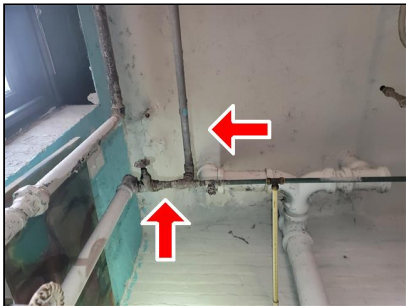
6.0 Item 1(Picture)

(1) Some of the visible water distribution pipes were galvanized steel. This pipes are old, and of a material no longer installed for this purpose due to bore shrinkage from accumulation of interior corrosion that over time reduces water flow. These pipes may need to be replaced soon.

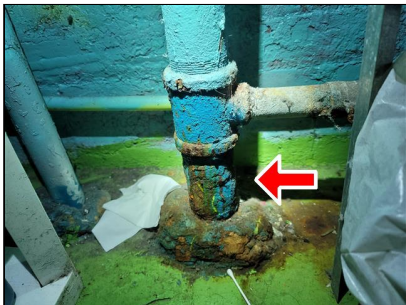
6.0 Item 3(Picture)

(2) Actively leaking, heavily-corroded water distribution pipes visible in the bathroom should be repaired by a qualified plumbing contractor to avoid damage to home materials or the development of conditions which encourage the growth of microbes such as mold.

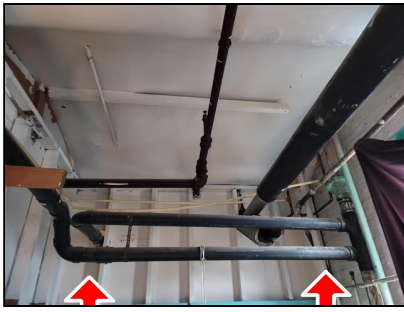
6.0 Item 4(Picture)

(3) Chlorinated Poly Vinyl Chloride (CPVC) water distribution pipes were poorly supported in the unit. This condition puts excessive strain on fittings and may result in premature failure. Horizontally-oriented CPVC distribution pipes should be supported at least every 3 feet. The Inspector recommends installation of

additional supports by a qualified contractor. Some portions of the home distribution piping will not be accessible for installation of additional supports.³⁴

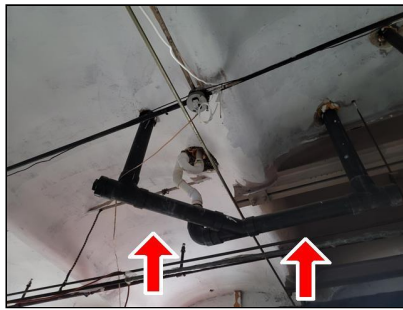
6.1 Item 2(Picture)

- ⚠ (1) Many traps were of a type called an "S-trap". S-traps are no longer allowed to be installed in new construction for safety reasons. A siphon can develop which empties the trap of water; a condition with the potential to allow toxic sewer gas to enter the living space. Although this type of trap may have been commonly considered safe at the time the home was originally constructed, as general knowledge of safe building practices has improved with the passage of time, building standards have changed to reflect current understanding. The Inspector recommends replacement of all such traps in the home by a qualified plumbing contractor.

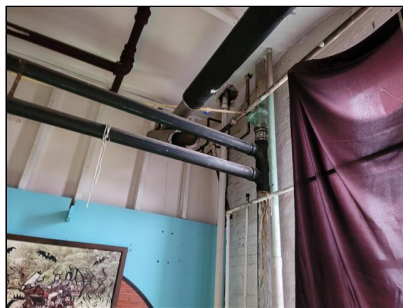
6.1 Item 4(Picture)

- ⚠ (2) Drain/waste pipes in the rear bedroom were damaged and had created unhealthy conditions at the time of the inspection. The Inspector recommends correction and disinfection by a qualified contractor.

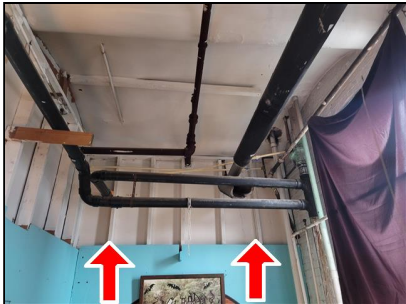
6.1 Item 6(Picture)

🔧 (3) Supports for the ABS or PVC drain/waste pipe visible in the rear bedroom were located too far apart.³⁵ The maximum support spacing recommended by generally-accepted modern plumbing standards is 4 feet. The Inspector recommends correction by a qualified contractor.

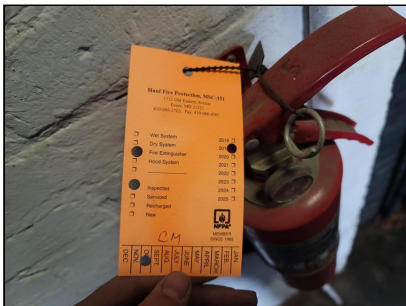
6.3 Item 1(Picture)

🔧 Some of the fire extinguishers in the common areas had expired inspections.

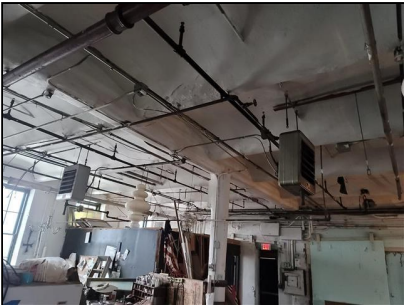
7.1 Item 1(Picture)

The apartment had no operable heat present in all the rooms. Heat was relied on old boiler distribution pipes to give off heat without radiators which was not suffice and was inoperable at the time of the inspection. Heat was not on and no controls were present. The Inspector recommends that heat be installed in each room with accessible thermostats to the occupants of the apartment by a qualified HVAC contractor or electrician. It was cold outside and in the units at the time of the inspection.

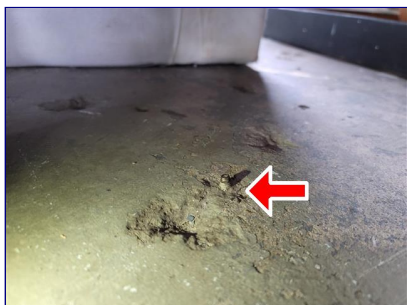
1.0 Item 1(Picture)

All floors were concrete and no flooring was installed. Many areas had metal bolts sticking out of floor which are a hazard.

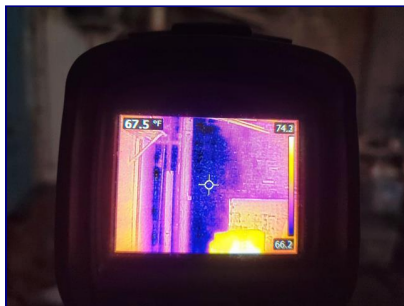
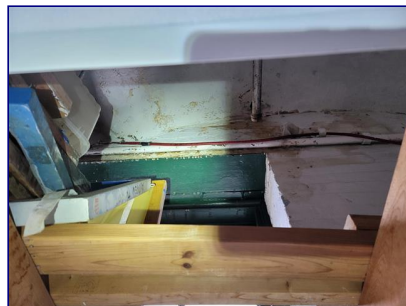
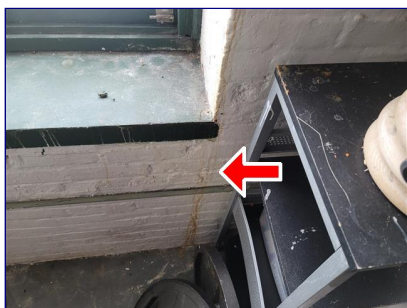
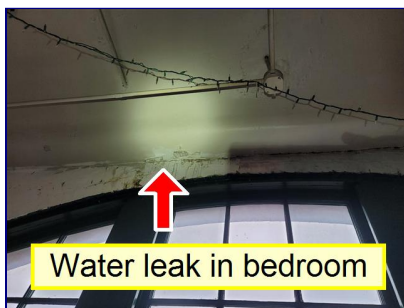
- (2) Stains on the walls in the visible in many areas at the time of the inspection appeared to be the result of moisture intrusion. The moisture meter showed elevated moisture levels in the affected areas at the time of the inspection, indicating that the leakage has been recent. The Inspector recommends consultation with a qualified contractor to discuss options and costs for correction and repair.

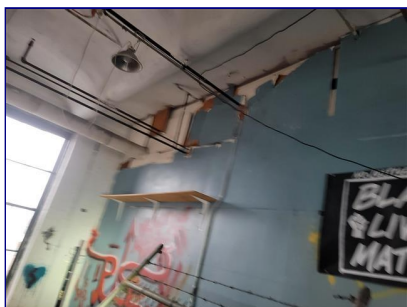
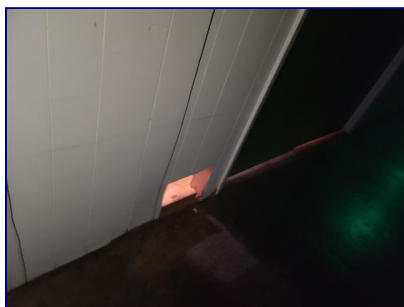
- (3) No insulation was installed in the exterior walls or ceilings. This condition will result in higher heating and cooling costs and lower comfort levels than would be the case if the walls were insulated.
- (4) Walls in the exhibited moderate damage or deterioration and were poorly installed.

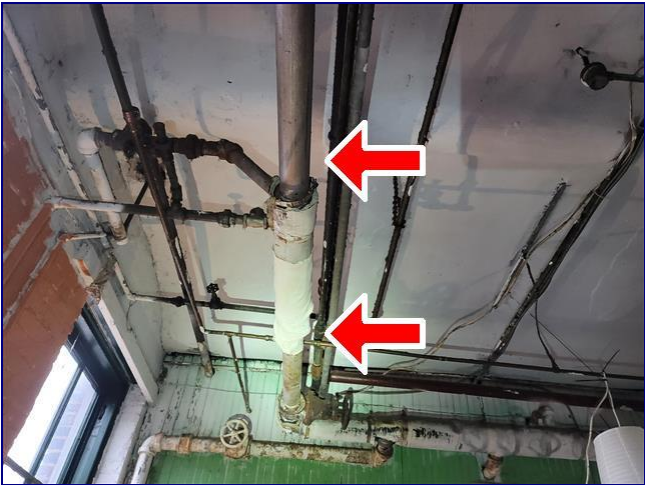
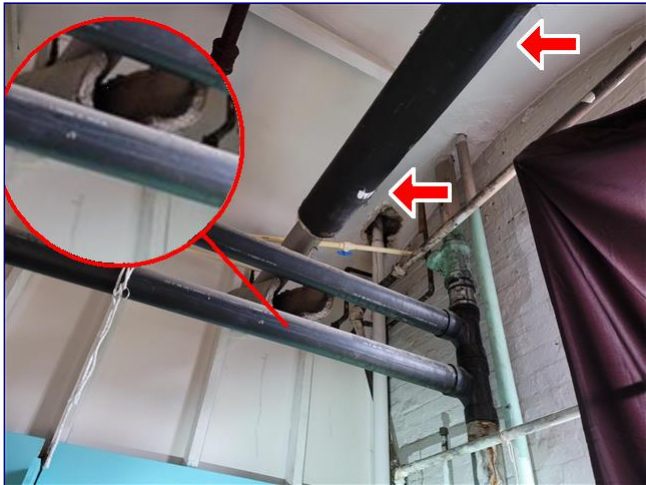
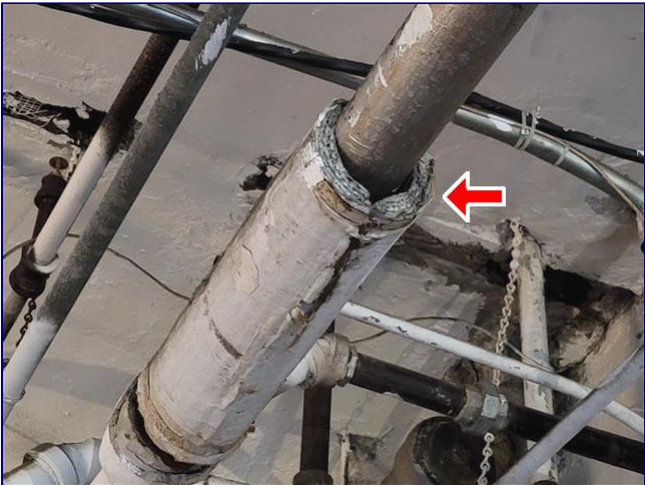
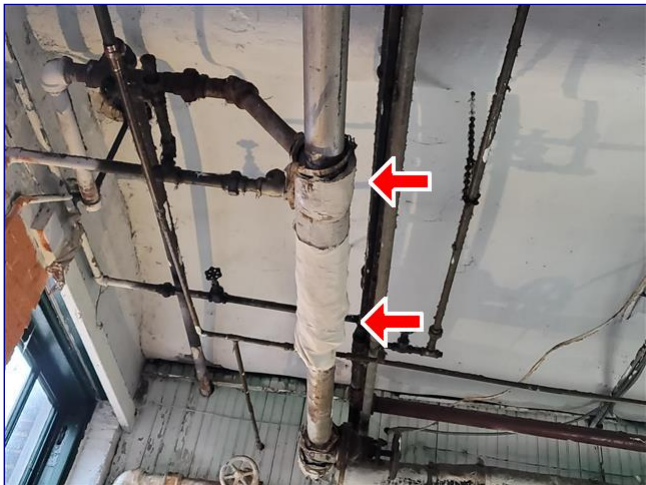
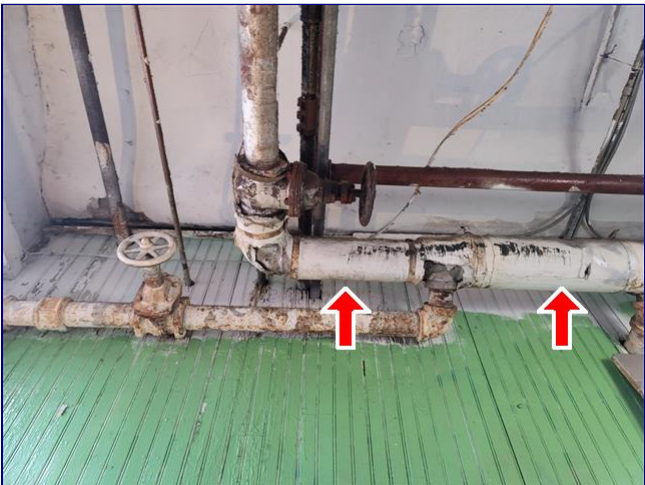
(1) Materials in the on the boiler distribution pipes throughout the home may contain asbestos. Asbestos has been classified as a known human carcinogen (a substance that causes cancer) by the U.S. Department of Health and Human Services, the EPA, and the International Agency for Research on Cancer. People who become ill from asbestos are usually those who are exposed to it on a regular basis, most often in a job where they work directly with the material or through substantial environmental contact. To cause health problems, asbestos must be in a form in which the fibers can be inhaled, such as when it is cut, torn, or sanded. The insulation on these pipes of concern had damage and deterioration that can be friable. The only way to know for certain whether asbestos is in a particular product or material is to have testing performed. A sample was taken and will be sent to a laboratory for testing.

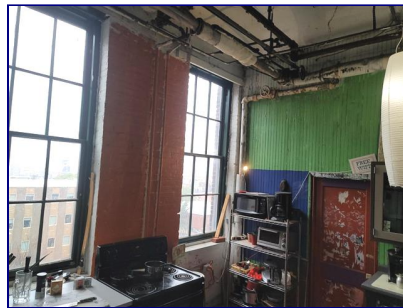
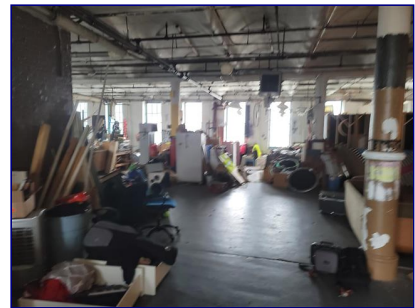
(2) Because this home was built before 1978, there is a good chance it has lead-based paint. In 1978, the federal government banned consumer uses of lead-containing paint as a potential health hazard, but some states banned it even earlier. Lead from paint, including lead-contaminated dust, is one of the most common causes of lead poisoning. Chipping, cracking, flaking and deteriorated paint was observed widespread throughout the building. All painted surfaces in the building should be repainted and repaired by a lead abatement contractor.

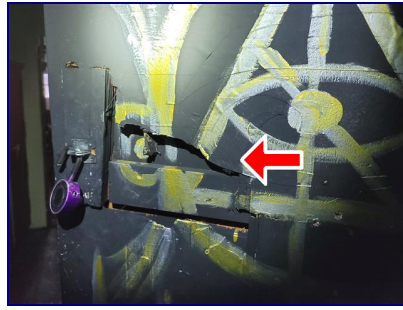
1.4 Item 2(Picture)

(1) Interior doors in the home were moderately damaged or deteriorated. This condition is a fire safety issue.

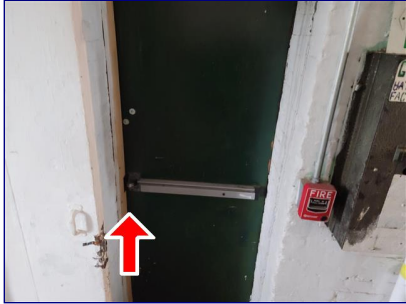
1.4 Item 3(Picture)

(2) The entry door did not have an operable locks and had sharp bolts sticking out. This condition is a fire hazard.

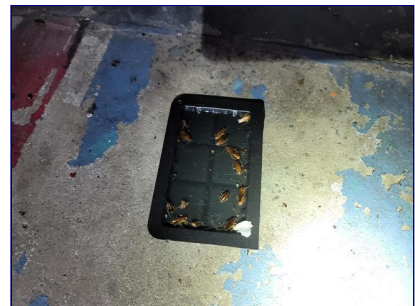
Signs of possible roach and pest infestation was observed and should be further evaluated and treated by a qualified pest control contractor.

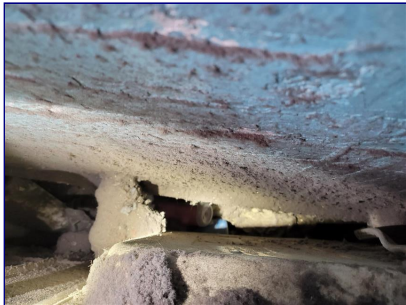
4.0 Item 1(Picture)

No vent connection was provided for the dryer. Lack of proper dryer venting to the exterior may result in excessively high humidity levels that can damage home materials or components and may encourage the growth of microbes such as mold. Lack of proper dryer venting can also result in the accumulation of lint in the home. Lint is combustible and its accumulation is a potential fire hazard and a possible health hazard from the inhalation of particulates. The Inspector recommends proper installation of an Underwriter's Laboratory (UL)-approved dryer vent for safety reasons. Dryer vents should be cleaned annually to ensure that safe conditions continue to exist. All work should be performed by a qualified contractor.

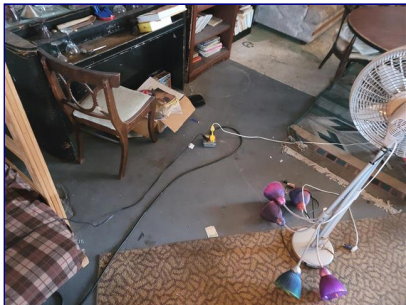
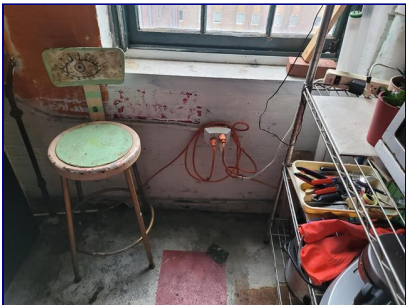
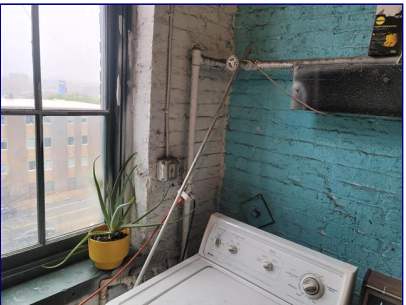
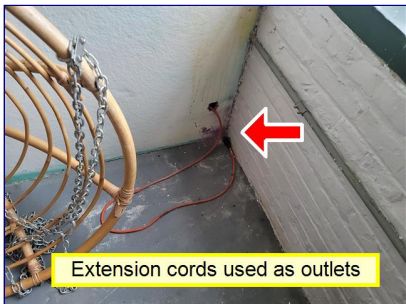
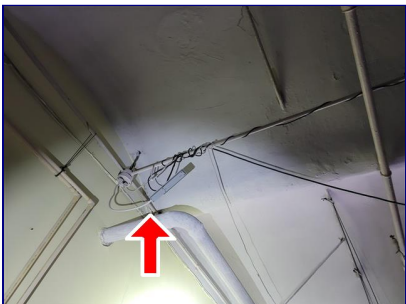
(1) The number of electrical receptacles in the home was inadequate and extension cords were used throughout the unit. This condition is potential fire hazard and should be corrected.

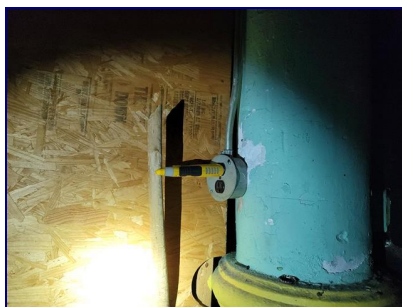
5.1 Item 7(Picture)

(2) Some electrical receptacles in this unit were improperly wired and should be corrected by a⁴⁸ qualified electrical contractor to prevent a fire hazard.

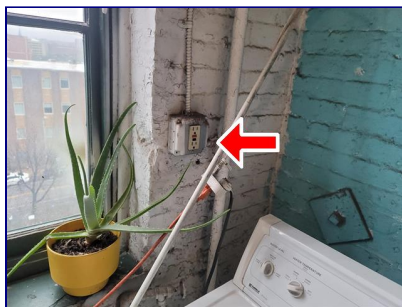
5.1 Item 9(Picture)

(3) Some electrical receptacles in the home were inoperable at the time of the inspection. The Inspector recommends service by a qualified electrical contractor.

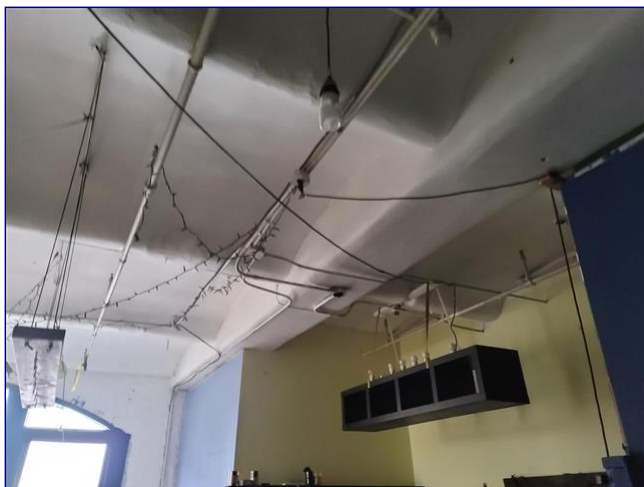
5.2 Item 1(Picture)

This unit did not have operable and enough light fixtures. Extension cords with lighting and string lights were used. This condition is a potential fire hazard.

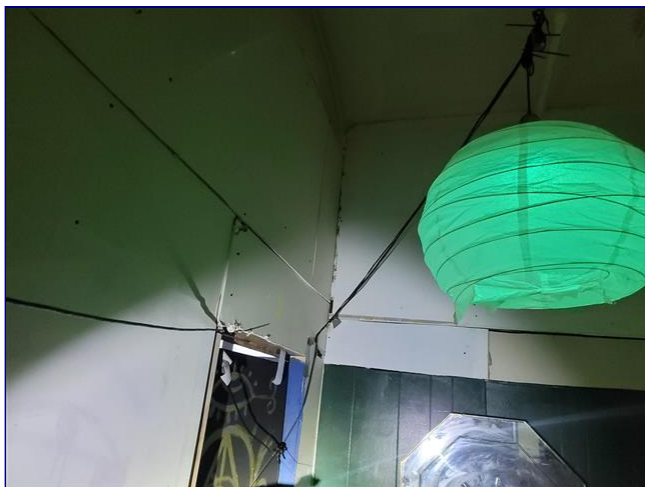
5.3 Item 1(Picture)

(1) One or more junction boxes were missing covers and energized electrical components were exposed to touch. This condition is an electrical shock/electrocution hazard.

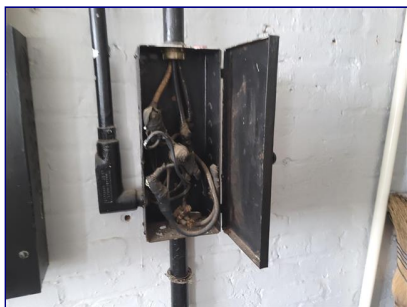
5.3 Item 2(Picture)

(2) Some of the electrical junction boxes had open wires and should be secured close to prevent electrical shock.

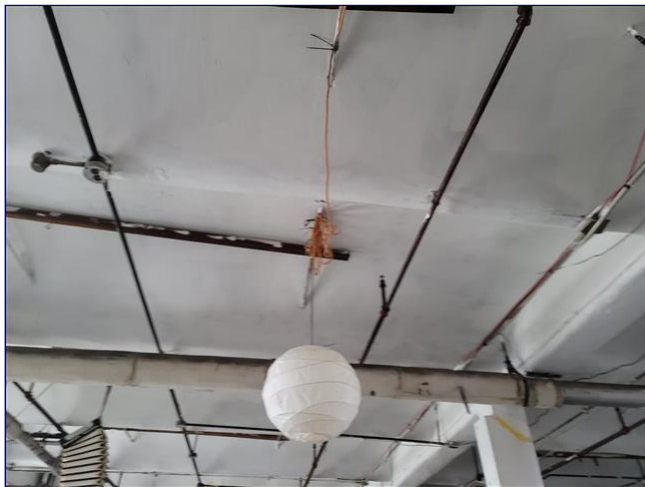
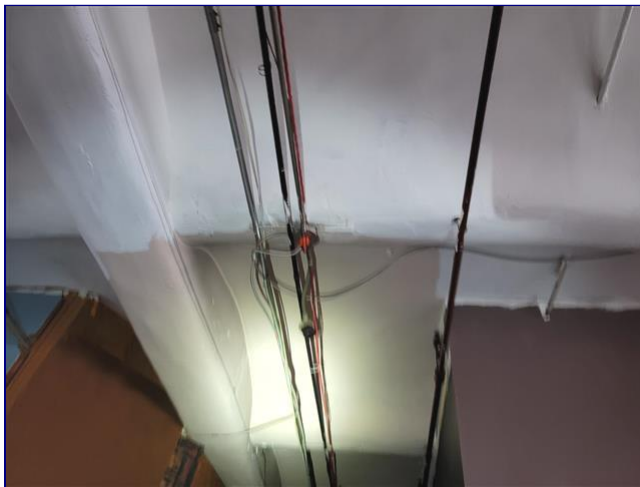
(3) Extension cords used as house wiring visible in the throughout the apartment at the time of the inspection is a potential fire hazard. The Inspector recommends removal of the extension cord and proper wiring be installed by a qualified electrical contractor.

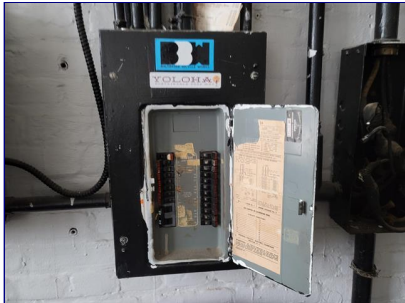
5.5 Item 1(Picture)

This sub-panel was made by Federal Pacific and was the Stab-lok model. Federal Pacific Stab-lok model sub-panels are reputed to have a high rate of circuit breaker failure which can result in a fire or shock/electrocution. One of the breakers was damaged and sparks when turned on. The Inspector recommends that you consult with a qualified electrical contractor concerning for replacing this sub-panel. Information about defective Federal Pacific Stab-lok panels is widely available on the internet.

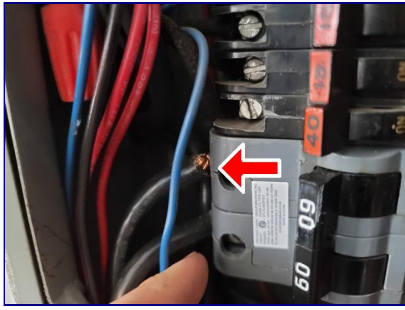
5.6 Item 1(Picture)

Strands from the service entrance wires were cut and may cause the the wires to overheat. The Inspector recommends evaluation and repair as necessary by a qualified licensed electrician.

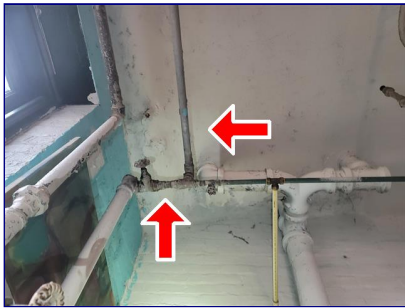
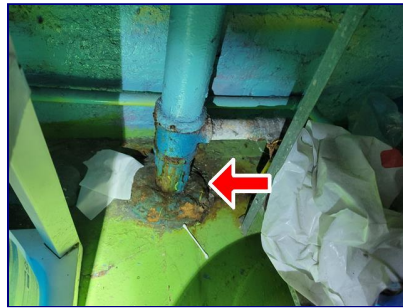
(1) Some of the visible water distribution pipes were galvanized steel. These pipes are old, and of a material no longer installed for this purpose due to bore shrinkage from accumulation of interior corrosion that over time reduces water flow. These pipes may need to be replaced soon.

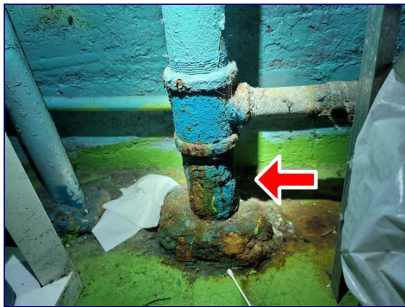
6.0 Item 3(Picture)

(2) Actively leaking, heavily-corroded water distribution pipes visible in the bathroom should be repaired by a qualified plumbing contractor to avoid damage to home materials or the development of conditions which encourage the growth of microbes such as mold.

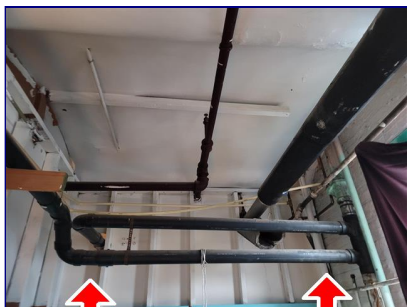
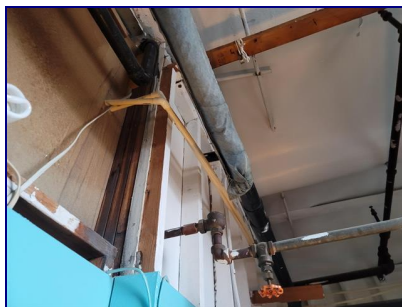
(3) Chlorinated Poly Vinyl Chloride (CPVC) water distribution pipes were poorly supported in the unit. This condition puts excessive strain on fittings and may result in premature failure. Horizontally-oriented CPVC distribution pipes should be supported at least every 3 feet. The Inspector recommends installation of additional supports by a qualified contractor. Some portions of the home distribution piping will not be accessible for installation of additional supports.

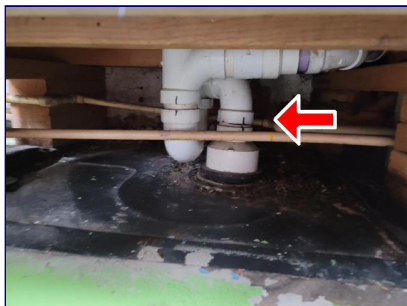
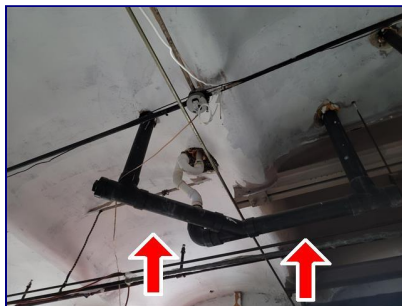
(1) Many traps were of a type called an "S-trap". S-traps are no longer allowed to be installed in new construction for safety reasons. A siphon can develop which empties the trap of water; a condition with the potential to allow toxic sewer gas to enter the living space. Although this type of trap may have been commonly considered safe at the time the home was originally constructed, as general knowledge of safe building practices has improved with the passage of time, building standards have changed to reflect current understanding. The Inspector recommends replacement of all such traps in the home by a qualified plumbing contractor.

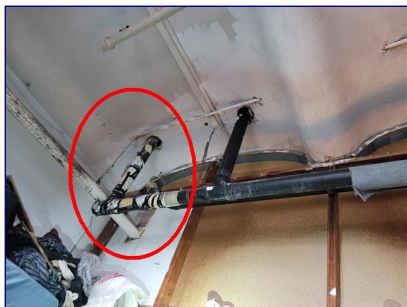
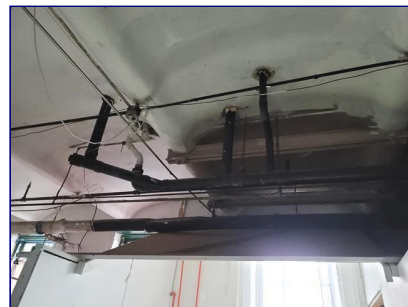
(2) Drain/waste pipes in the rear bedroom were damaged and had created unhealthy conditions at the time of the inspection. The Inspector recommends correction and disinfection by a qualified contractor.

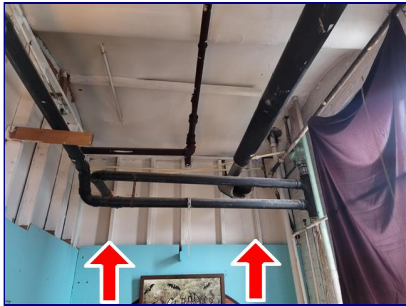
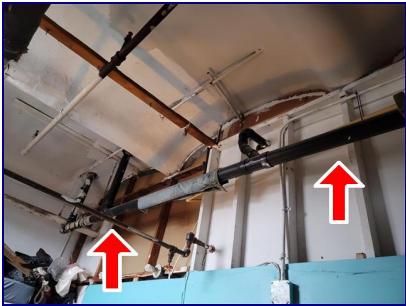
(3) Supports for the ABS or PVC drain/waste pipe visible in the rear bedroom were located too far apart. The maximum support spacing recommended by generally-accepted modern plumbing standards is 4 feet. The Inspector recommends correction by a qualified contractor.

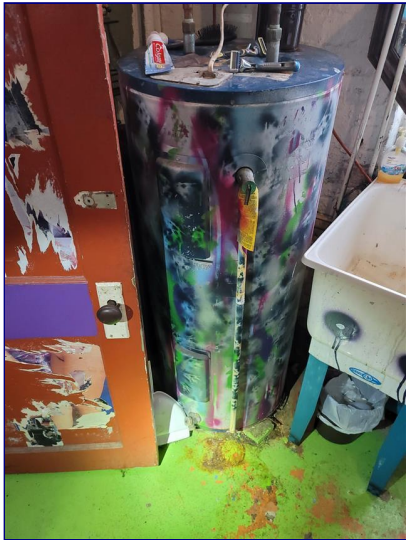
6.2 Item 1(Picture)

The pressure relief valve was leaking at the time of the inspection. Because the TPR valve is an important safety component it should be replaced by a qualified HVAC technician or plumbing contractor.

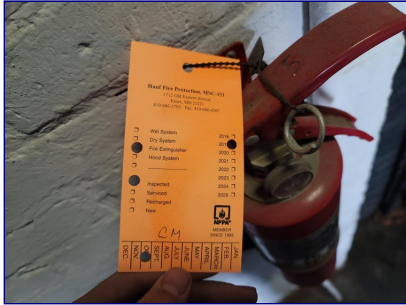
6.3 Item 1(Picture)

Some of the fire extinguishers in the common areas had expired inspections.

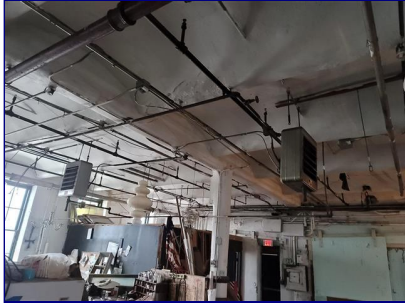
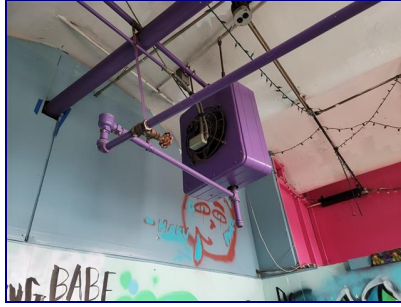
The apartment had no operable heat present in all the rooms. Heat was relied on old boiler distribution pipes to give off heat without radiators which was not suffice and was inoperable at the time of the inspection. Heat was not on and no controls were present. The Inspector recommends that heat be installed in each room with accessible thermostats to the occupants of the apartment by a qualified HVAC contractor or electrician. It was cold outside and in the units at the time of the inspection.
