## Testimony of Indigo Null

### HB0036 – Real Property – Actions to Repossess – Proof of Rental Licensure

## Inspection Report

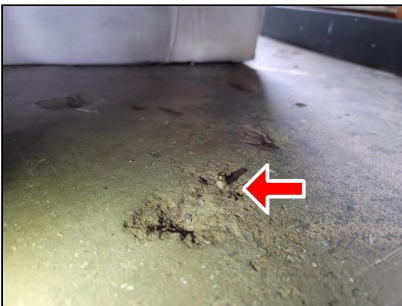
1.0 Item 1(Picture)

- 🔧 All floors were concrete and no flooring was installed. Many areas had metal bolts sticking out of floor which are a hazard.

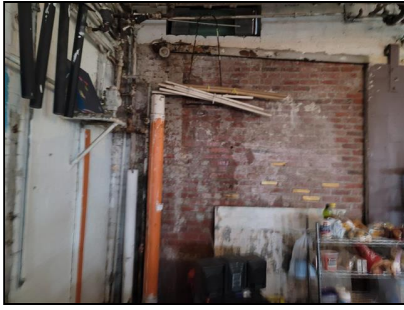
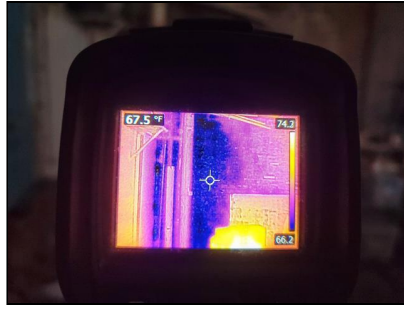
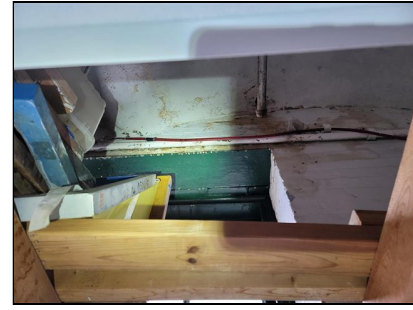
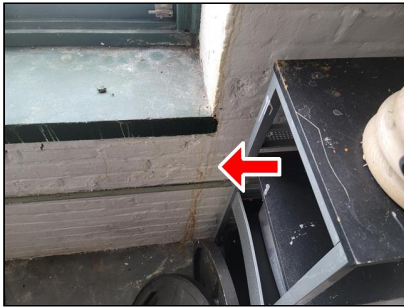
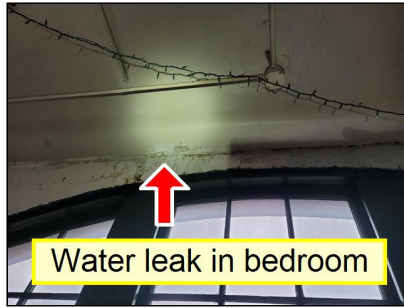
17  
🔧 (2) Stains on the walls in the visible in many areas at the time of the inspection appeared to be the result of moisture intrusion. The moisture meter showed elevated moisture levels in the affected areas at the time of the inspection, indicating that the leakage has been recent. The Inspector recommends consultation with a qualified contractor to discuss options and costs for correction and repair.

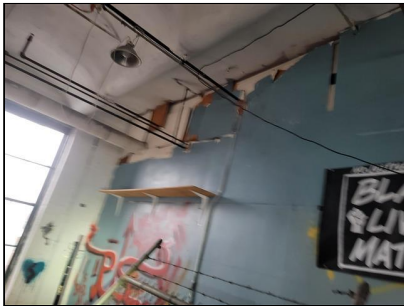
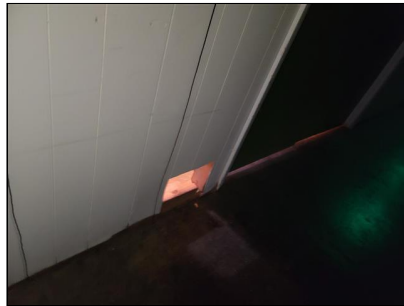
🔧 (4) Walls in the exhibited moderate damage or deterioration and were poorly installed.

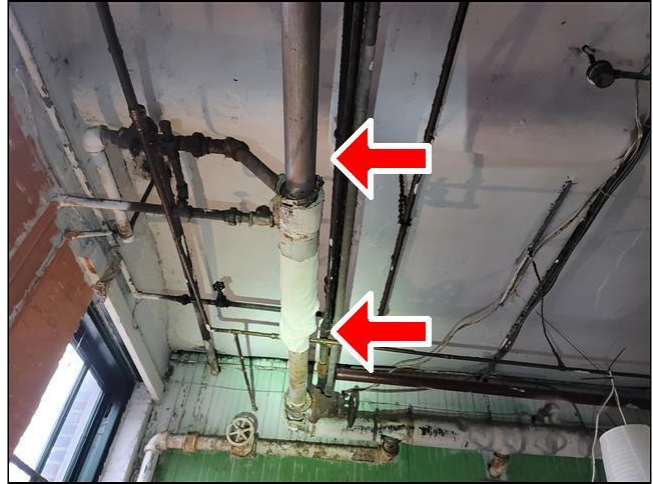
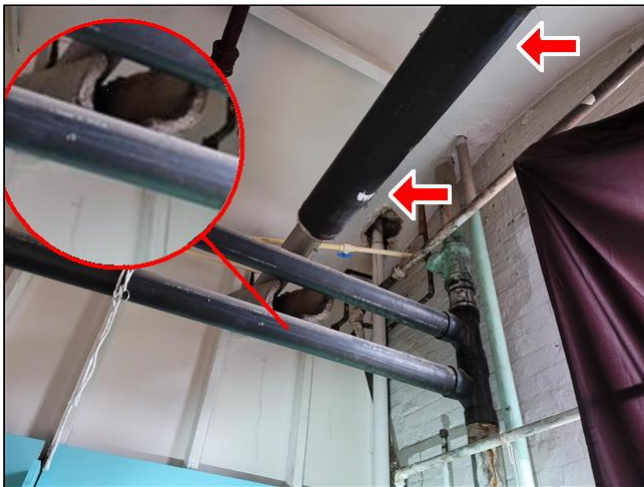
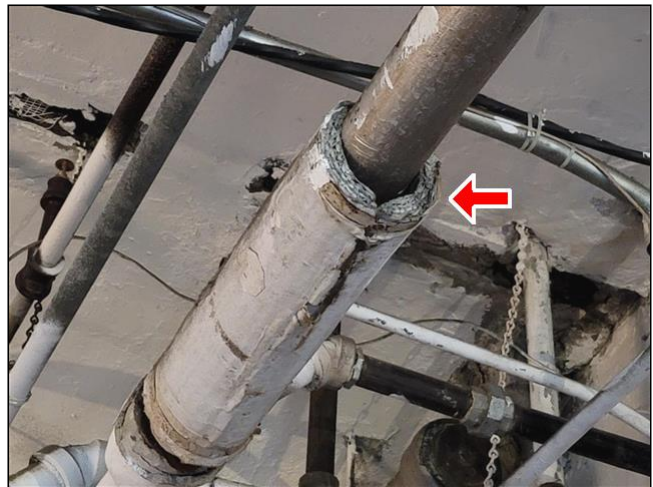
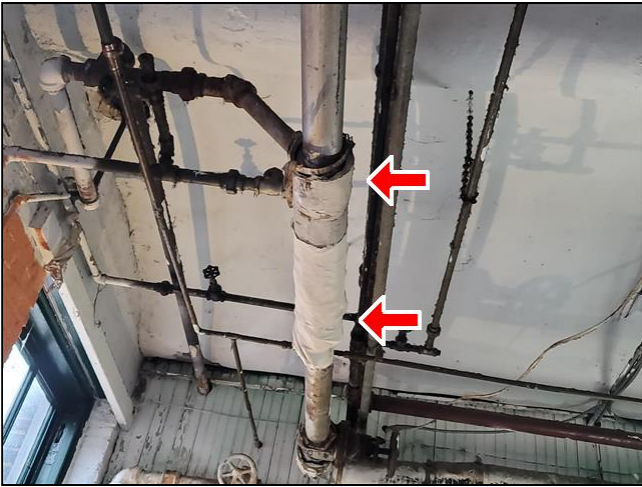
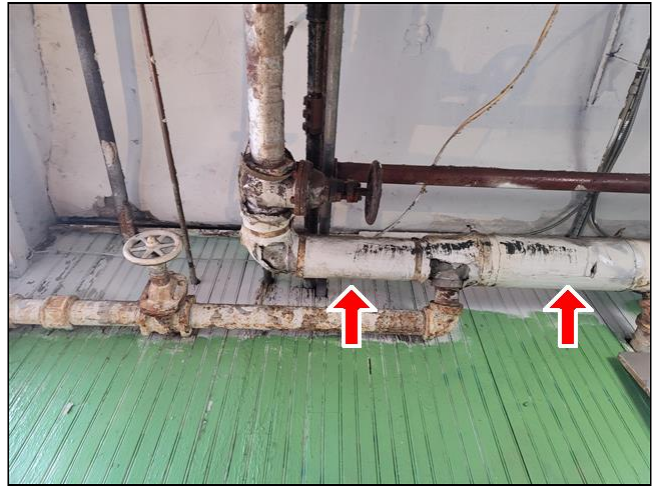
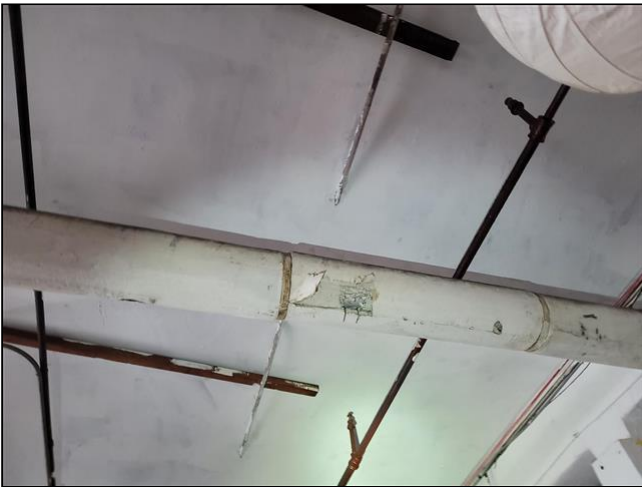
(1) Materials in the on the boiler distribution pipes throughout the home may contain asbestos. Asbestos has been classified as a known human carcinogen (a substance that causes cancer) by the U.S. Department of Health and Human Services, the EPA, and the International Agency for Research on Cancer. People who become ill from asbestos are usually those who are exposed to it on a regular basis, most often in a job where they work directly with the material or through substantial environmental contact. To cause health problems, asbestos must be in a form in which the fibers can be inhaled, such as when it is cut, torn, or sanded. The insulation on these pipes of concern had damage and deterioration that can be friable. The only way to know for certain whether asbestos is in a particular product or material is to have testing performed. A sample was taken and will be sent to a laboratory for testing.

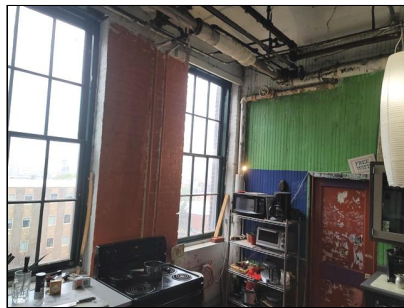
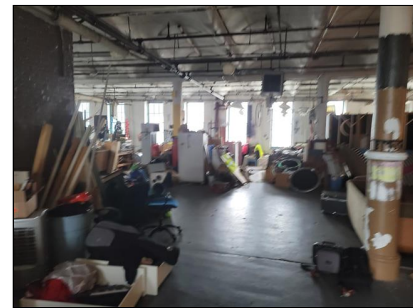
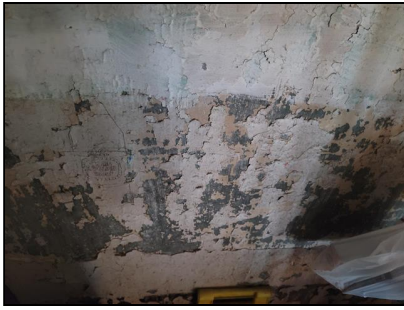
(2) Because this home was built before 1978, there is a good chance it has lead-based paint. In 1978, the federal government banned consumer uses of lead-containing paint as a potential health hazard, but some states banned it even earlier. Lead from paint, including lead-contaminated dust, is one of the most common causes of lead poisoning. Chipping, cracking, flaking and deteriorated paint was observed widespread throughout the building. All painted surfaces in the building should be repainted and repaired by a lead abatement contractor.

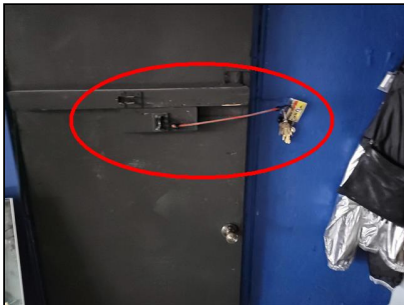
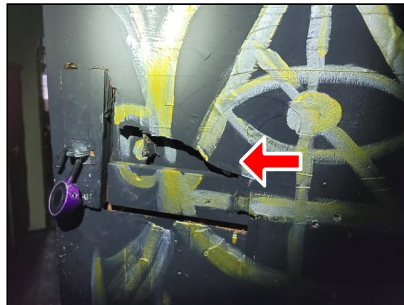
🔧 (1) Interior doors in the home were moderately damaged or deteriorated. This condition is a fire safety issue.

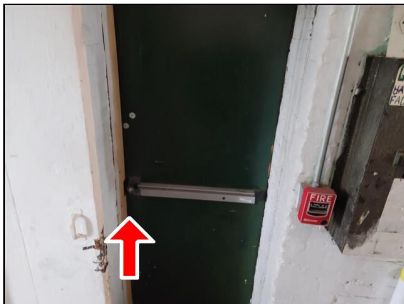
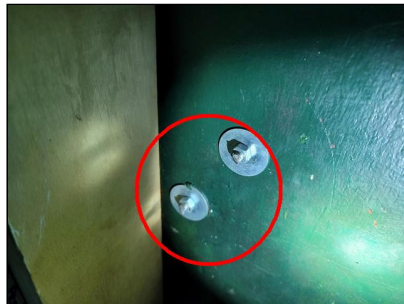
🔧 (2) The entry door did not have an operable locks and had sharp bolts sticking out. This condition is a fire hazard.

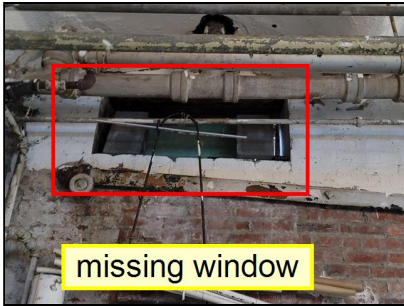
1.5 Item 2(Picture)

- (2) The lower sash of many of the windows in the unit would not stay up when lifted and released, and fell with enough force to cause significant injury. The Inspector recommends replacement by a qualified contractor.
- (3) Windows in the home were generally old, deteriorated, had chipping paint and were inoperable. The Inspector recommends window replacement.
- (4) A window in the common area was boarded up with loose wood and cinder blocks allowing moisture and air leakage into the building.

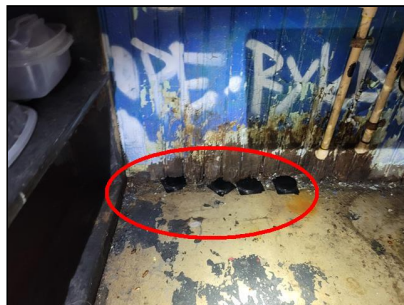
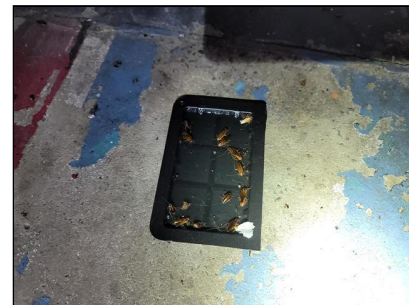
- Signs of possible roach and pest infestation was observed and should be further evaluated and treated by a qualified pest control contractor.

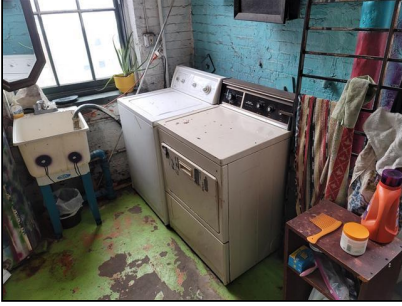
1.7 Item 1(Picture)

🔧 Laundry appliances were not functioning properly and should be repaired by a qualified technician.

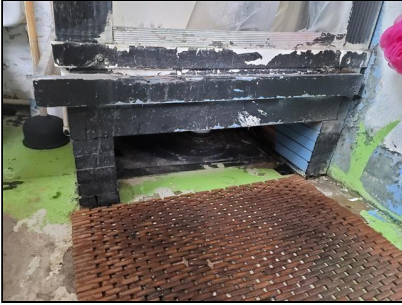
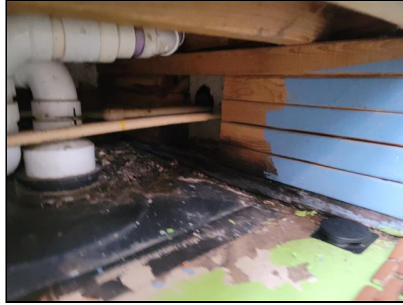
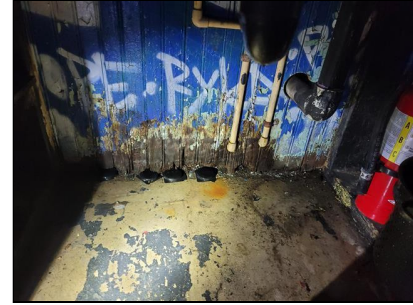
- ⚠ (2) Water flow at the shower in the entry bathroom appeared to be inadequate. The Inspector recommends that you have this condition evaluated by a qualified plumbing contractor to determine the potential need and costs for correction.
- ⚠ (3) Fungi growth was observed below the shower pan due to water entering from behind the shower walls. The Inspector recommends installing a new shower enclosure to prevent water leakage and mold growth. The mold growth should be remediated by a qualified professional.

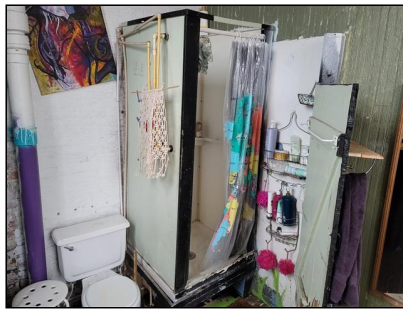
2.4 Item 6(Picture)

- ⚠ (4) In the bathroom, the shower enclosure was old and deteriorated.

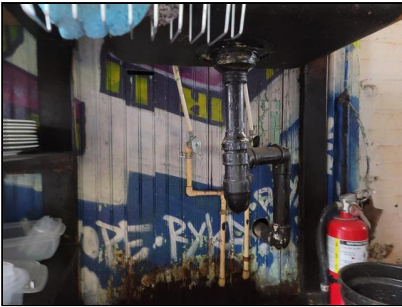
3.1 Item 1(Picture)

- ⚡ (1) Leaking connections at the trap assembly beneath the kitchen sink should be repaired to avoid future/additional damage to the cabinet floor and possibly the wall/floor structures below. The Inspector recommends repair by a qualified plumbing contractor.

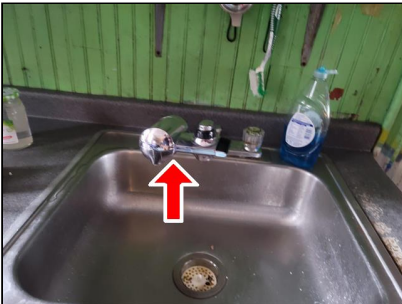
3.1 Item 2(Picture)

- ⚡ (2) The kitchen sink faucet leaks when turned off.

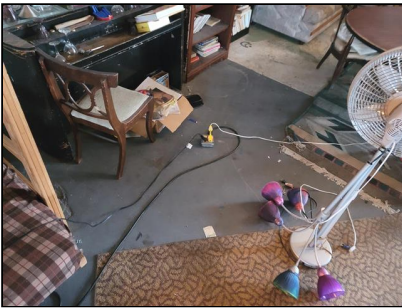
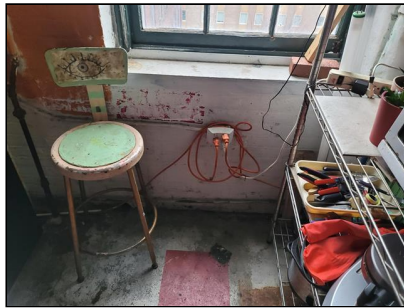
- ⚡ (1) The number of electrical receptacles in the home was inadequate and extension cords were used throughout the unit. This condition is potential fire hazard and should be corrected.

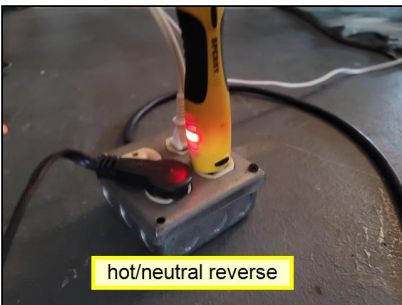
5.1 Item 6(Picture)

- ⚡ (2) Some electrical receptacles in this unit were improperly wired and should be corrected by a qualified electrical contractor to prevent a fire hazard.

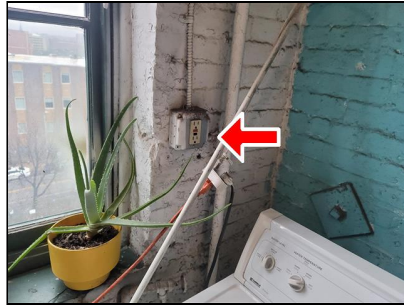
5.1 Item 9(Picture)

🔧 (3) Some electrical receptacles in the home were inoperable at the time of the inspection. The Inspector<sup>30</sup> recommends service by a qualified electrical contractor.

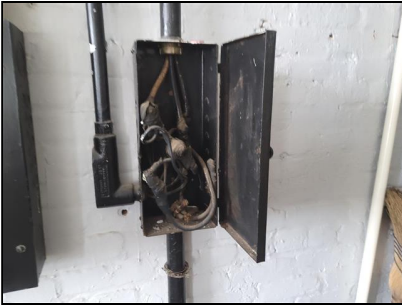
5.3 Item 2(Picture)

🔧 (2) Some of the electrical junction boxes had open wires and should be secured close to prevent electrical shock.<sup>31</sup>

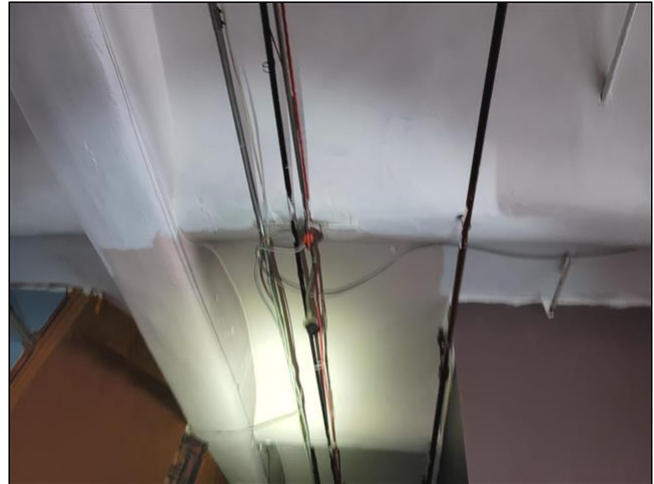
5.3 Item 4(Picture)

🔧 (3) Extension cords used as house wiring visible in the throughout the apartment at the time of the inspection is a potential fire hazard. The Inspector recommends removal of the extension cord and proper wiring be installed by a qualified electrical contractor.

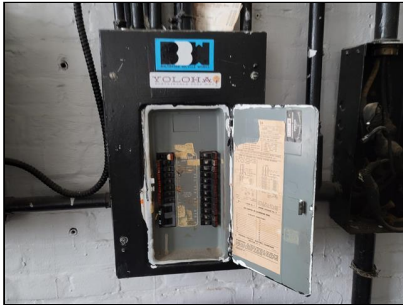
5.5 Item 1(Picture)

This sub-panel was made by Federal Pacific and was the Stab-lok model. Federal Pacific Stab-lok model sub-panels are reputed to have a high rate of circuit breaker failure which can result in a fire or shock/electrocution. One of the breakers was damaged and sparks when turned on. The Inspector recommends that you consult with a qualified electrical contractor concerning for replacing this sub-panel. Information about defective Federal Pacific Stab-lok panels is widely available on the internet.

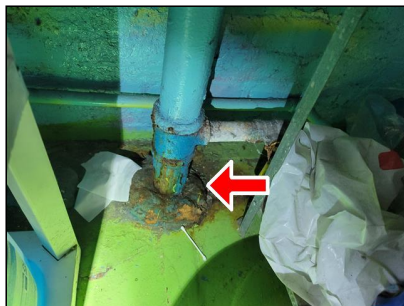
6.0 Item 2(Picture)

- (1) Some of the visible water distribution pipes were galvanized steel. This pipes are old, and of a material no longer installed for this purpose due to bore shrinkage from accumulation of interior corrosion that over time reduces water flow. These pipes may need to be replaced soon.

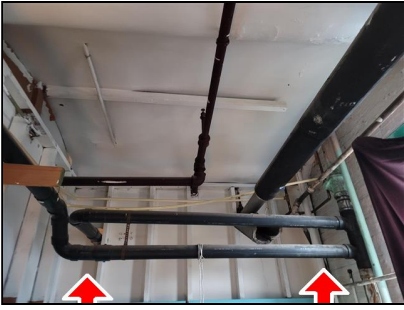
6.0 Item 4(Picture)

- (3) Chlorinated Poly Vinyl Chloride (CPVC) water distribution pipes were poorly supported in the unit. This condition puts excessive strain on fittings and may result in premature failure. Horizontally-oriented CPVC distribution pipes should be supported at least every 3 feet. The Inspector recommends installation of

additional supports by a qualified contractor. Some portions of the home distribution piping will not be accessible for installation of additional supports.<sup>34</sup>

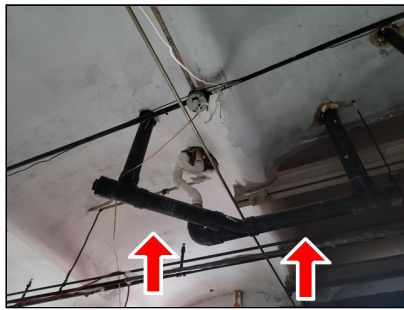
6.1 Item 2(Picture)

(1) Many traps were of a type called an "S-trap". S-traps are no longer allowed to be installed in new construction for safety reasons. A siphon can develop which empties the trap of water; a condition with the potential to allow toxic sewer gas to enter the living space. Although this type of trap may have been commonly considered safe at the time the home was originally constructed, as general knowledge of safe building practices has improved with the passage of time, building standards have changed to reflect current understanding. The Inspector recommends replacement of all such traps in the home by a qualified plumbing contractor.

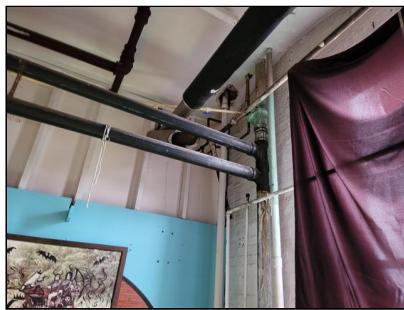
6.1 Item 4(Picture)

(2) Drain/waste pipes in the rear bedroom were damaged and had created unhealthy conditions at the time of the inspection. The Inspector recommends correction and disinfection by a qualified contractor.

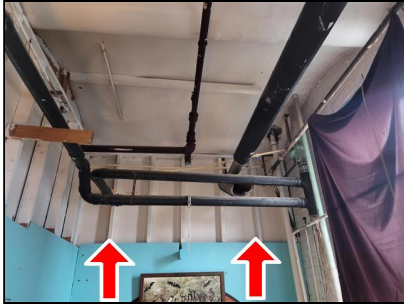
6.1 Item 6(Picture)

⚡ (3) Supports for the ABS or PVC drain/waste pipe visible in the rear bedroom were located too far apart. The maximum support spacing recommended by generally-accepted modern plumbing standards is 4 feet. The Inspector recommends correction by a qualified contractor.

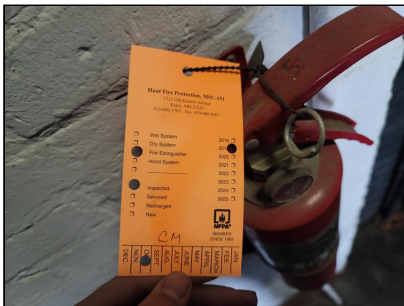
6.3 Item 1(Picture)

⚡ Some of the fire extinguishers in the common areas had expired inspections.

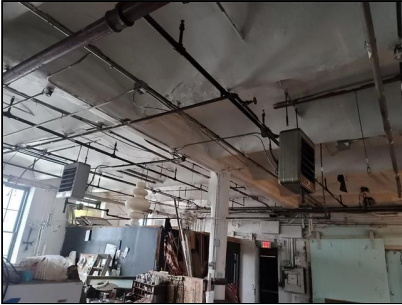
7.1 Item 1(Picture)

The apartment had no operable heat present in all the rooms. Heat was relied on old boiler distribution pipes to give off heat without radiators which was not suffice and was inoperable at the time of the inspection. Heat was not on and no controls were present. The Inspector recommends that heat be installed in each room with accessible thermostats to the occupants of the apartment by a qualified HVAC contractor or electrician. It was cold outside and in the units at the time of the inspection.

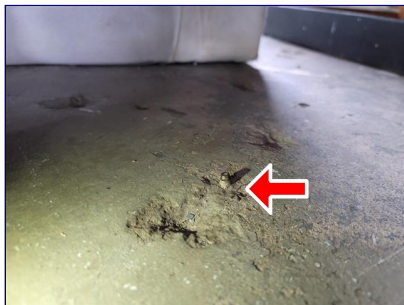
1.0 Item 1(Picture)

All floors were concrete and no flooring was installed. Many areas had metal bolts sticking out of floor which are a hazard.

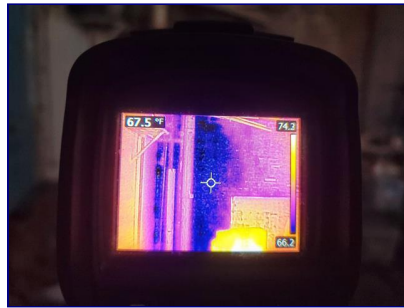
1.1 Item 3(Picture)

(2) Stains on the walls in the visible in many areas at the time of the inspection appeared to be the result of moisture intrusion. The moisture meter showed elevated moisture levels in the affected areas at the time of the inspection, indicating that the leakage has been recent. The Inspector recommends consultation with a qualified contractor to discuss options and costs for correction and repair.

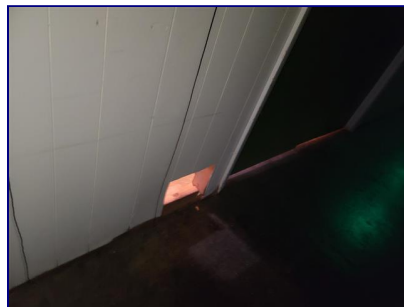
1.1 Item 8(Picture)

(4) Walls in the exhibited moderate damage or deterioration and were poorly installed.

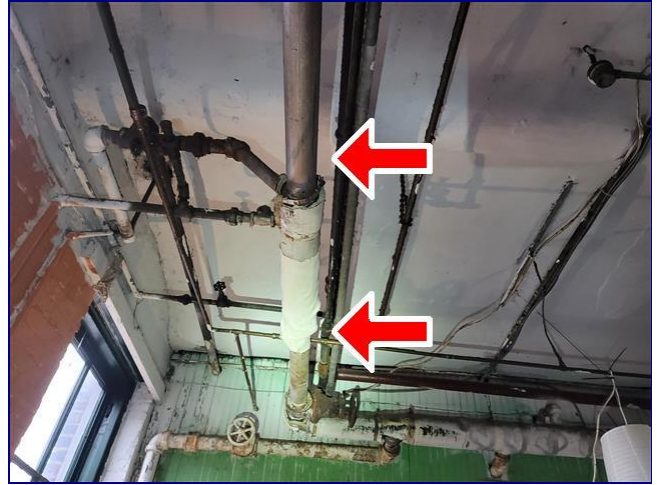
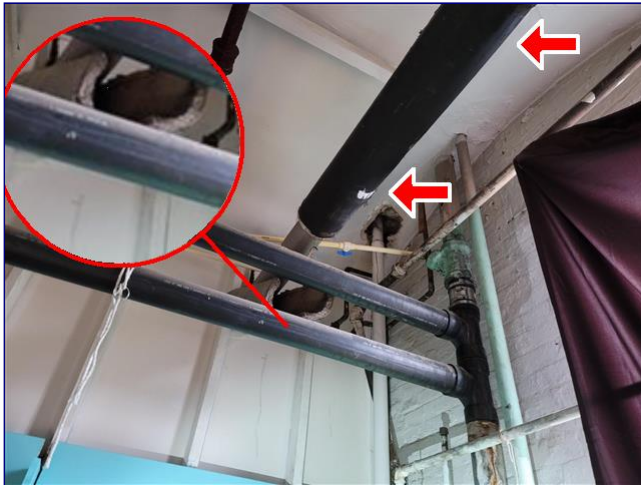
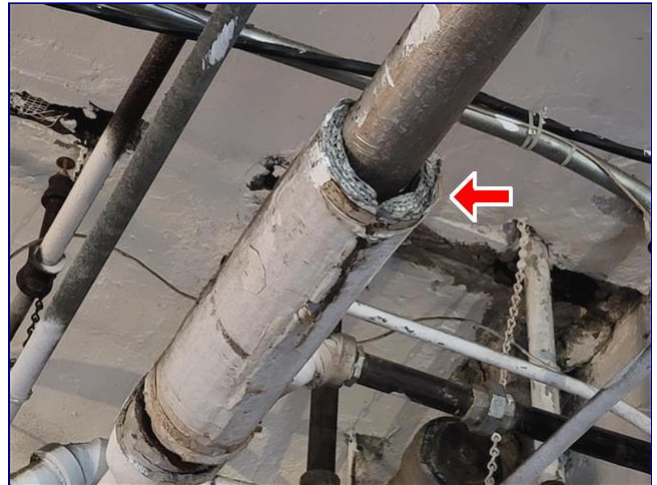
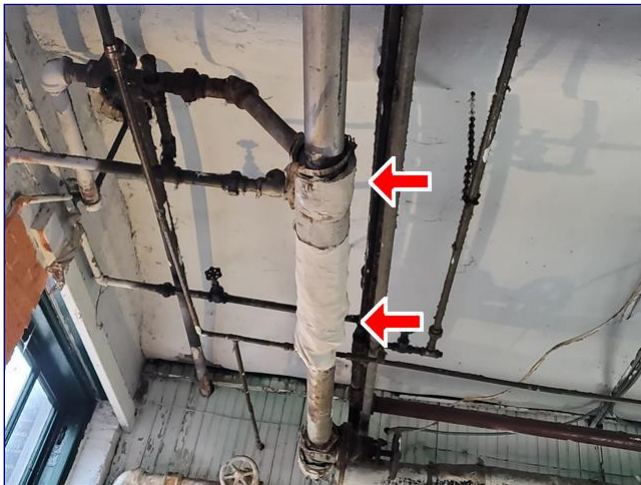
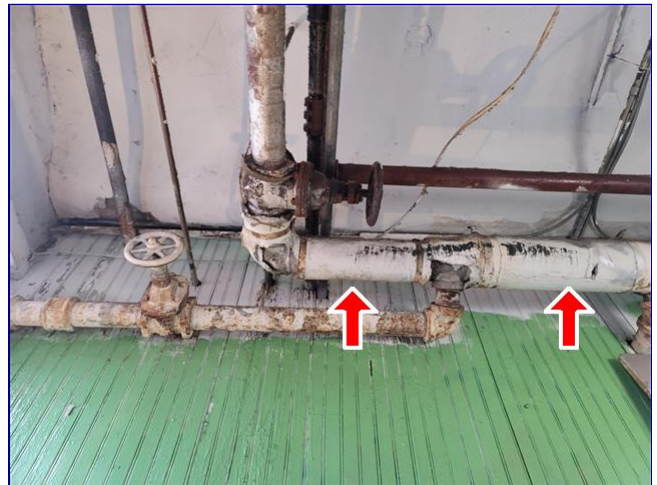
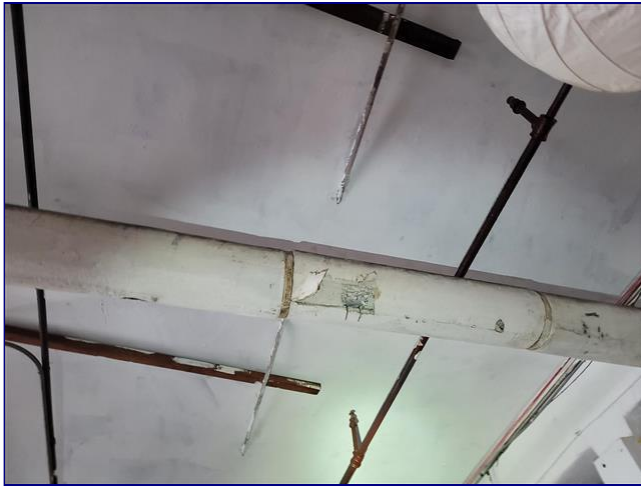
(1) Materials in the on the boiler distribution pipes throughout the home may contain asbestos. Asbestos has been classified as a known human carcinogen (a substance that causes cancer) by the U.S. Department of Health and Human Services, the EPA, and the International Agency for Research on Cancer. People who become ill from asbestos are usually those who are exposed to it on a regular basis, most often in a job where they work directly with the material or through substantial environmental contact. To cause health problems, asbestos must be in a form in which the fibers can be inhaled, such as when it is cut, torn, or sanded. The insulation on these pipes of concern had damage and deterioration that can be friable. The only way to know for certain whether asbestos is in a particular product or material is to have testing performed. A sample was taken and will be sent to a laboratory for testing.

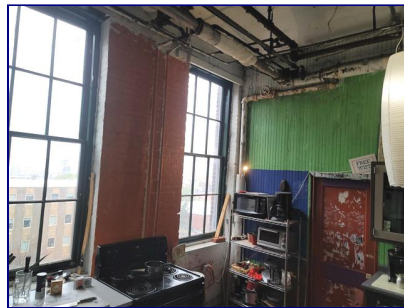
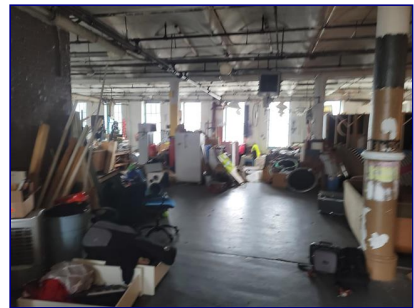
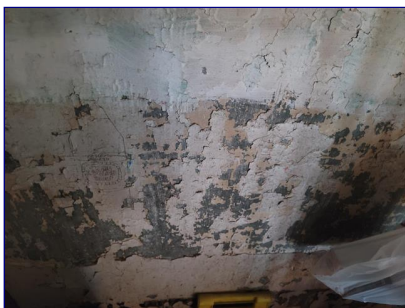
(2) Because this home was built before 1978, there is a good chance it has lead-based paint. In 1978, the federal government banned consumer uses of lead-containing paint as a potential health hazard, but some states banned it even earlier. Lead from paint, including lead-contaminated dust, is one of the most common causes of lead poisoning. Chipping, cracking, flaking and deteriorated paint was observed widespread throughout the building. All painted surfaces in the building should be repainted and repaired by a lead abatement contractor.

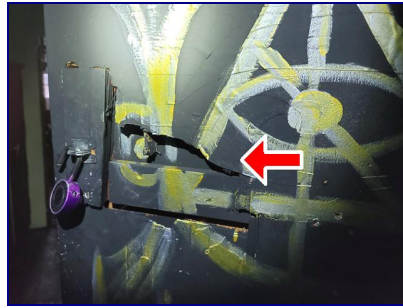
1.4 Item 2(Picture)

(1) Interior doors in the home were moderately damaged or deteriorated. This condition is a fire safety issue.

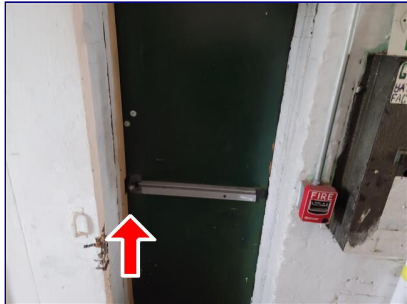
1.4 Item 3(Picture)

(2) The entry door did not have an operable locks and had sharp bolts sticking out. This condition is a fire hazard.

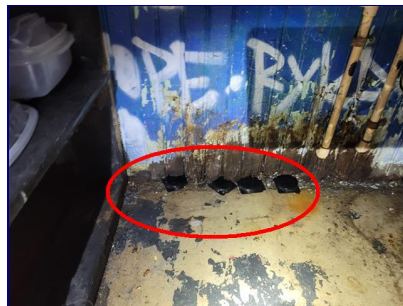
1.6 Item 2(Picture)

Signs of possible roach and pest infestation was observed and should be further evaluated and treated by a qualified pest control contractor.

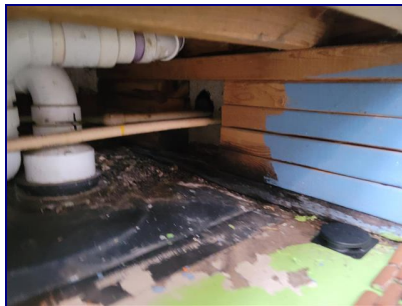
2.4 Item 3(Picture)

- ⚡ (2) Water flow at the shower in the entry bathroom appeared to be inadequate. The Inspector<sup>45</sup> recommends that you have this condition evaluated by a qualified plumbing contractor to determine the potential need and costs for correction.
- ⚡ (3) Fungi growth was observed below the shower pan due to water entering from behind the shower walls. The Inspector recommends installing a new shower enclosure to prevent water leakage and mold growth. The mold growth should be remediated by a qualified professional.

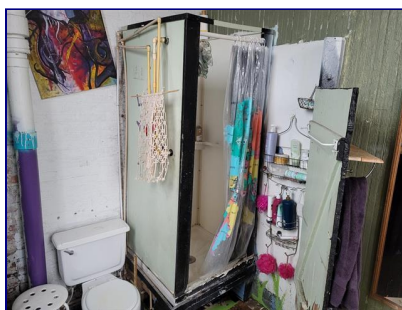
2.4 Item 6(Picture)

- ⚡ (4) In the bathroom, the shower enclosure was old and deteriorated.

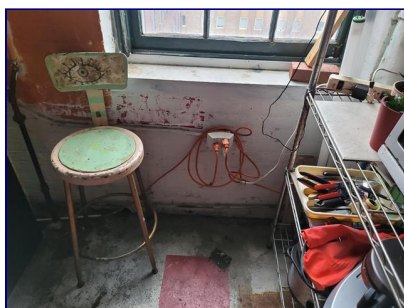
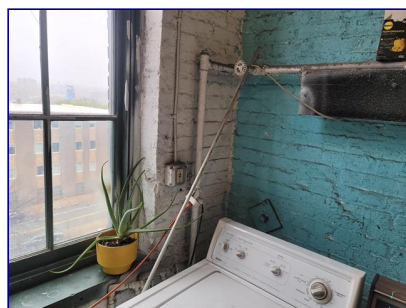
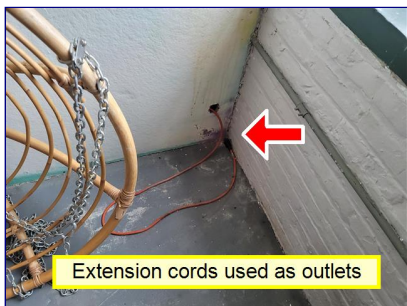
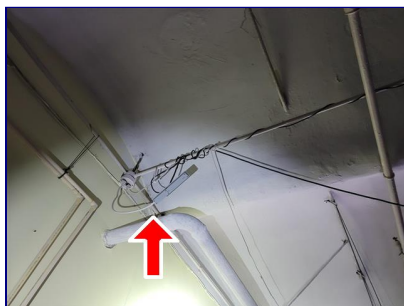
(1) The number of electrical receptacles in the home was inadequate and extension cords were used throughout the unit. This condition is potential fire hazard and should be corrected.

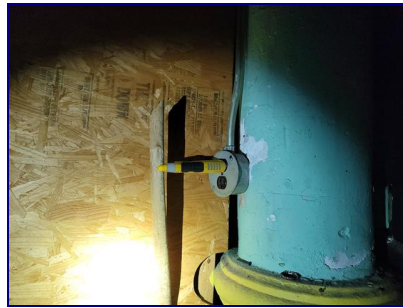
5.1 Item 7(Picture)

- (2) Some electrical receptacles in this unit were improperly wired and should be corrected by a qualified electrical contractor to prevent a fire hazard.<sup>48</sup>

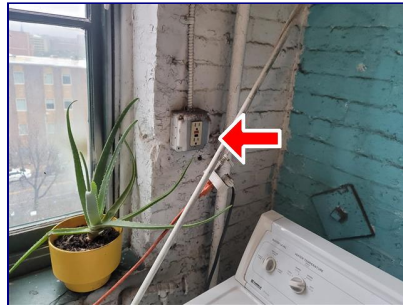
5.1 Item 9(Picture)

- (3) Some electrical receptacles in the home were inoperable at the time of the inspection. The Inspector recommends service by a qualified electrical contractor.

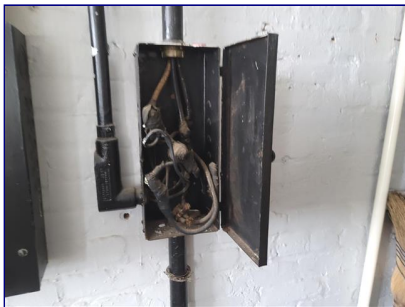
5.3 Item 2(Picture)

(2) Some of the electrical junction boxes had open wires and should be secured close to prevent electrical shock.

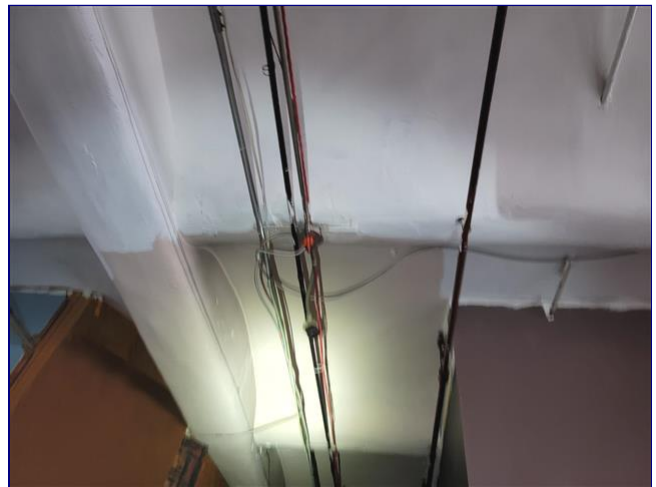
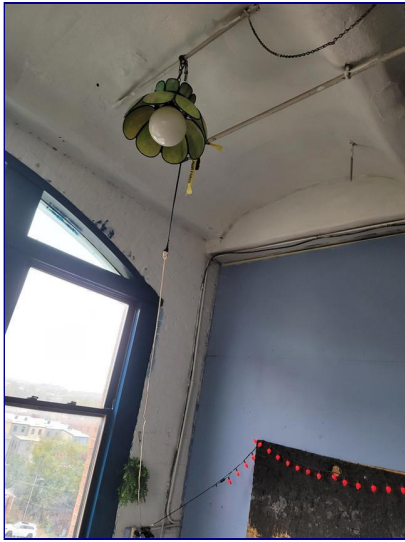
(3) Extension cords used as house wiring visible in the throughout the apartment at the time of the inspection is a potential fire hazard. The Inspector recommends removal of the extension cord and proper wiring be installed by a qualified electrical contractor.

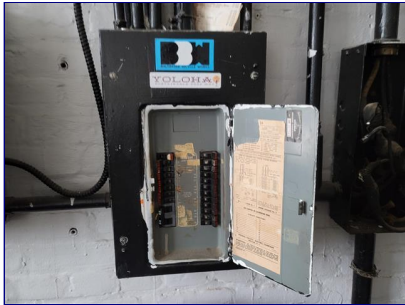
5.5 Item 1(Picture)

- 🔧 This sub-panel was made by Federal Pacific and was the Stab-lok model. Federal Pacific Stab-lok model sub-panels are reputed to have a high rate of circuit breaker failure which can result in a fire or shock/electrocution. One of the breakers was damaged and sparks when turned on. The Inspector recommends that you consult with a qualified electrical contractor concerning for replacing this sub-panel. Information about defective Federal Pacific Stab-lok panels is widely available on the internet.

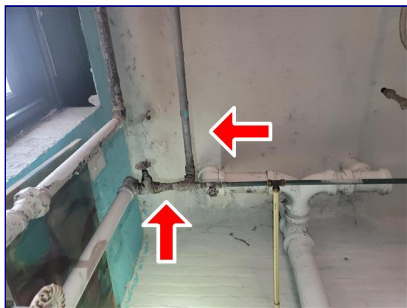
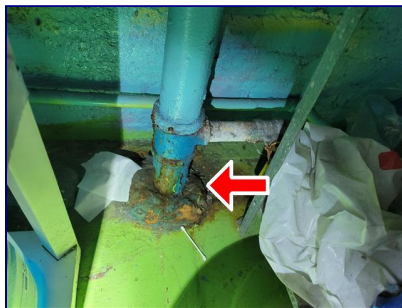
- (1) Some of the visible water distribution pipes were galvanized steel. These pipes are old, and of a material no longer installed for this purpose due to bore shrinkage from accumulation of interior corrosion that over time reduces water flow. These pipes may need to be replaced soon.

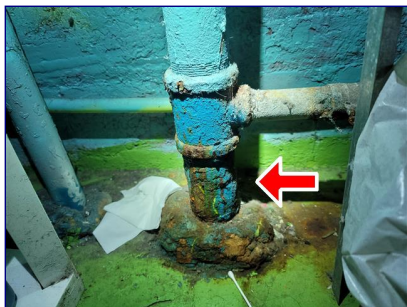
6.0 Item 3(Picture)

- (2) Actively leaking, heavily-corroded water distribution pipes visible in the bathroom should be repaired by a qualified plumbing contractor to avoid damage to home materials or the development of conditions which encourage the growth of microbes such as mold.

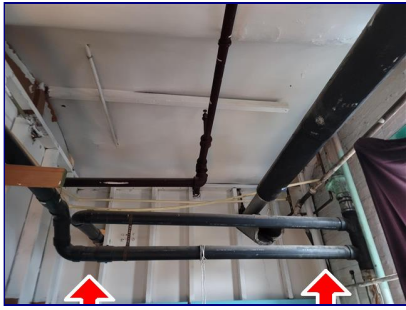
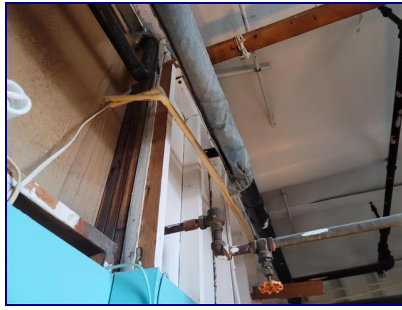
- (3) Chlorinated Poly Vinyl Chloride (CPVC) water distribution pipes were poorly supported in the unit. This condition puts excessive strain on fittings and may result in premature failure. Horizontally-oriented CPVC distribution pipes should be supported at least every 3 feet. The Inspector recommends installation of additional supports by a qualified contractor. Some portions of the home distribution piping will not be accessible for installation of additional supports.

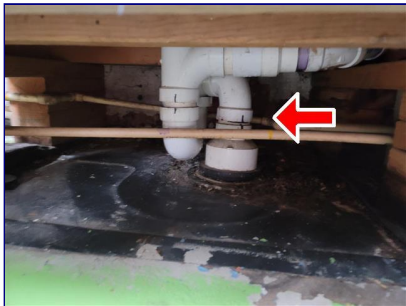
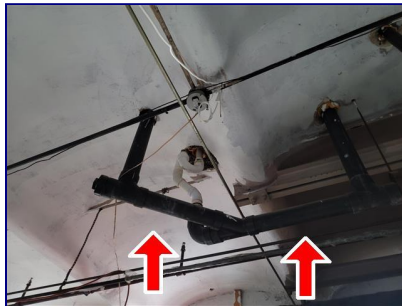
(1) Many traps were of a type called an "S-trap". S-traps are no longer allowed to be installed in new construction for safety reasons. A siphon can develop which empties the trap of water; a condition with the potential to allow toxic sewer gas to enter the living space. Although this type of trap may have been commonly considered safe at the time the home was originally constructed, as general knowledge of safe building practices has improved with the passage of time, building standards have changed to reflect current understanding. The Inspector recommends replacement of all such traps in the home by a qualified plumbing contractor.

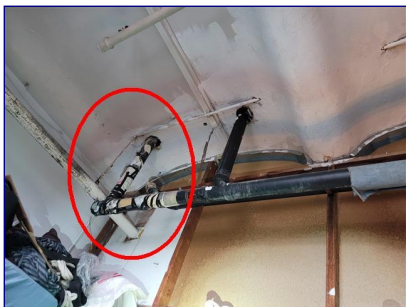
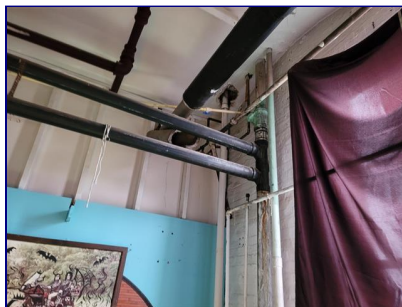
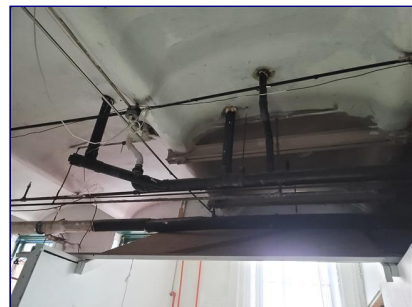
(2) Drain/waste pipes in the rear bedroom were damaged and had created unhealthy conditions at the time of the inspection. The Inspector recommends correction and disinfection by a qualified contractor.

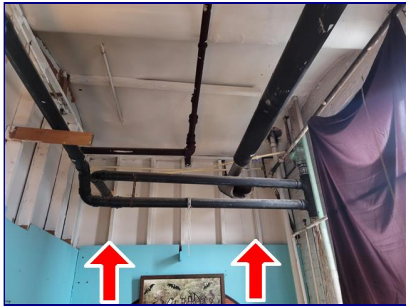
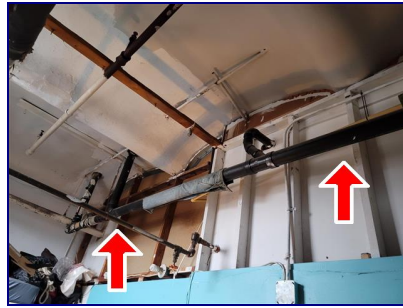
(3) Supports for the ABS or PVC drain/waste pipe visible in the rear bedroom were located too far apart. The maximum support spacing recommended by generally-accepted modern plumbing standards is 4 feet. The Inspector recommends correction by a qualified contractor.

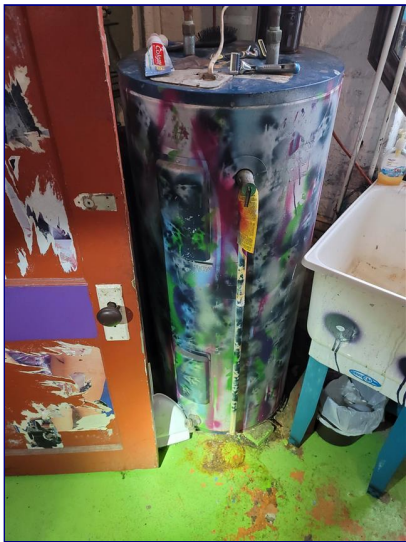
6.2 Item 1(Picture)

The pressure relief valve was leaking at the time of the inspection. Because the TPR valve is an important safety component it should be replaced by a qualified HVAC technician or plumbing contractor.

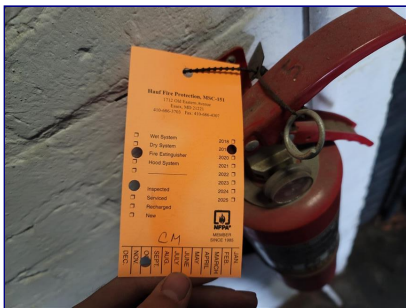
6.3 Item 1(Picture)

Some of the fire extinguishers in the common areas had expired inspections.

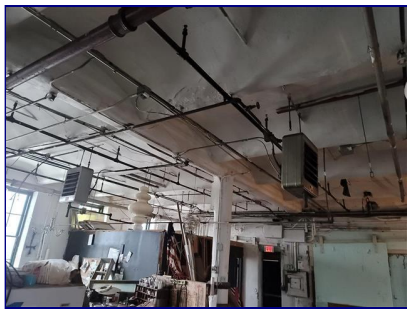
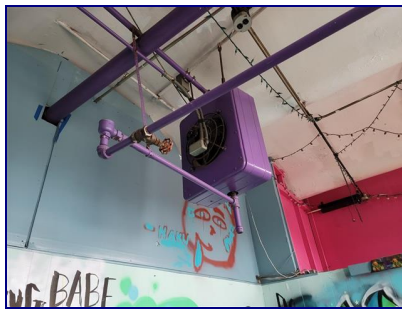
The apartment had no operable heat present in all the rooms. Heat was relied on old boiler distribution pipes to give off heat without radiators which was not suffice and was inoperable at the time of the inspection. Heat was not on and no controls were present. The Inspector recommends that heat be installed in each room with accessible thermostats to the occupants of the apartment by a qualified HVAC contractor or electrician. It was cold outside and in the units at the time of the inspection.
