Building Explosion and Fire  
Silver Spring, Maryland  
August 10, 2016

**Accident Report**

NTSB/PAR-19/01  
PB2019-100722

# Pipeline Accident Report

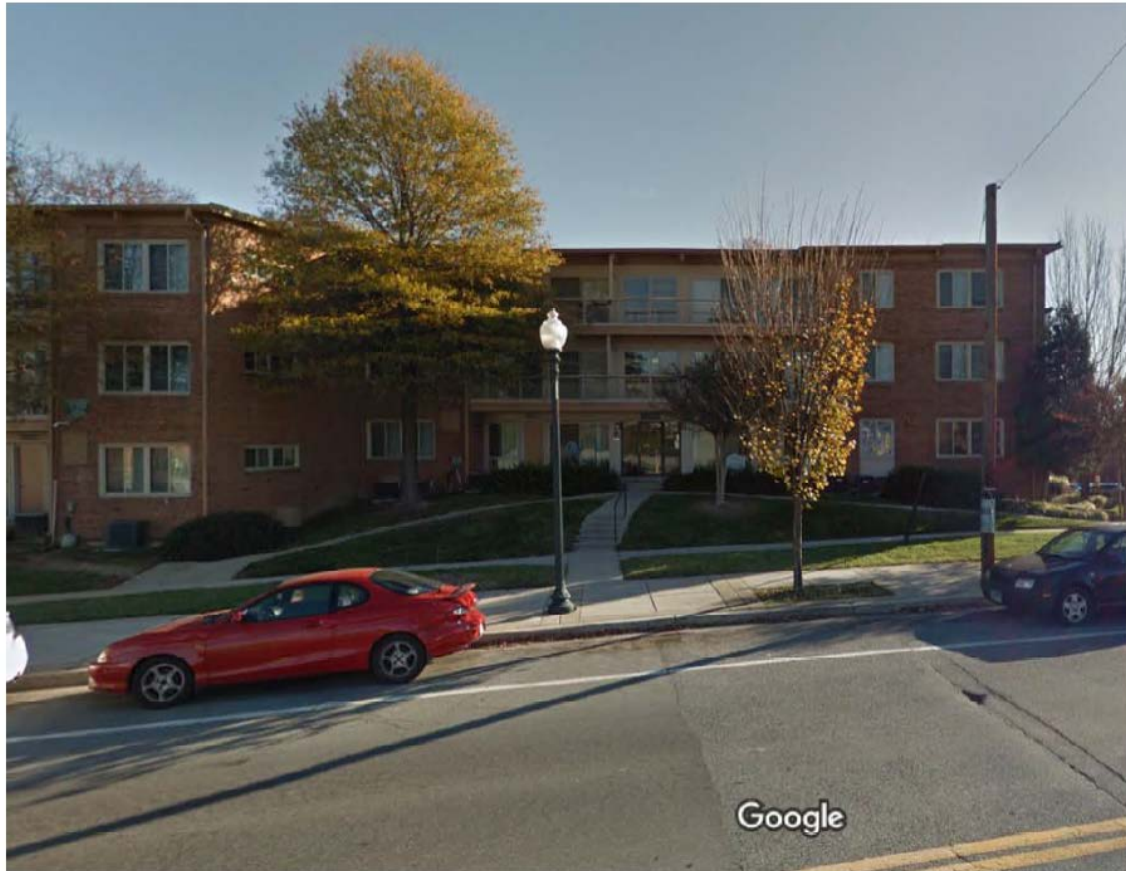
**Figure 1.** The accident location, 8701 Arliss Street, before the August 10, 2016, explosion. (Photograph from Google Earth, dated November 2015.)

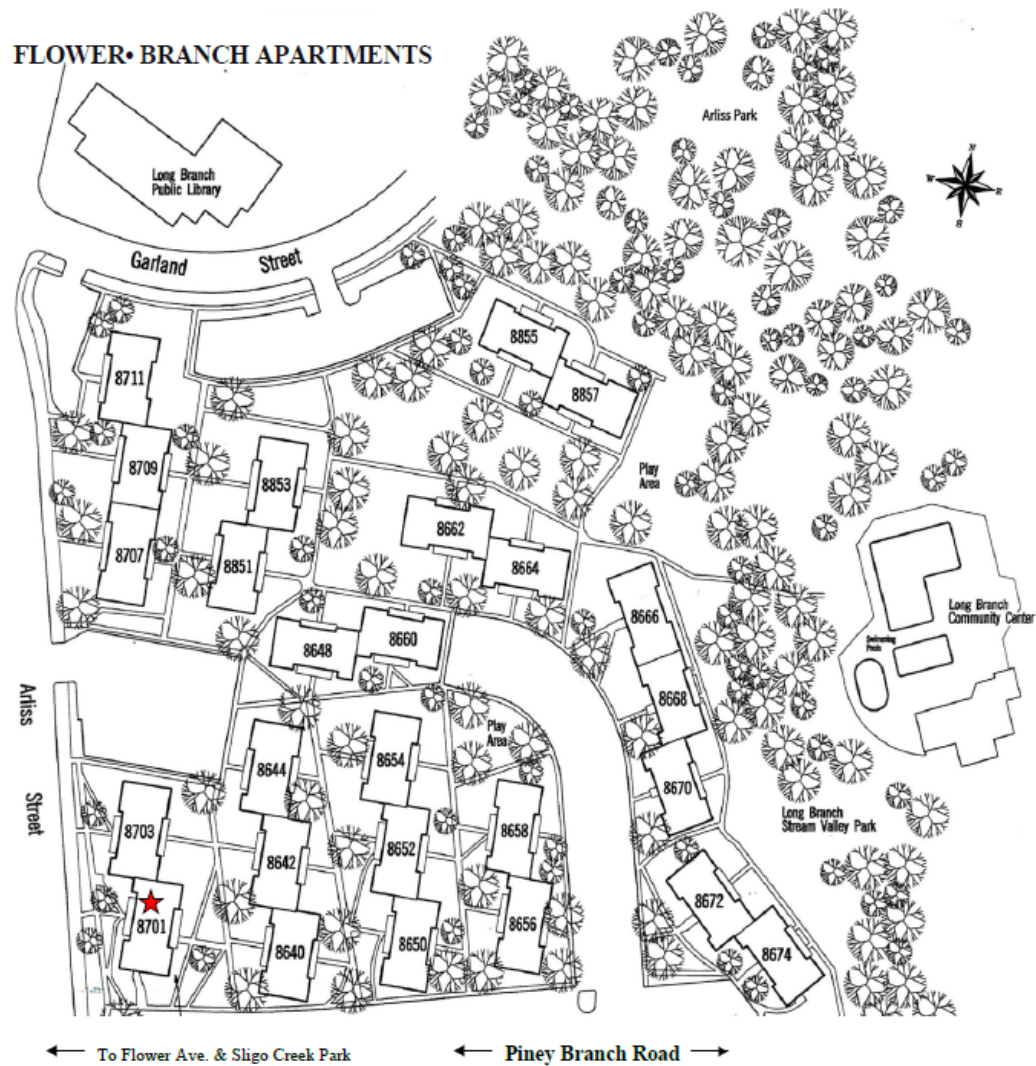
**Figure 3.** Layout of the Flower Branch apartment complex. Building 8701 is identified by a red star. (Graphic provided by Kay Management.)

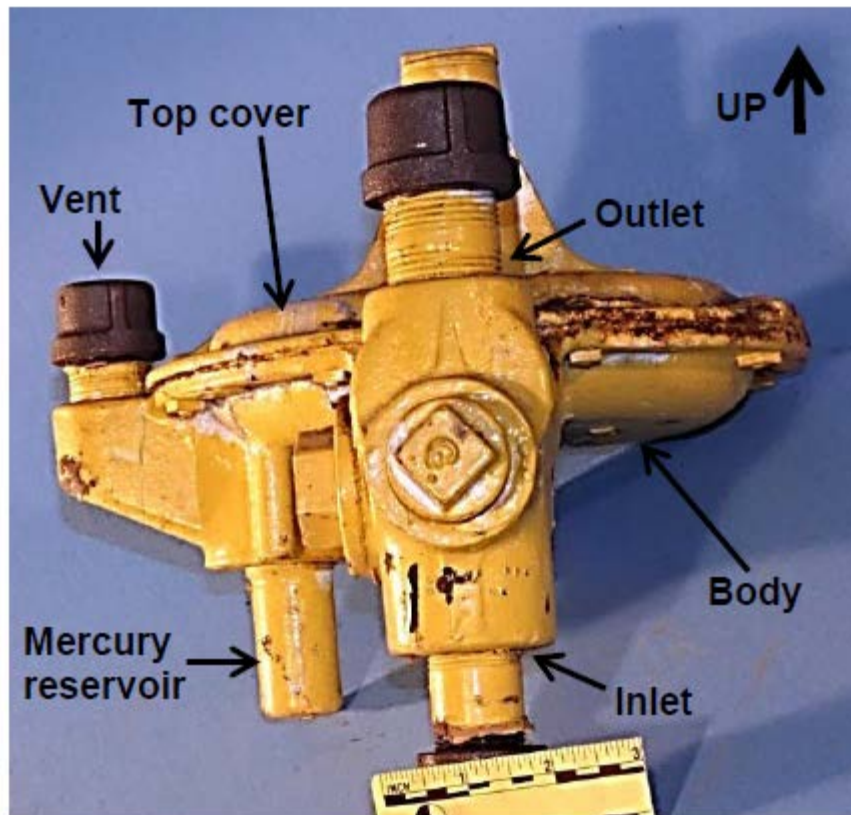
**Figure 8.** Exemplar mercury service regulator taken from a nearby Flower Branch apartment building.

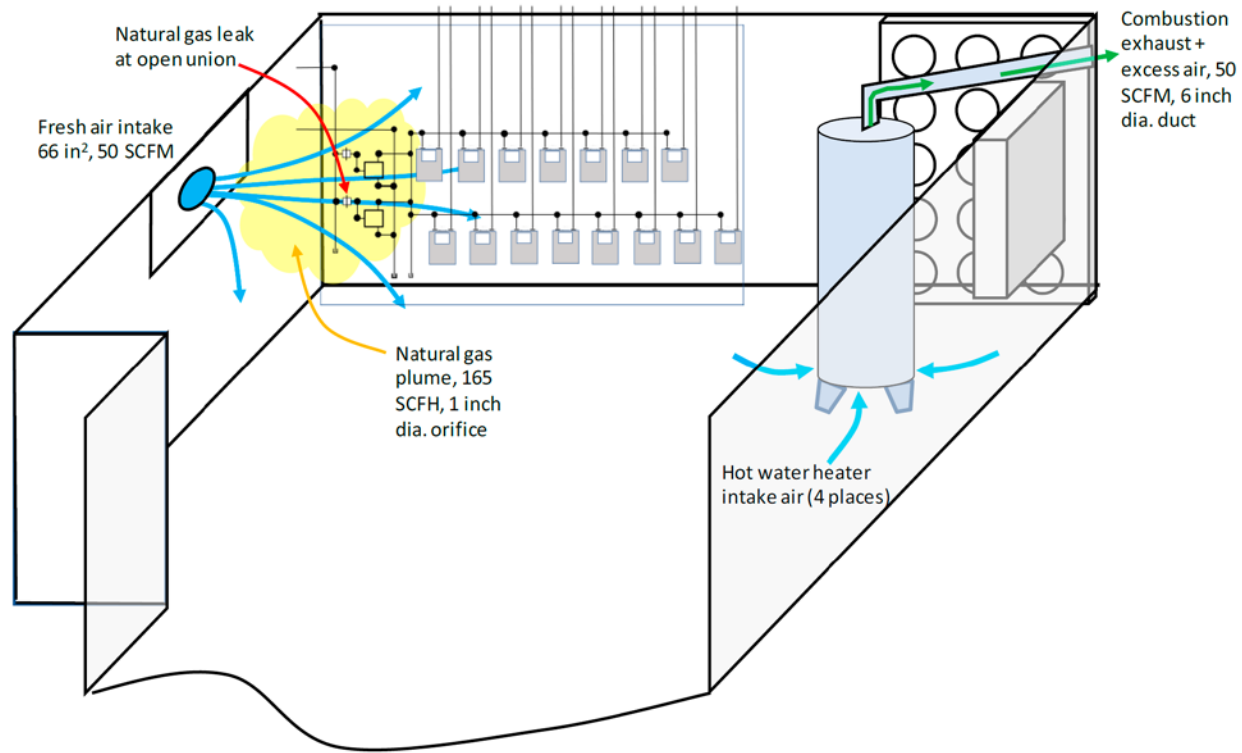
regulator vent leak would reduce to zero. The water heater was assumed to be active 20 minutes of every hour. WG provided gas composition analysis and the concentration for LEL for the gas being delivered to the Flower Branch apartments on the day of the accident. The LEL was reported to be 4.78 percent, which was used in the model. The general configuration of the meter room can be seen in figure 16.

**Figure 16.** Three-dimensional visualization of the meter room.
