Collington Branch – The Need for Stream Restoration

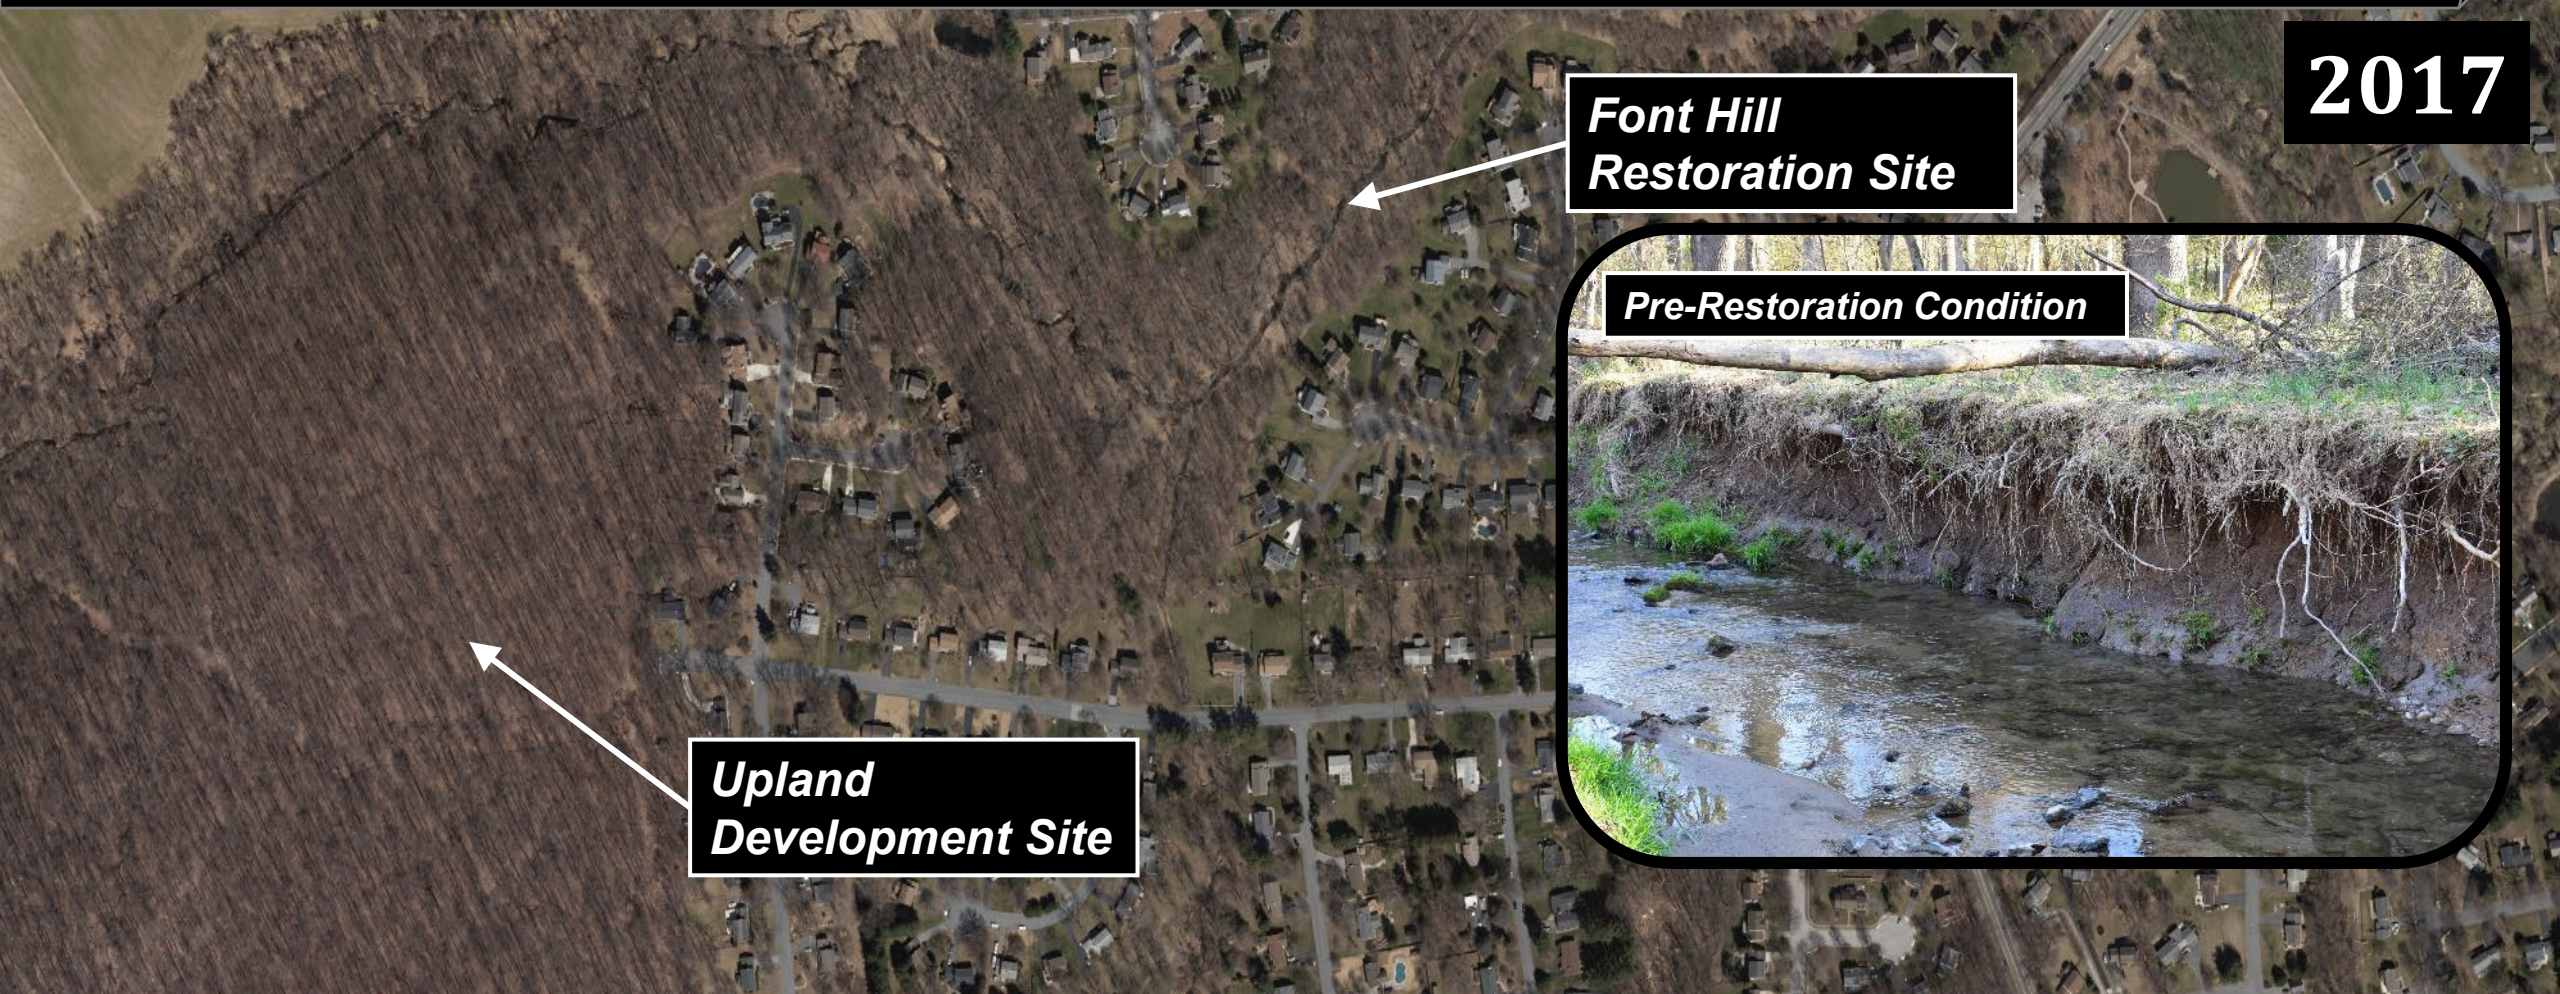
2017

These slides depict a before and after sequence for the Font Hill Stream and Wetland Restoration Project. The background photos show a temporal progression where hundreds of acres above this project were clear cut for development juxtaposing a temporary impact to install a very beneficial integrated stream and wetland project with permanent forest loss.

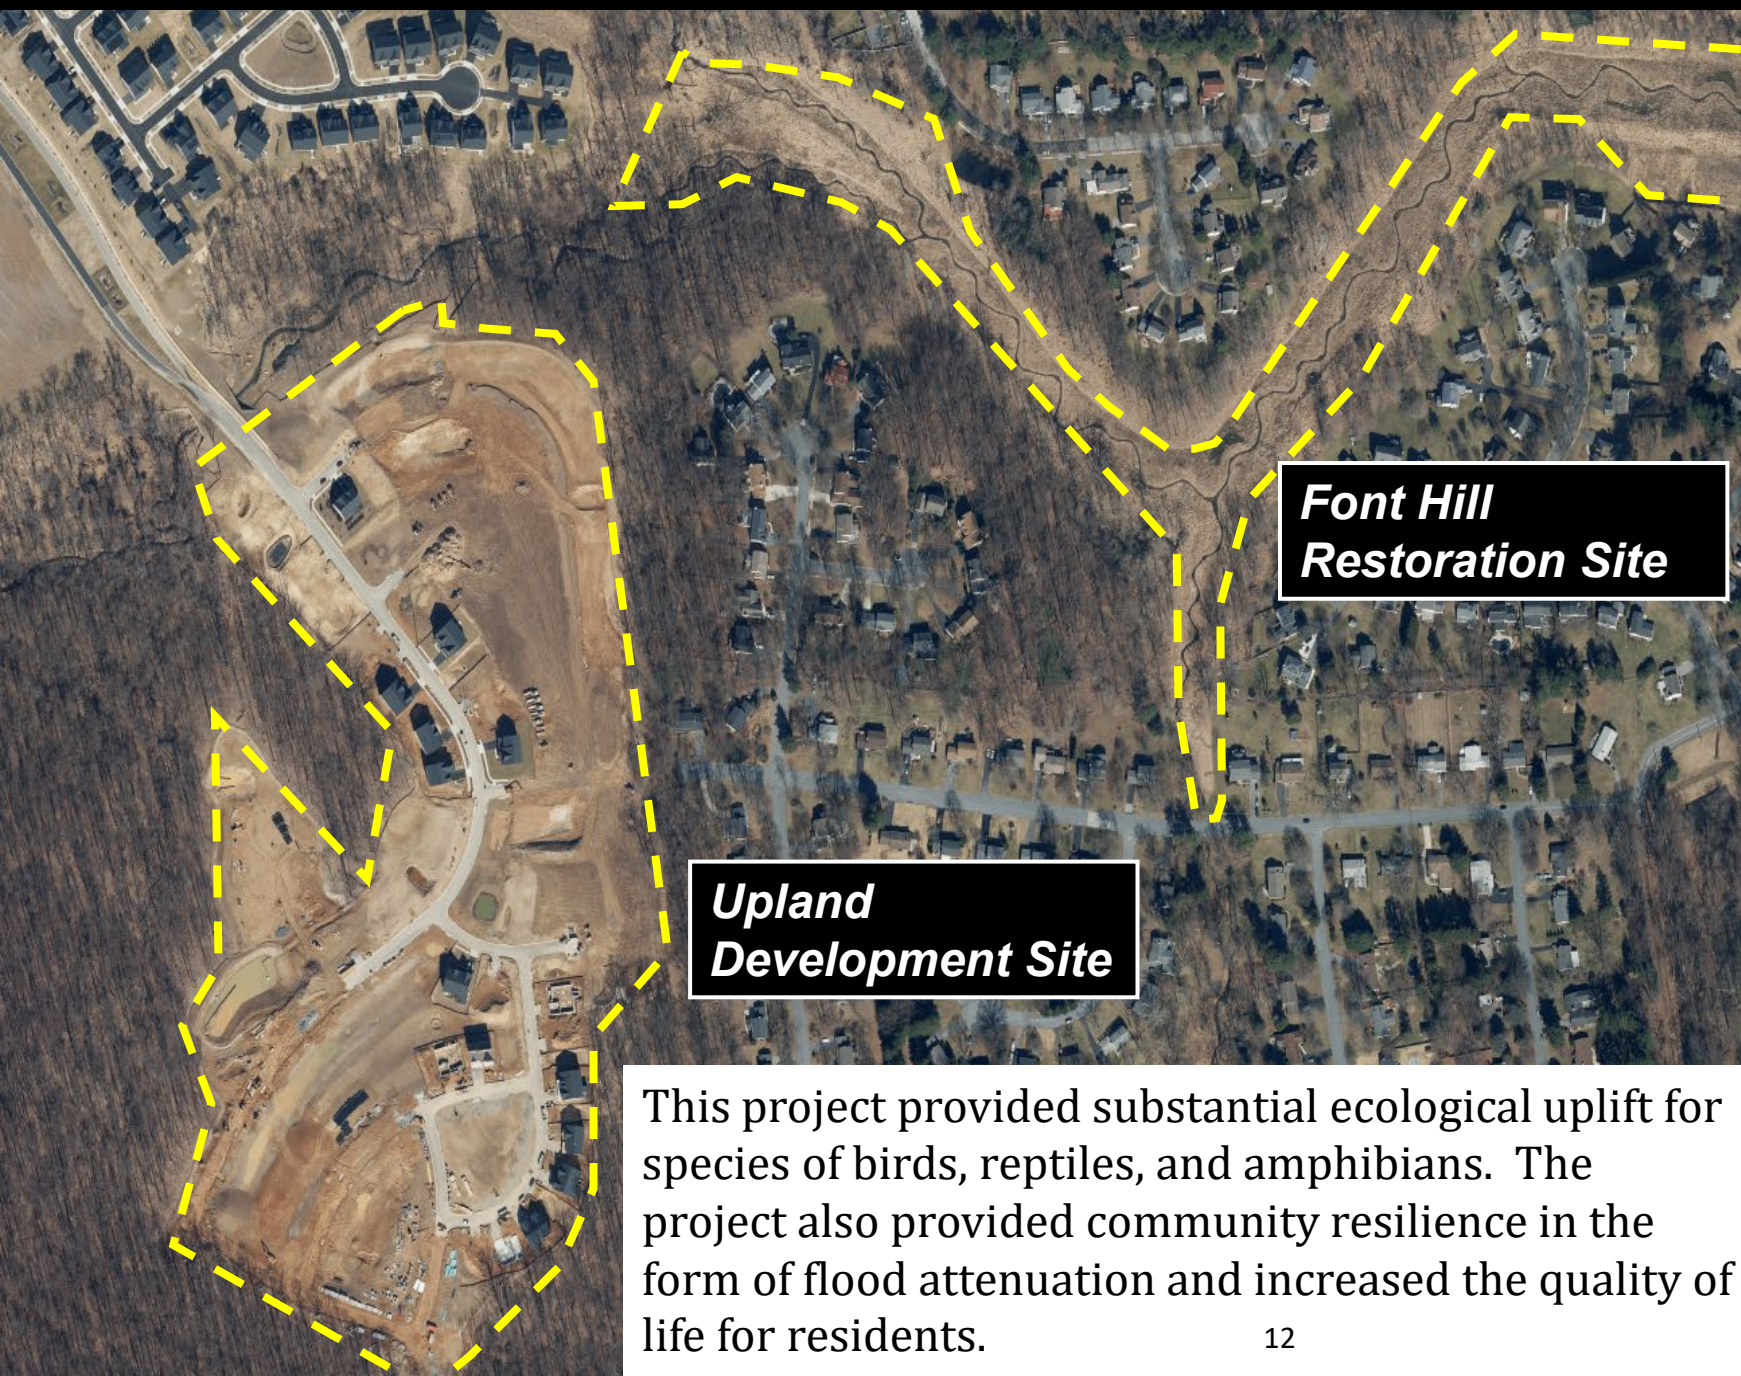
2022

This project provided substantial ecological uplift for species of birds, reptiles, and amphibians. The project also provided community resilience in the form of flood attenuation and increased the quality of life for residents.
