# Land as Nature Intended It

Stream Restoration Efforts Restore Watersheds, Improve Water Quality

by Beth Forbes, Stormwater Program Manager

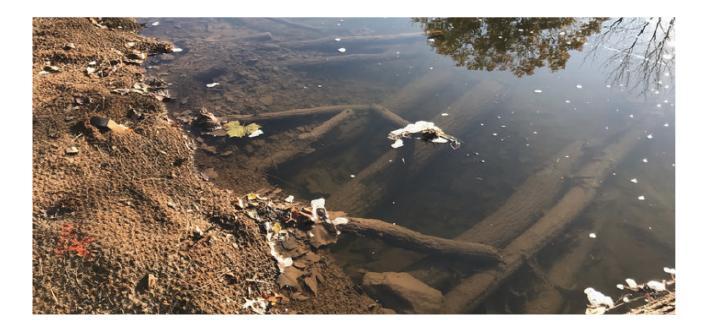
While there was a lot of tree impact to Whetstone Run to remove the legacy sediments, the project's design incorporates two features that help keep the stream's flow from becoming too warm for aquatic life. One feature is the toe wood that is installed at the stream's meanders (pictured here). Many trees felled on-site for the project were reused in structures that

provide shade for aquatic life. Until trees reestablish in the floodplain area, fish and other aquatic life will find respite from the sun under these structures.
