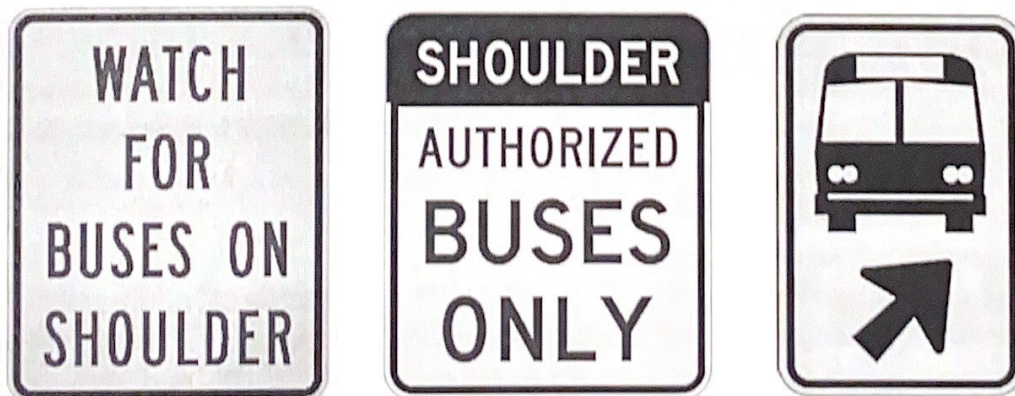
Figure 3: Samples of BOS Signage

**In general, BOS implementation has used minimal signing and markings.** In addition to relevant signage recommended in the Manual for Uniform Control Devices (MUTCD), regions implementing BOS projects have used a number of different signs as appropriate to their state codes, though there does appear to be a gradual convergence. Signs will indicate authorized bus use of shoulders, both along the shoulders and at intersections and merges. For roads within the National Highway System, the precise signage is subject to approval from the Federal Highway Administration (FHWA) and the Federal Transit Administration (FTA).

In the Twin Cities, small yellow advisory "pinch-point" signs are posted when the shoulder narrows to less than 10 feet and the bus must re-merge into the general lanes.
